A3 BLOCK DIAGRAM

FILE LIST

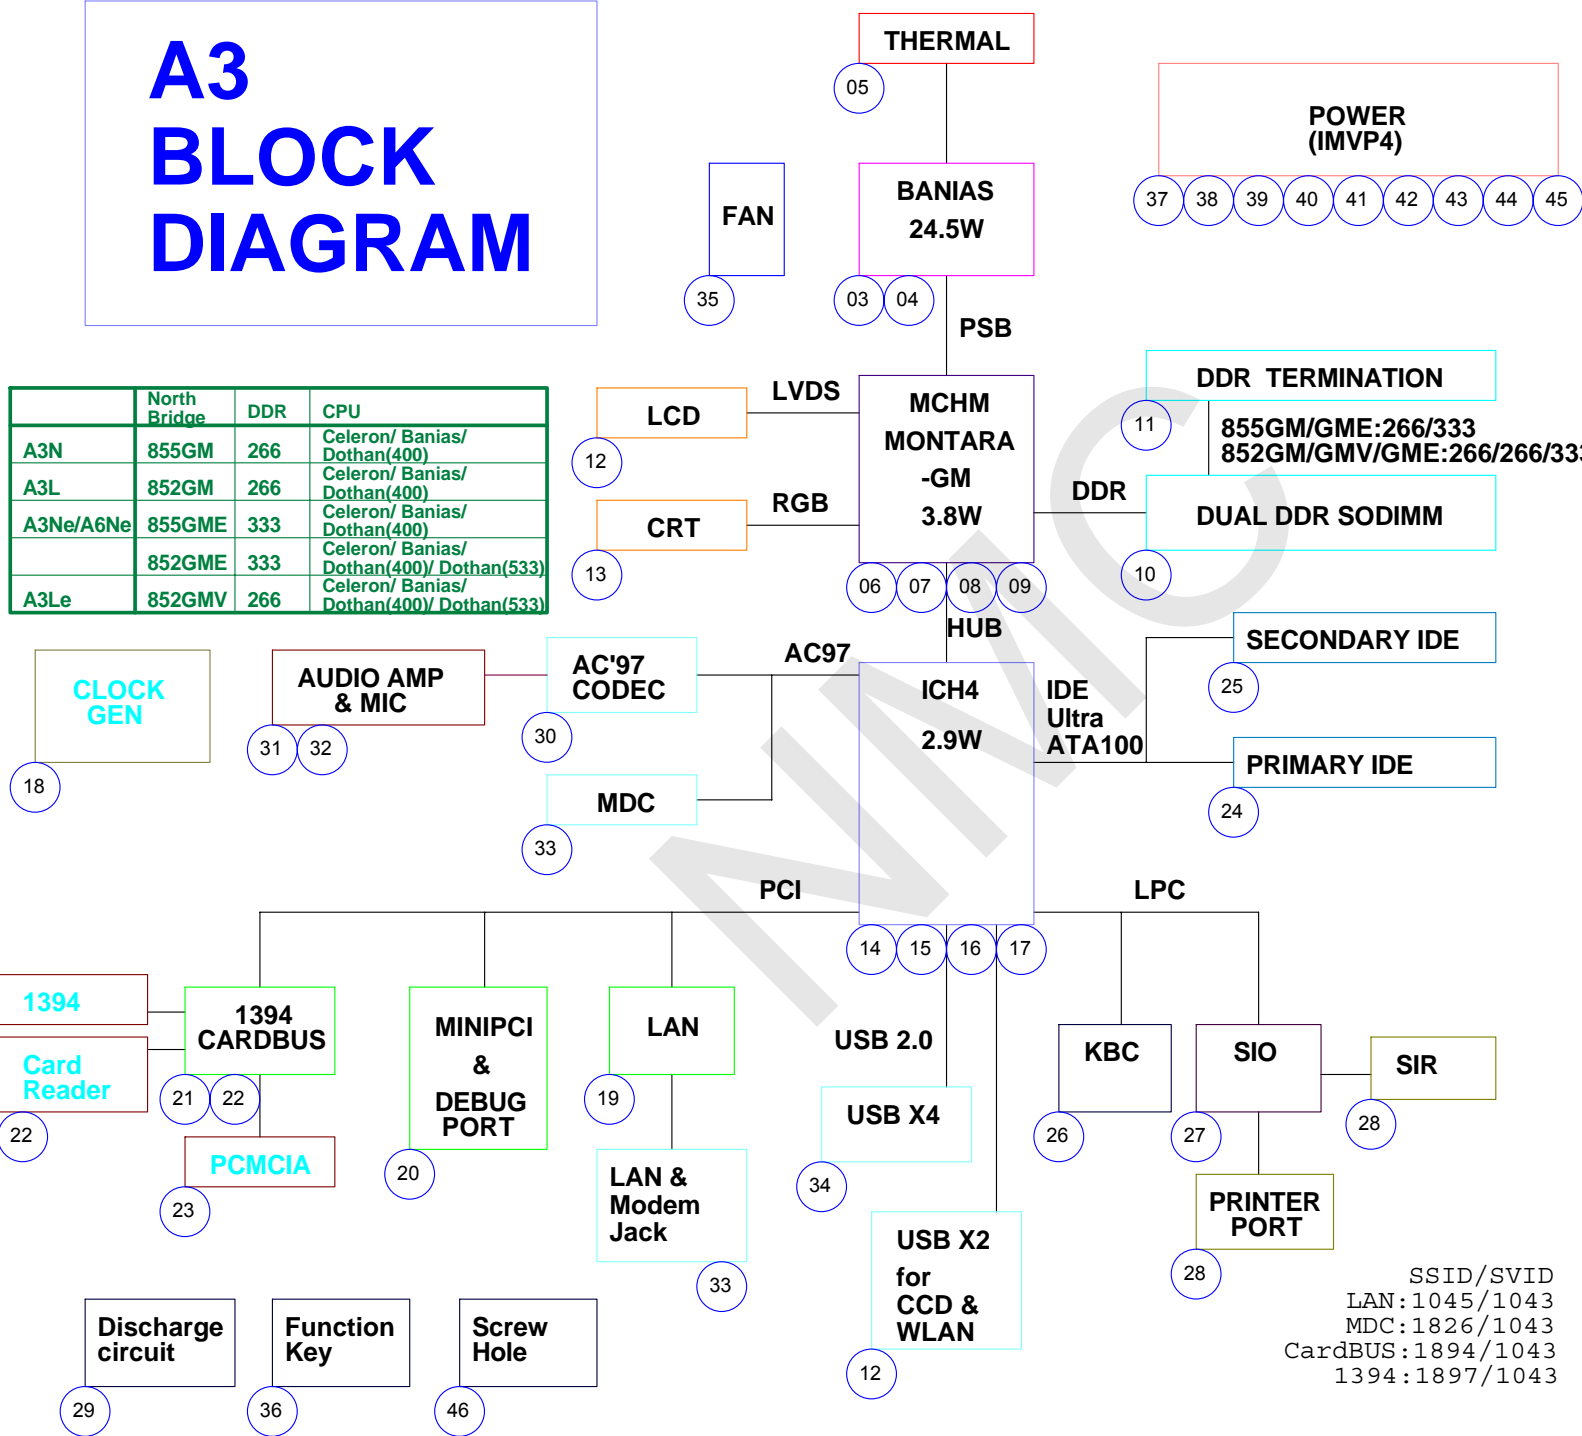
North Bridge	DDR	CPU
A3N	855GM	266	Celeron/ Banias/ Dothan(400)
A3L	852GM	266	Celeron/ Banias/ Dothan(400)
A3Ne/A6Ne	855GME	333	Celeron/ Banias/ Dothan(400)
	852GME	333	Celeron/ Banias/ Dothan(400)/ Dothan(533)
A3Le	852GMV	266	Celeron/ Banias/ Dothan(400)/ Dothan(533)

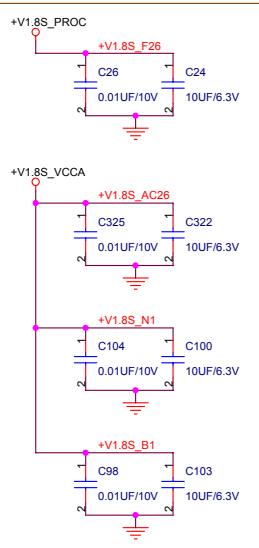
CPU PLL CIRCUITS
 1.71V - 1.89V(+/- 5%)
 SO-S1M: 0.3A

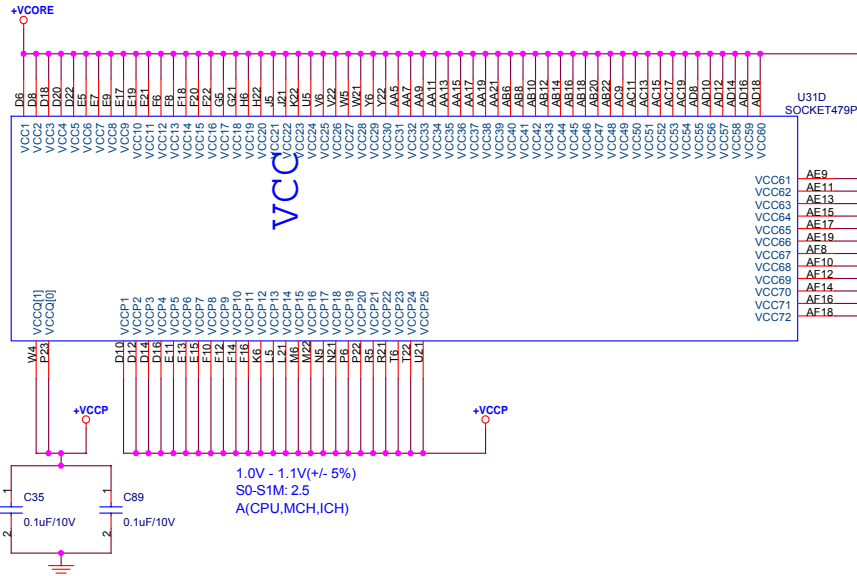
HFM(1.3GHz-1.7GHz): 1.468V
 LFM(600MHz): 0.956V
 0.745V - 1.356V(+/- 1.5%)
 C0: 25 A
 C3: 7.59A
 C4: 0.9A

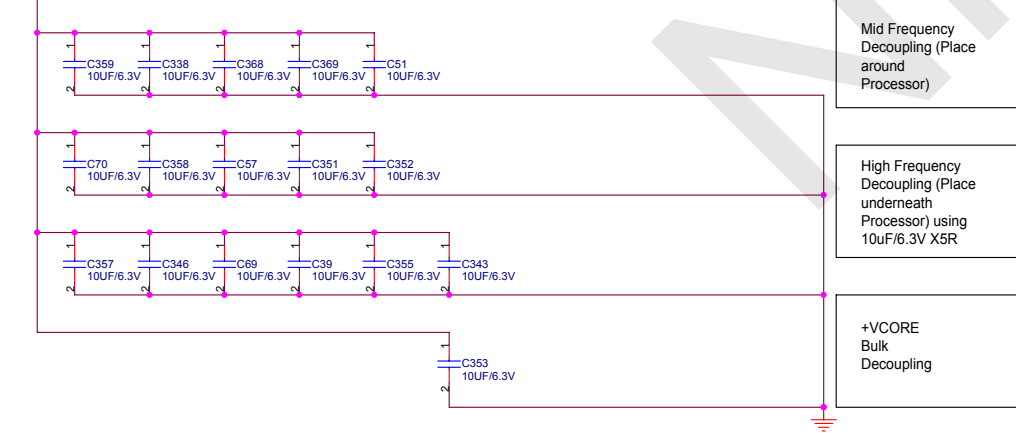
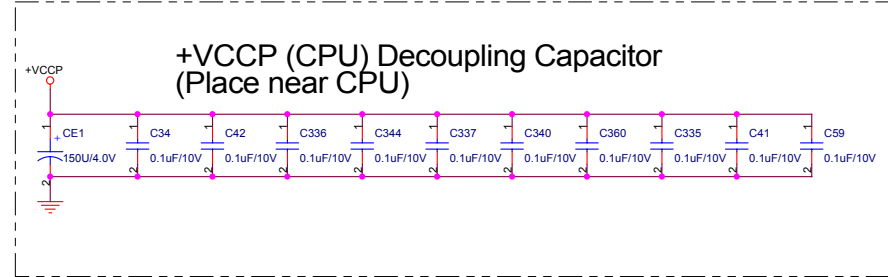
CPU VCORE Decoupling Capacitor

M3N : Four 200 uF are located in IMVP4
 A3N : Delete 10uF/6.3V from 35pcs to 17pcs

- Mid Frequency Decoupling (Place around Processor)
- High Frequency Decoupling (Place underneath Processor) using 10uF/6.3V X5R
- +VCORE Bulk Decoupling

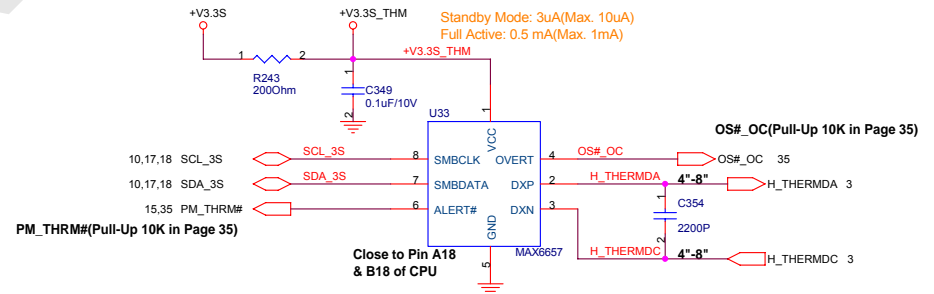
2308
 For A3N/A3NE/A3L:
 Load R397
 For A3LE:
 Load C537, C538, Q93, R398, R399, R400, R404, R405, U53

Route H_THERMDA and H_THERMDC on the same layer

-----OTHER SIGNALS
 12 mils
 =====GND
 10 mils
 =====H_THERMDA(10 mils)
 10 mils
 =====H_THERMDC(10 mils)
 10 mils
 =====GND
 12 mils
 -----OTHER SIGNALS

Avoid BPSB,Power

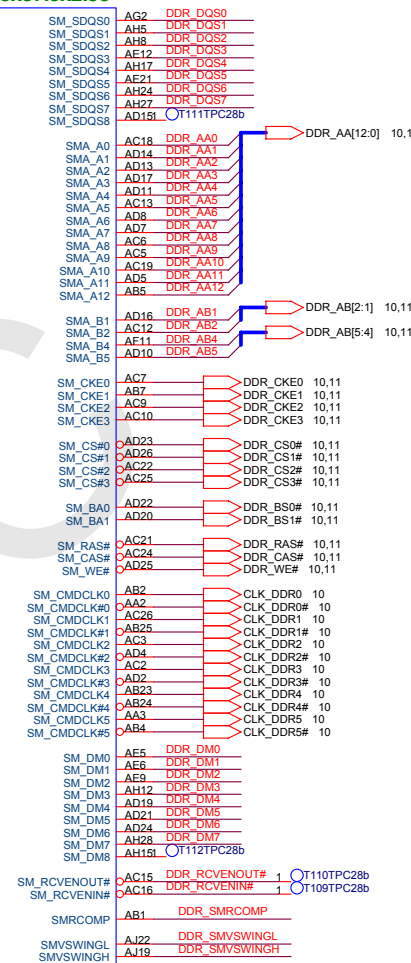
DDR SYSTEM MEMORY

(MCH-Sighting041)
M-GM system memory interface generates single pulse CKE events which may cause intermittent hangs and display corruptions when using Micron and Infineon SO-DIMMs.

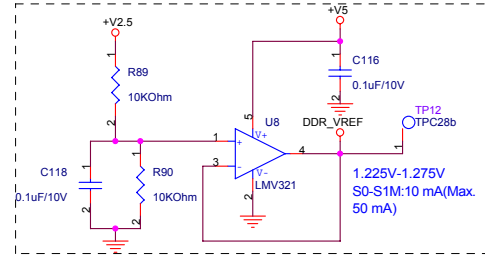
Intel suggested that DDR_VREF should be turned off in S3-S5. But measure the leakage because there is no +V2.5S.

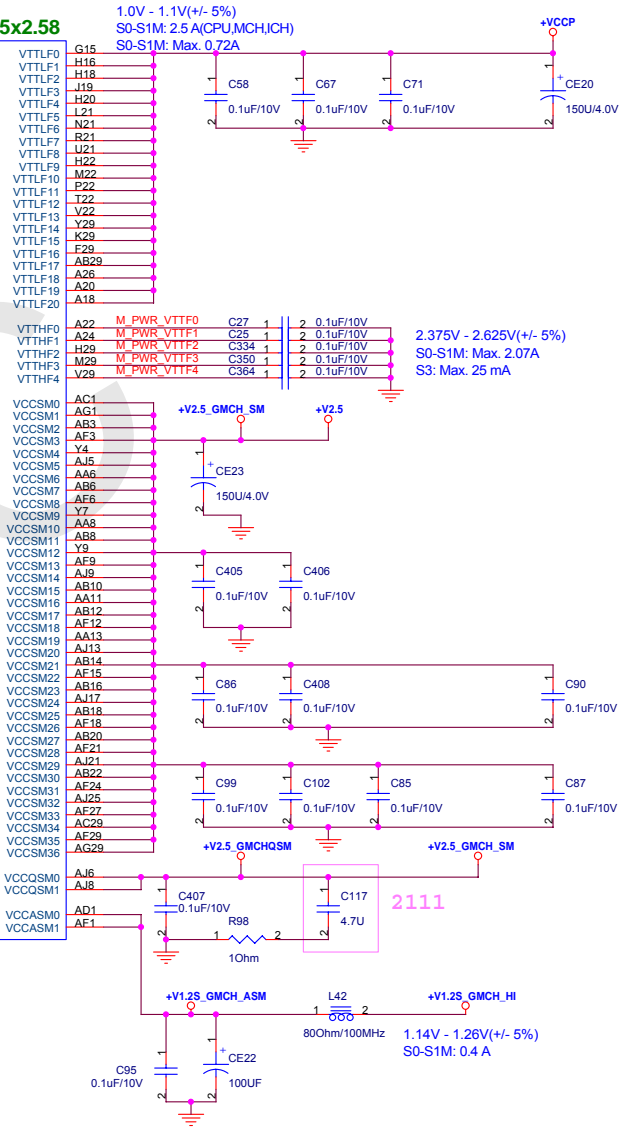
NB
VCC,VCCASM,VCCCHL,VCCAGPLL,VCCADPLLA,VCCADPLLB:
855GM/852GM: 1.2V
855GME: 1.35V
852GME/852GMV: 1.5V

Caution:
L2 be placed between Pin U9 and U13

Caution:
There is no vias between Pin B8 and C99,C100 (It means C99,C100 must be in same layer with MCHM)

Caution:
There is no vias between Pin B11 and C106,C107 (It means C106,C107 must be in same layer with MCHM)

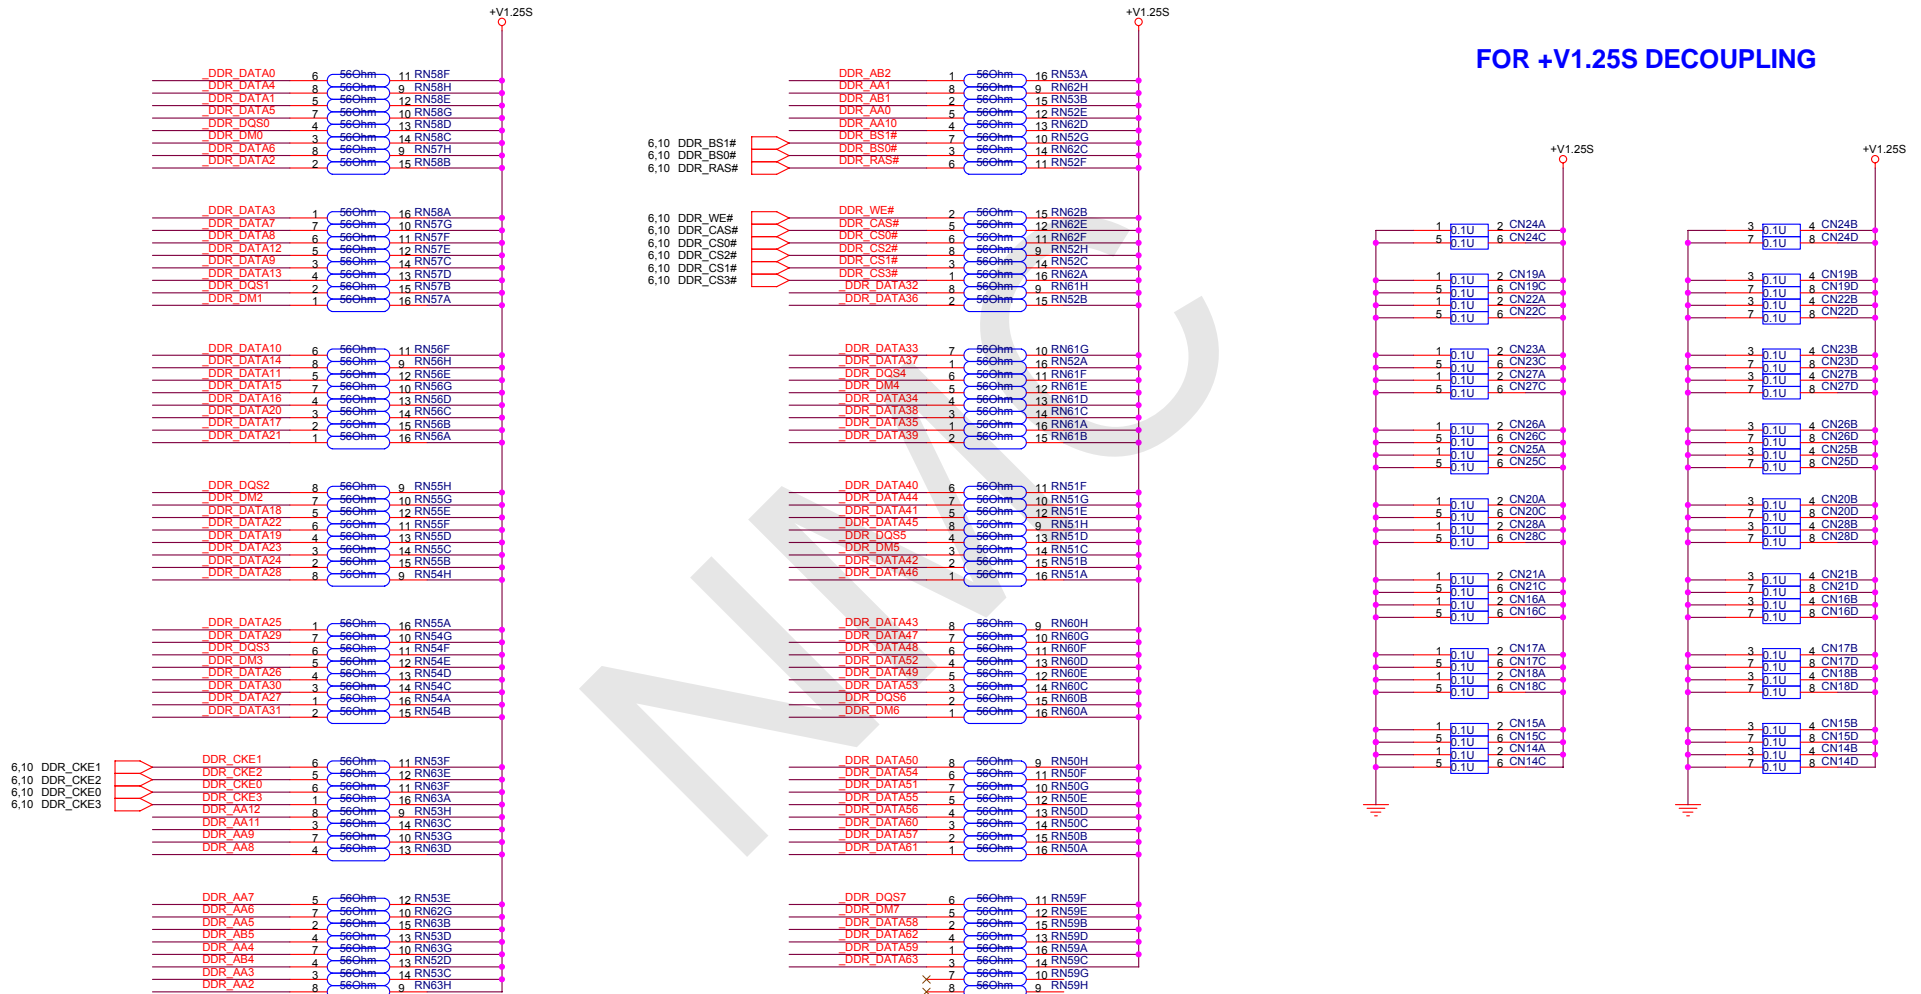
DDR TERMINATION

FOR +V1.25S DECOUPLING

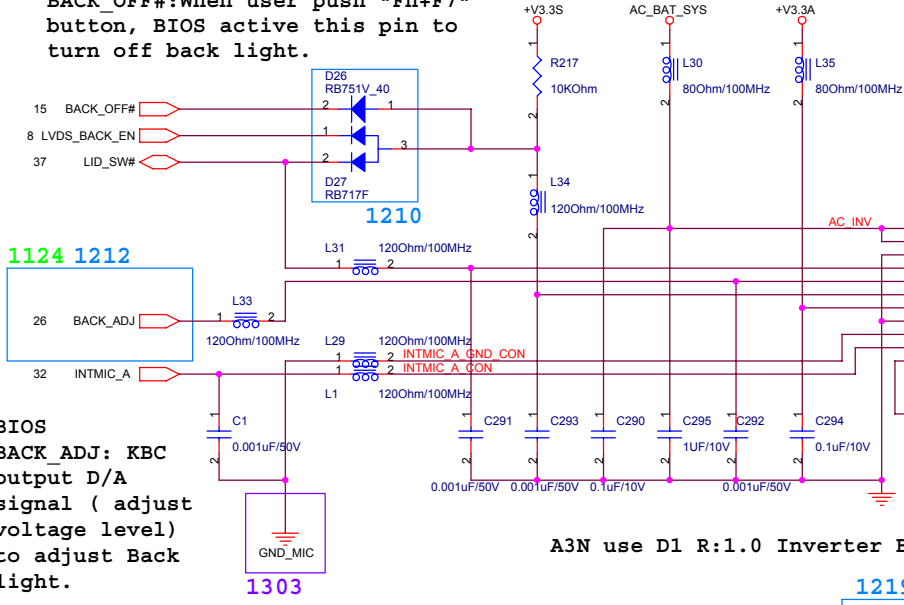
BIOS
BACK_OFF#:When user push "Fn+F7"
 button, BIOS active this pin to
 turn off back light.

BIOS
BACK_ADJ: KBC
 output D/A
 signal (adjust
 voltage level)
 to adjust Back
 light.

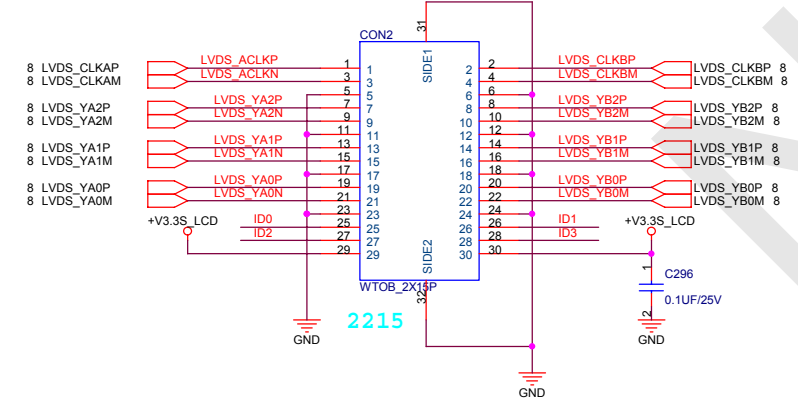
LCD CABLE ID:	PID3	PID2	PID1	PID0
14.1 XGA	1	1	1	1
15.1 XGA	1	1	0	1
15.1 SXGA+	1	0	1	1

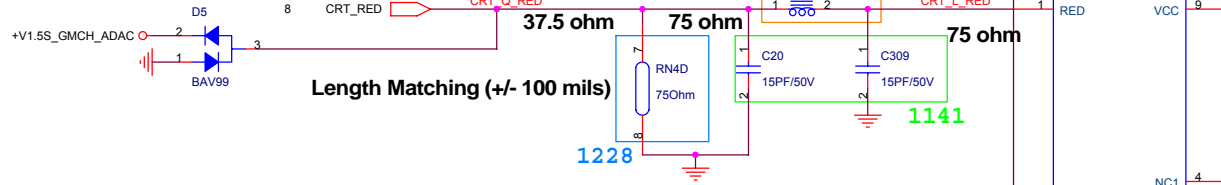
Place Pi-Filter close to CRT
(<= 200 mils)

Guarded by GND (Space >= 20mils)

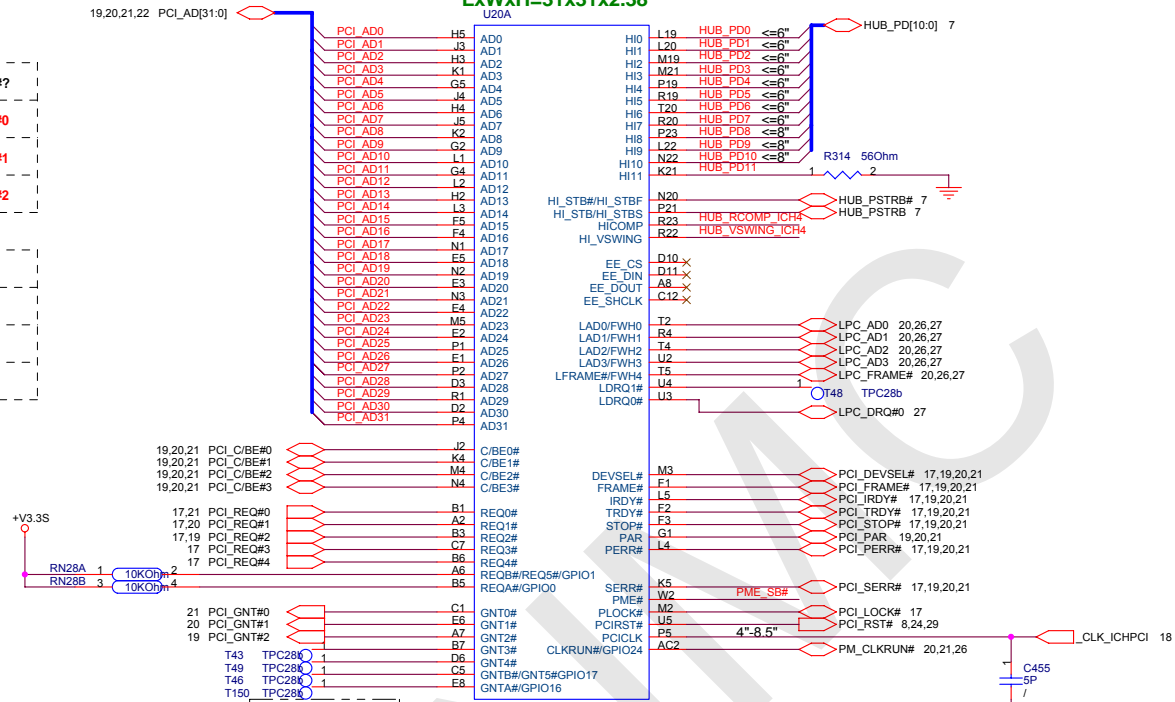
ICH4 pin E8
Strap Option
Default: Pull-High 20K
Pull-Down for BIOS
TOP-BLOCK SWAP

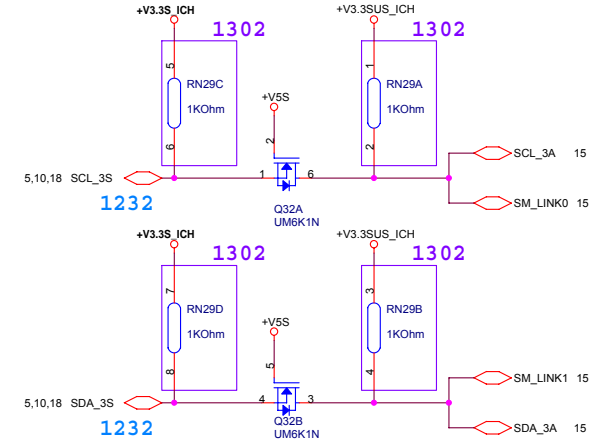
ICH4 SMLink & SMBus must be tied together

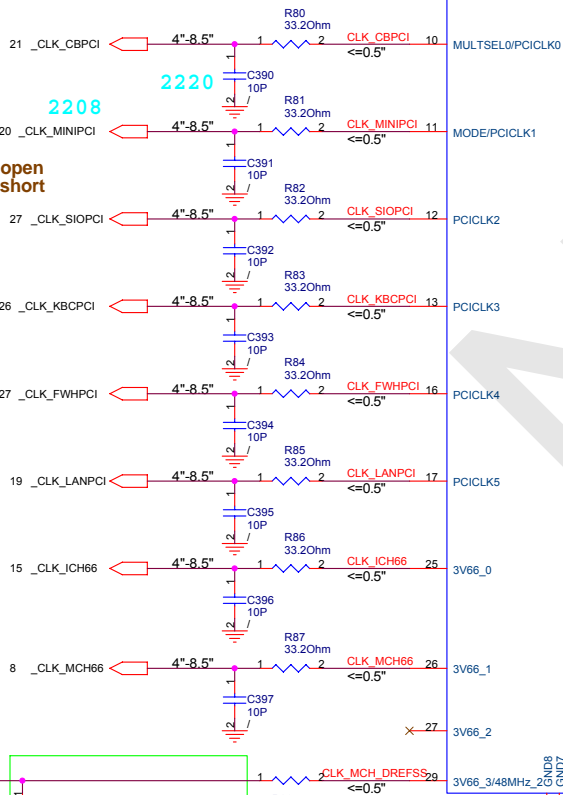
I2C address: D2H
3.3V +/- 5%
S1M: 40 mA
S0: 360 mA

FS1	FS0	FUNCTION
0	0	66 MHz
0	1	100MHz
1	0	200MHz
1	1	133MHz

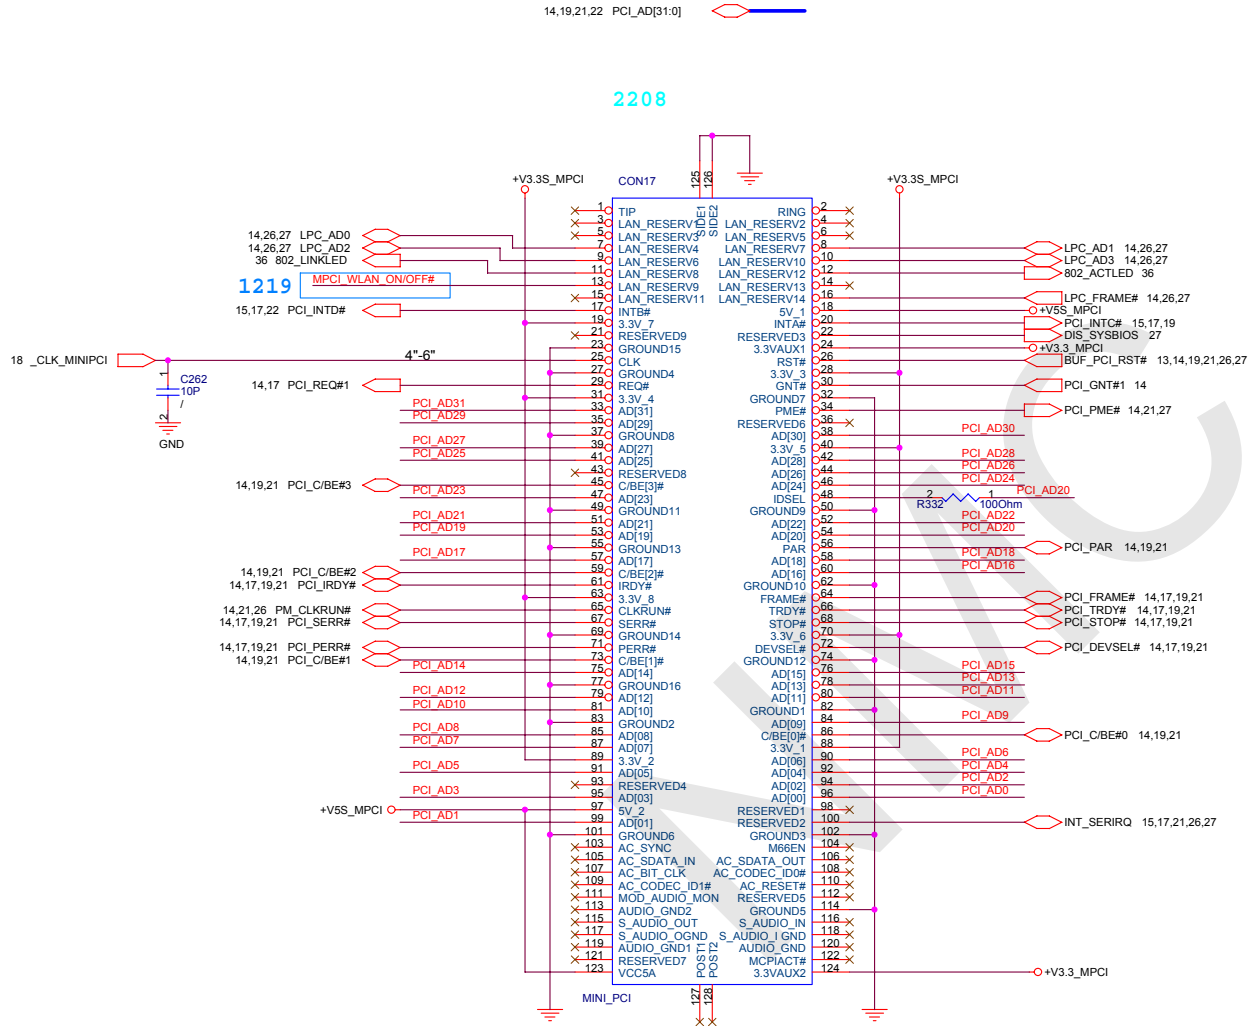
Intel Calexico(802.11a+802.11b)
 802.11b Tx: 500-526 mA Rx: 280-299 mA Sleep: 30 mA
 802.11a Tx: 435-475 mA Rx:310-327 mA Sleep: 30 mA

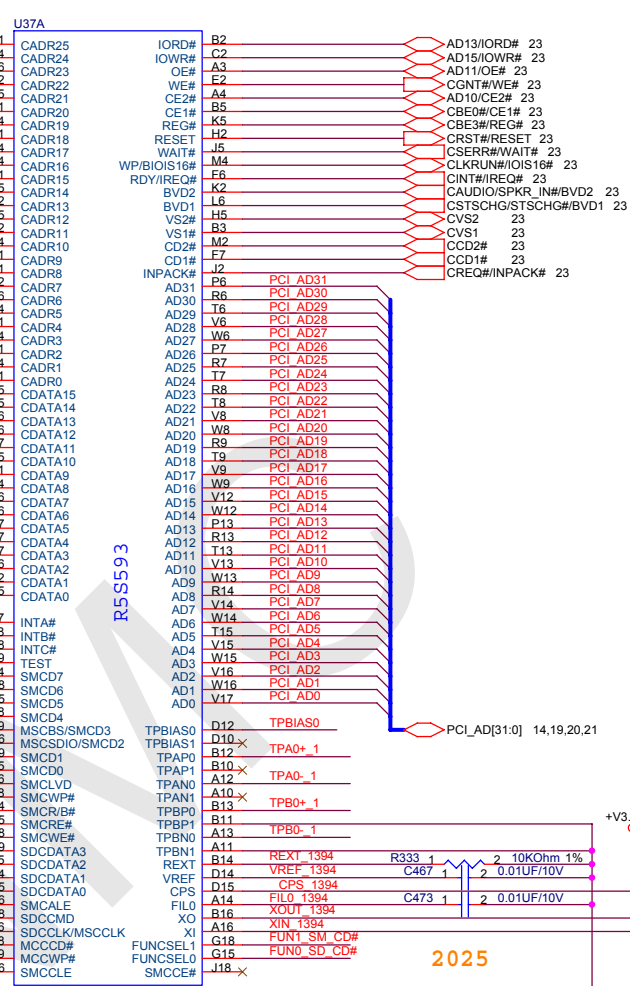
Memory Card Detect

FUNSEL1	FUNSEL0	Function
0	0	Not Support
0	1	SmartMedia
1	0	MMC/SD
1	1	Memory Stick

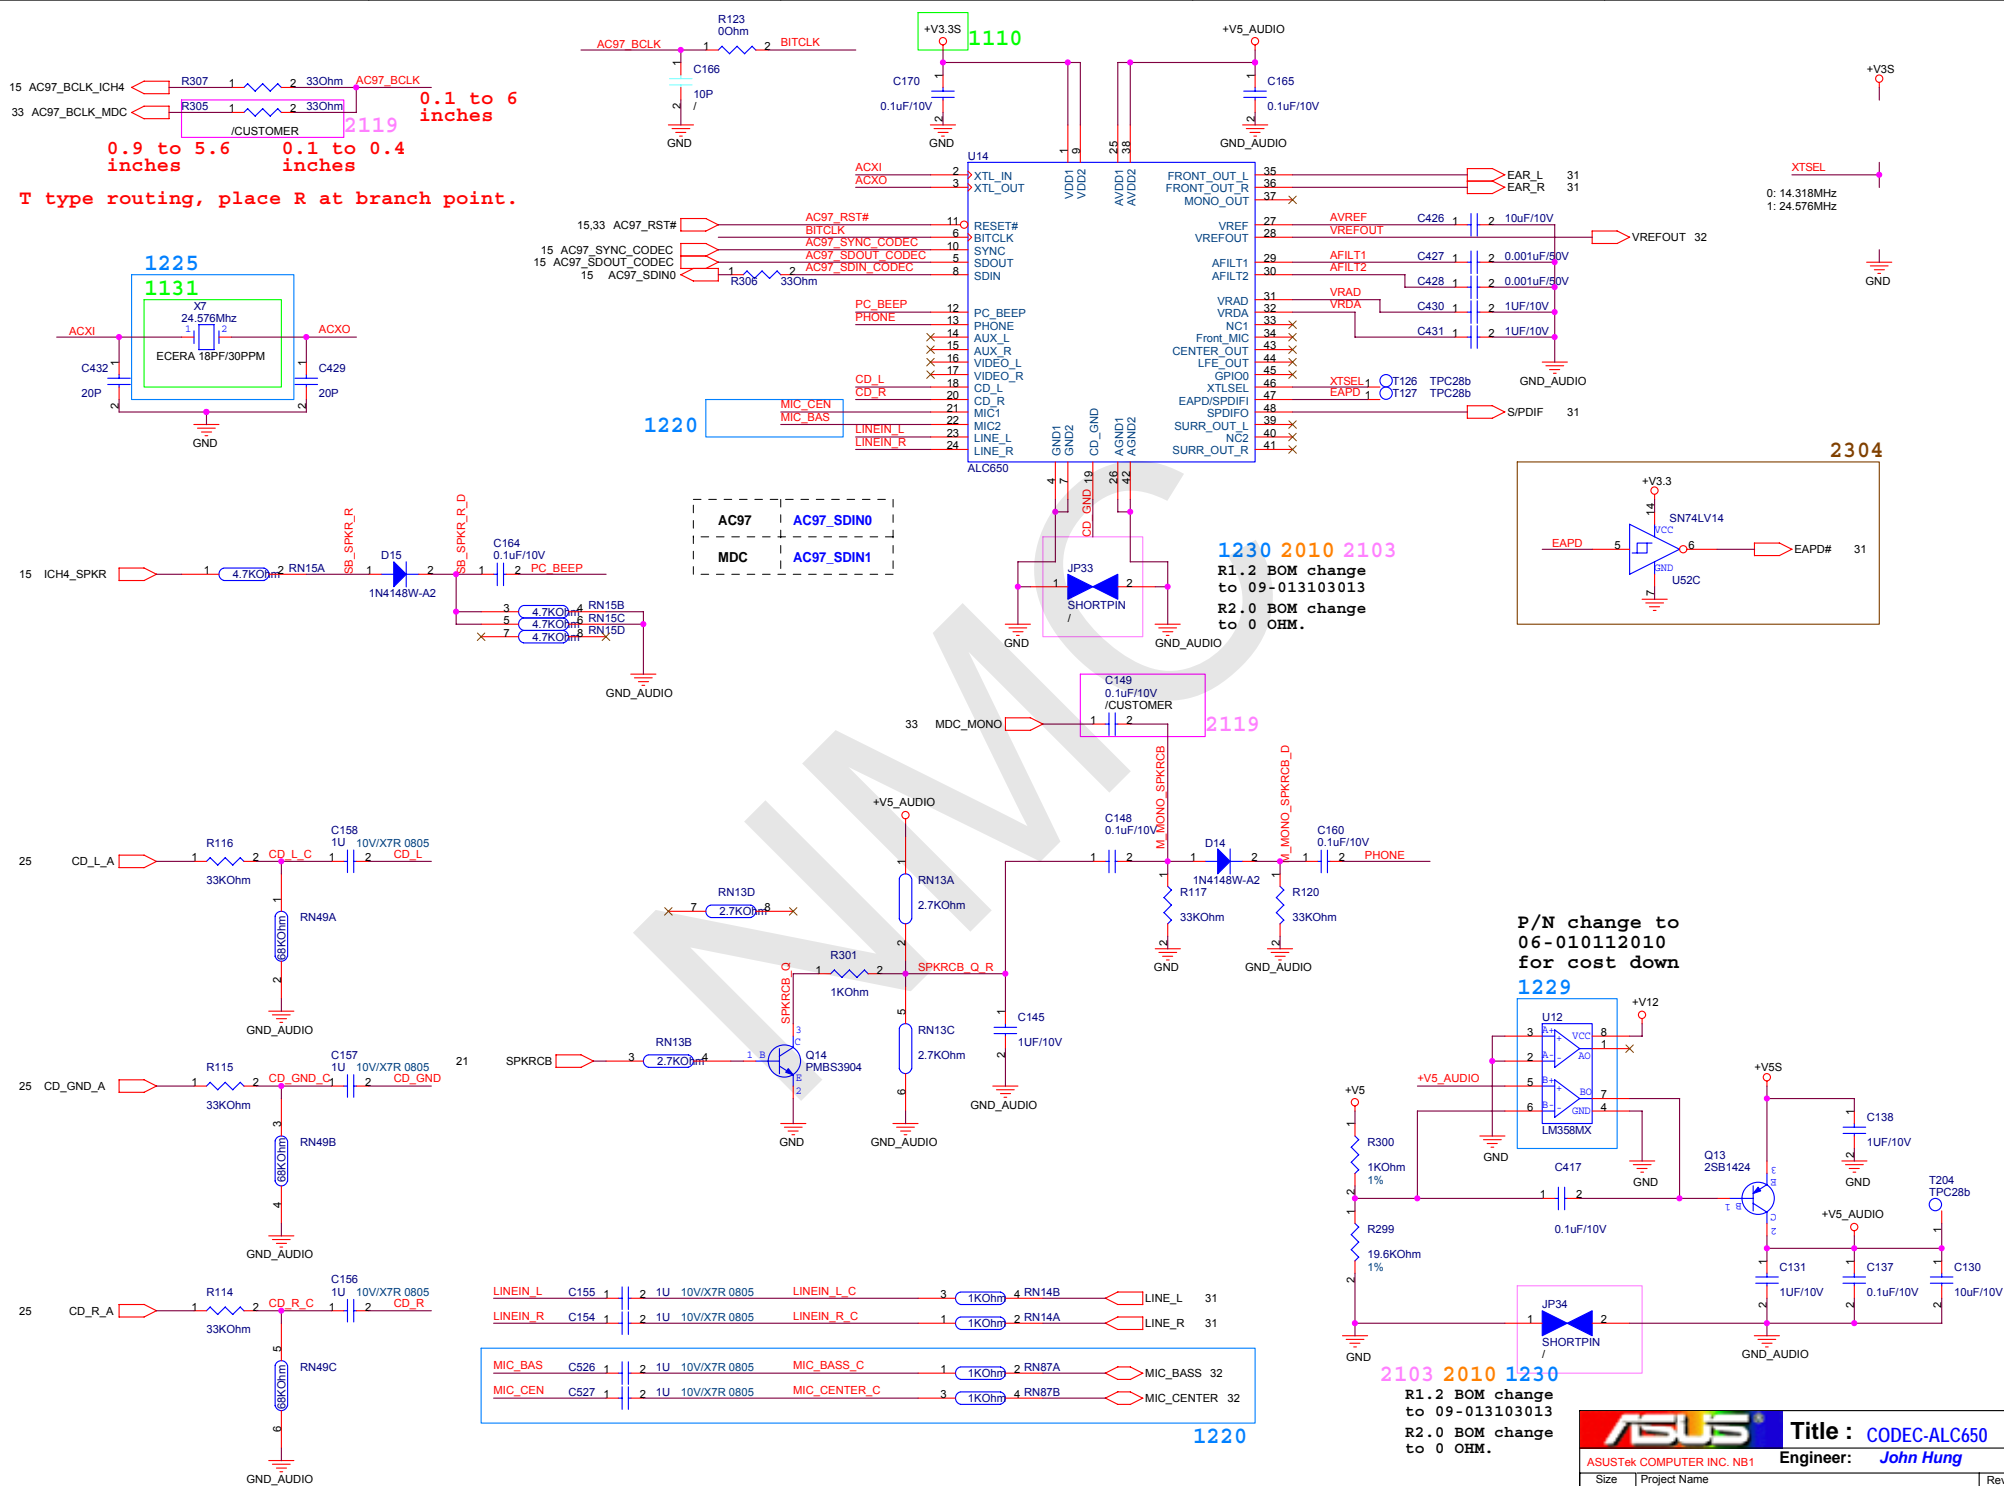
15 AC97_BCLK_ICH4
33 AC97_BCLK_MDC

R307 1 2 330hm AC97_BCLK
R305 1 2 330hm /CUSTOMER

0.1 to 6 inches
0.9 to 5.6 inches
0.1 to 0.4 inches

T type routing, place R at branch point.

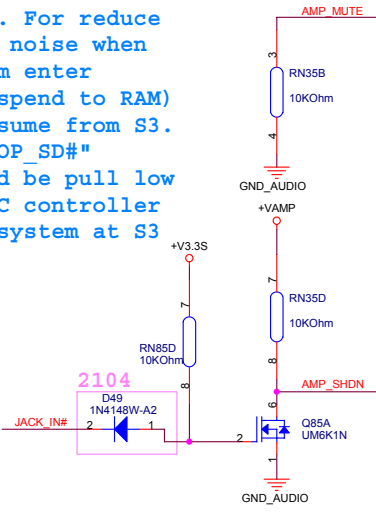
R:1.2. For reduce "POP" noise when system enter S3(suspend to RAM) or resume from S3. Net "OP_SD#" should be pull low by KBC controller when system at S3 mode.

R:2.1 Use "OP_SD#", speaker will have "POP" noise after logo display when turn on system. Don't use "OP_SD#".

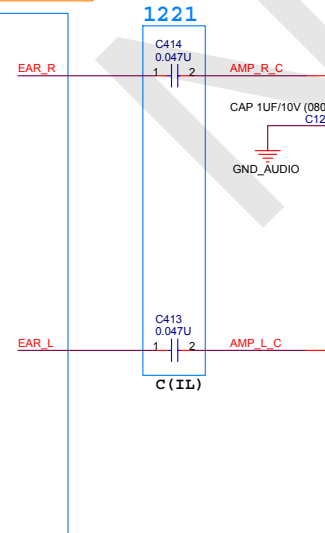
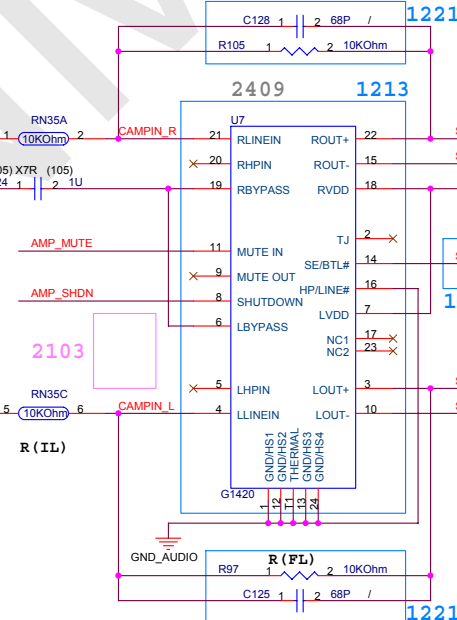
Pop noise can be heard via headphone when system boot, restart and resume from S3. Add OP_SD# to control the turn-on timing.

But when system resume from S3, pop noise is behind OP_SD# pull high. Add a delay circuit to prevent it.

Prevent "POP" noise at speaker.

$f(\text{highpass}) = \frac{1}{2 * 3.14 * C(IL) * R(IL)} = 500$
 $f(\text{lowpass}) = \frac{1}{2 * 3.14 * C(150P) * R(10K)} = 106K$

BTL Gain=-2
R(FL) 10K
R(IL) 10K
=V
Speaker W=V*V
=2*2
=4ohm
=1W
Can use 1W(4ohm) speaker

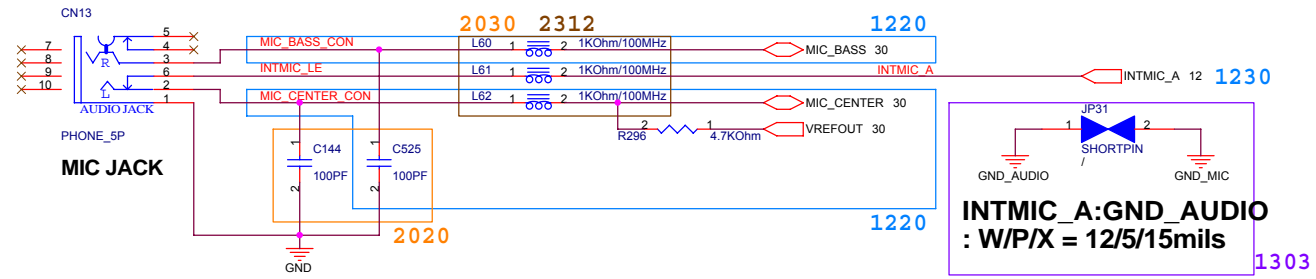
MIC OP CIRCUIT

MIC JACK

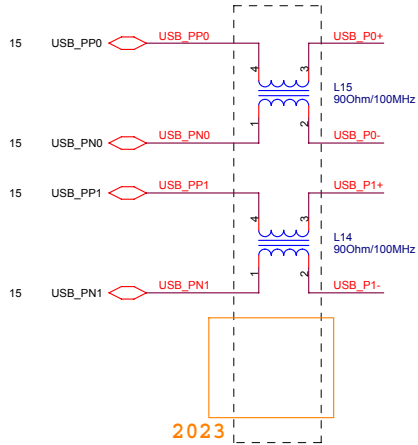
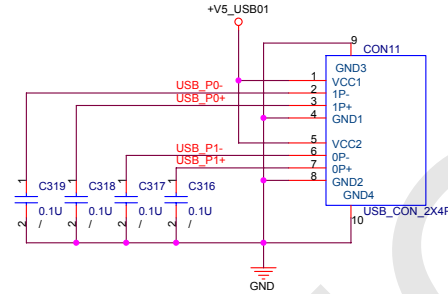
USB PORT 0 & PORT 1

VPLP R:2.2 use 07-014110900 (2nd source is 07-014110201)

2023
R & L Co-Lay

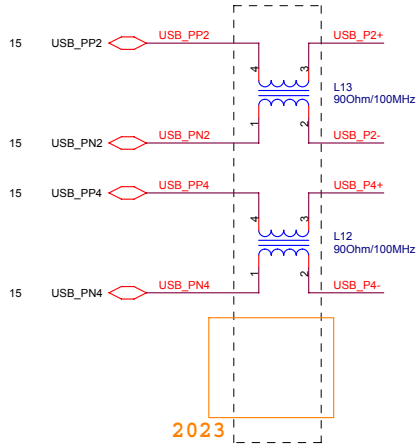
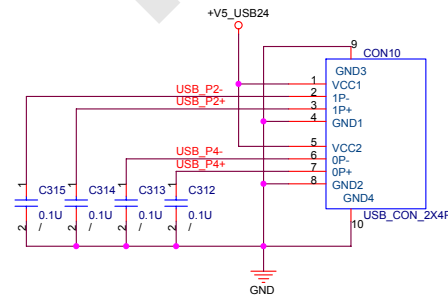
USB PORT 2 & PORT 4

VPLP R:2.2 use 07-014110900 (2nd source is 07-014110201)

2023
R & L Co-Lay

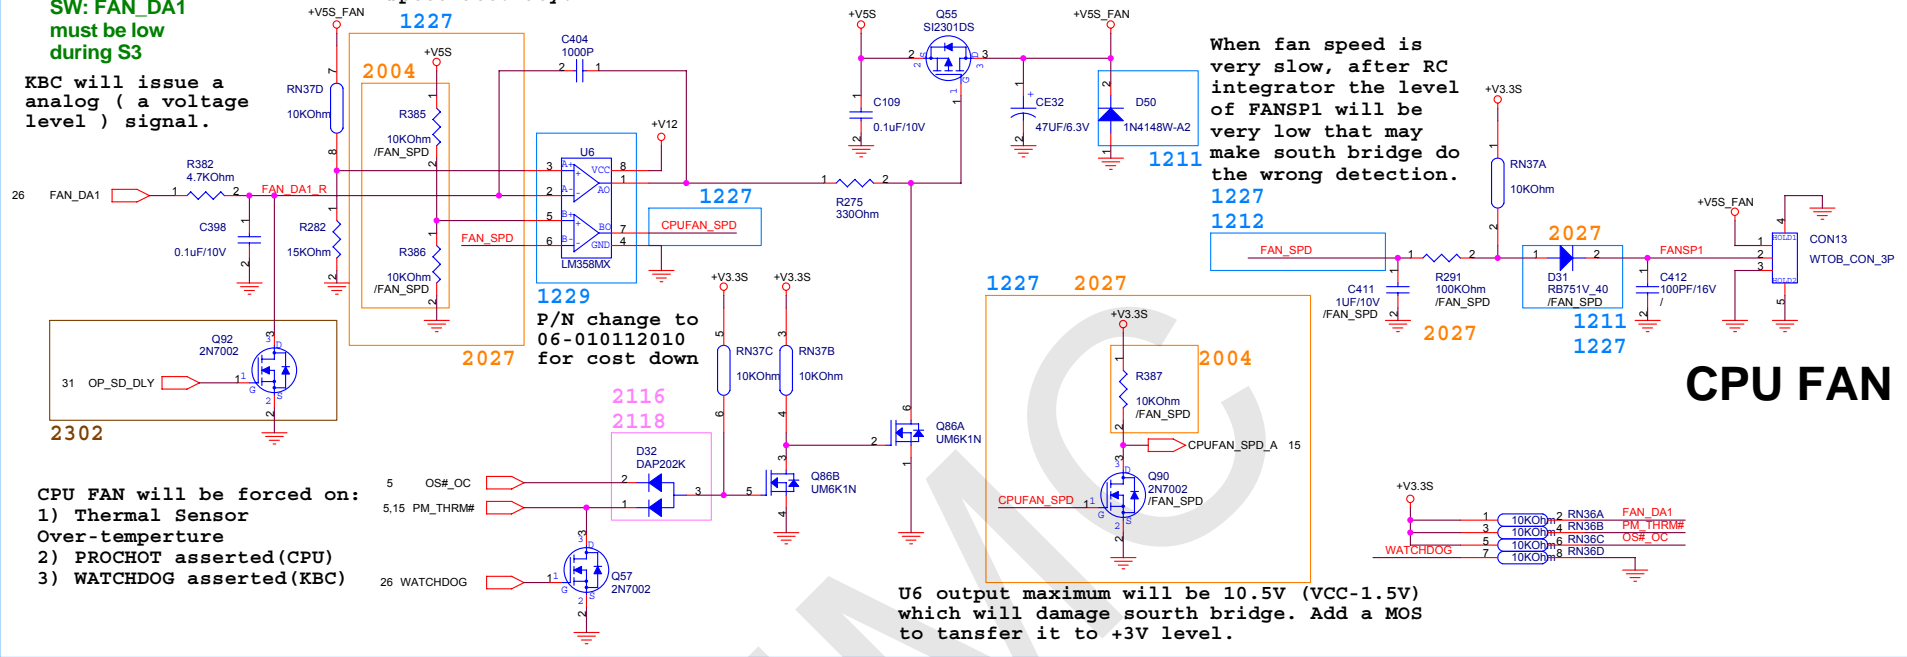
Fan Speed Control

Using a OP AMP and fine-tuning the level, we can improve the fan speed accuracy.

SW: FAN_DA1 must be low during S3

KBC will issue a analog (a voltage level) signal.

When fan speed is very slow, after RC integrator the level of FANSP1 will be very low that may make south bridge do the wrong detection.

CPU FAN

- CPU FAN will be forced on:
- 1) Thermal Sensor Over-temperature
 - 2) PROCHOT asserted(CPU)
 - 3) WATCHDOG asserted(KBC)

U6 output maximum will be 10.5V (VCC-1.5V) which will damage south bridge. Add a MOS to transfer it to +3V level.

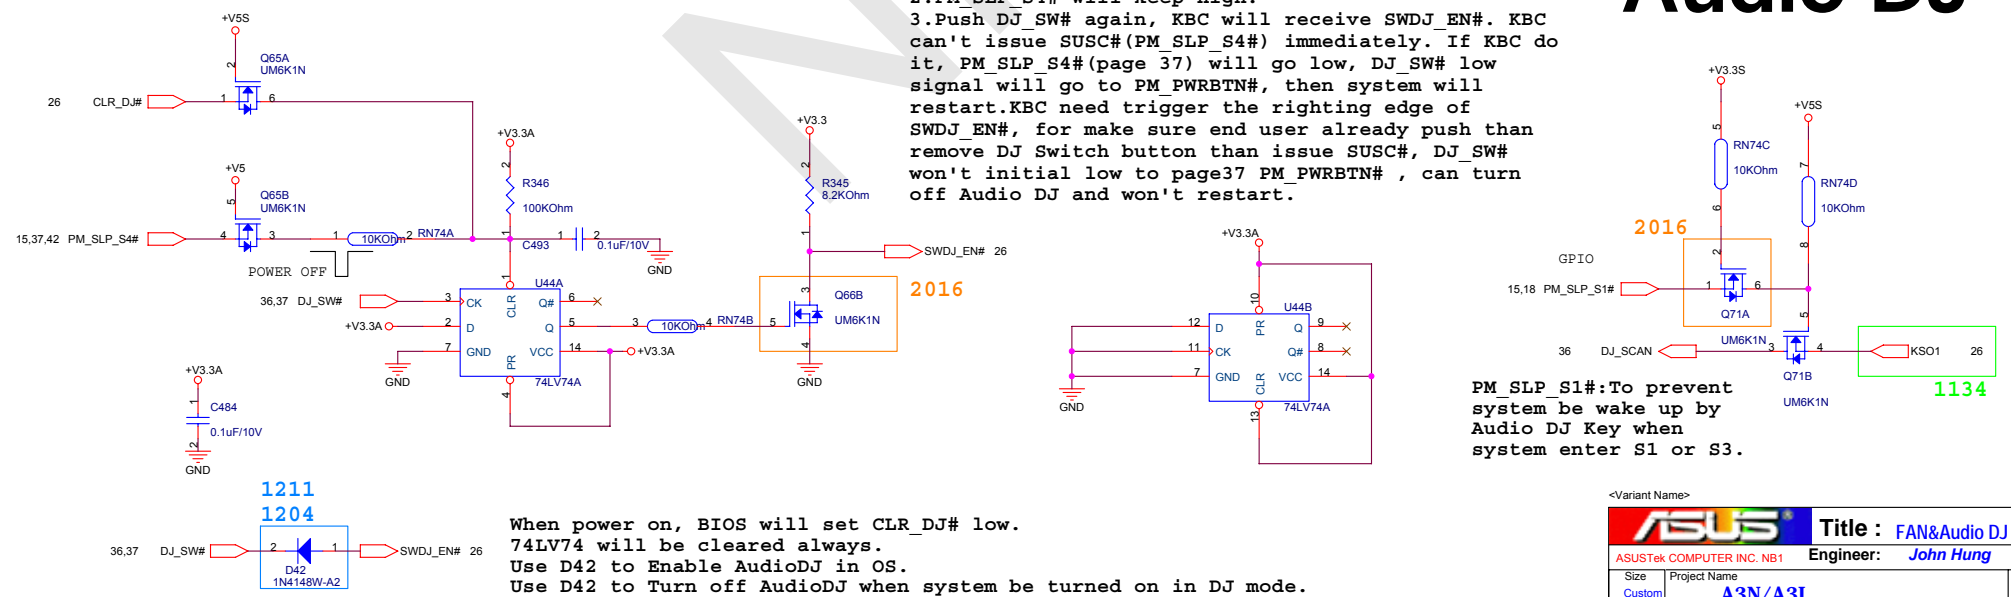
SWDJ_EN# function :

1. Push DJ_SW#, turn on Audio DJ.
2. PM_SLP_S4# will keep high.
3. Push DJ_SW# again, KBC will receive SWDJ_EN#. KBC can't issue SUSC#(PM_SLP_S4#) immediately. If KBC do it, PM_SLP_S4#(page 37) will go low, DJ_SW# low signal will go to PM_PWRBTN#, then system will restart. KBC need trigger the righting edge of SWDJ_EN#, for make sure end user already push than remove DJ Switch button than issue SUSC#, DJ_SW# won't initial low to page37 PM_PWRBTN#, can turn off Audio DJ and won't restart.

PM_SLP_S1#: To prevent system be wake up by Audio DJ Key when system enter S1 or S3.

When power on, BIOS will set CLR_DJ# low. 74LV74 will be cleared always. Use D42 to Enable AudioDJ in OS. Use D42 to Turn off AudioDJ when system be turned on in DJ mode.

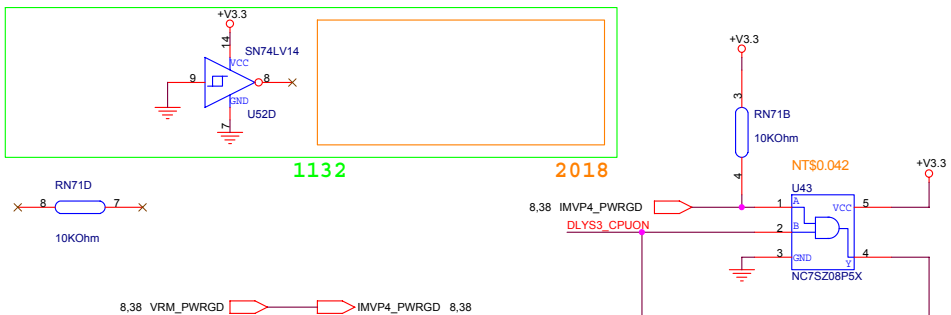
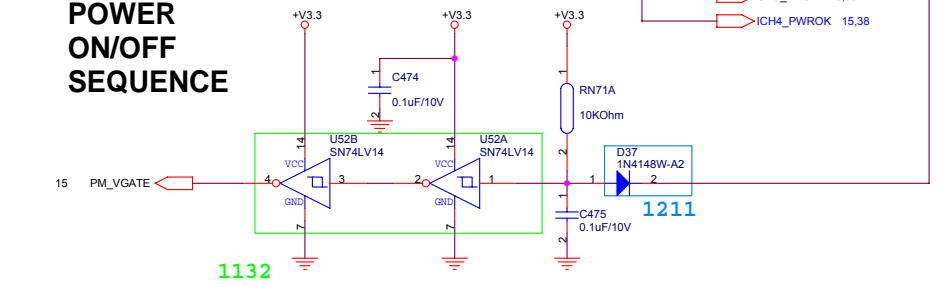
POWER ON/OFF SEQUENCE

System Power Sequence
 +VCCRTC -> RTCRST# -> V5REFSUS -> 3.3/1.8VSUS ->
 RSMRST# -> SLP_S4# -> SLP_S3# -> VCCLAN -> LANPWROK
 -> V5REF -> VCC -> VCORE -> PWROK -> VGATE
 SUSSTAT# -> PCIRST#
 CPU : +VCORE, +VCCP, +V1.8S
 NB : +V1.2S, +V1.5S, +2.5V, +VCCP
 SB : +V1.5SUS, +V3.3SUS, +VCCP, +V1.5S, +V3.3S
 DDR : +V2.5, +V1.25, +V1.25S

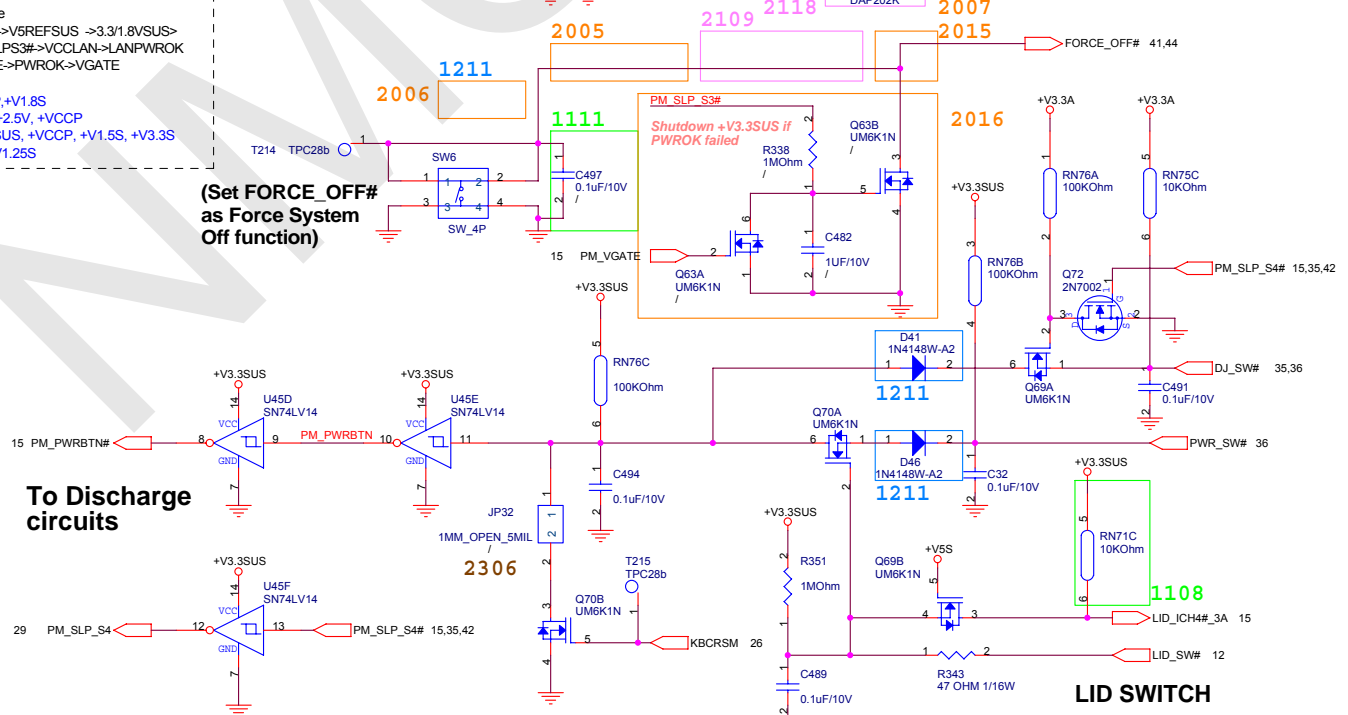
(Set FORCE_OFF# as Force System Off function)

To Discharge circuits
