A3 BLOCK DIAGRAM

FILE LIST

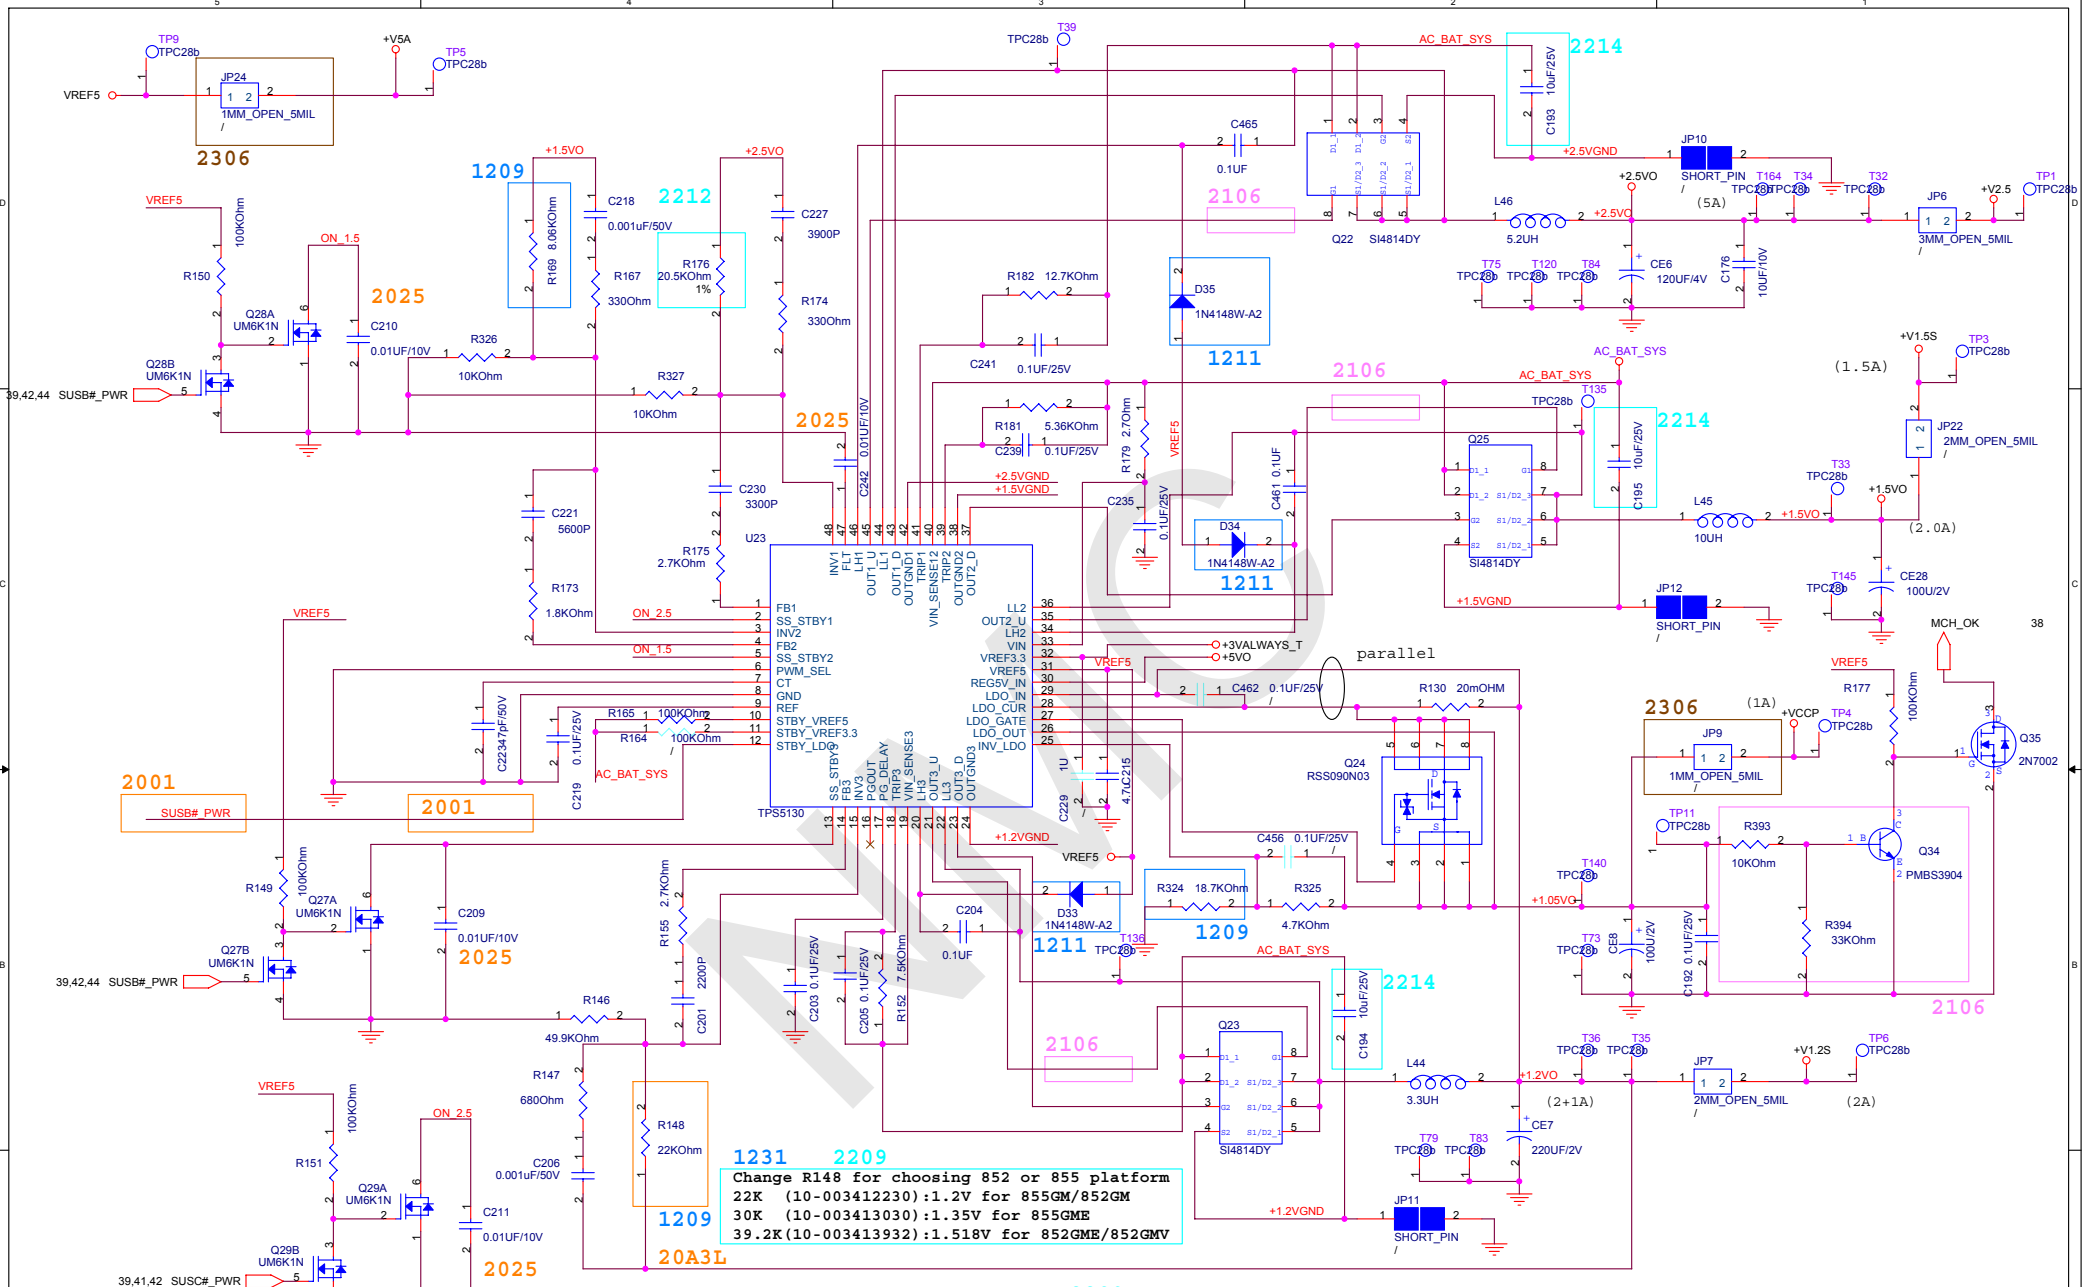
CPU

Celeron	Banias	Dothan (400)	Dothan (533)
Frequency	100	100	100	133
VCCA[1:3]	1.8V	1.8V	1.8V	NC
VCCA[0]	1.8V	1.8V	1.8V	1.5V
U54 switch to	Pin 3,4			Pin 1,2

NB
 VCC,VCCASM,VCCHL,VCCAGPLL,VCCADPLLA,VCCADPLLB:
 855GM/852GM: 1.2V
 855GME: 1.35V
 852GME/852GMV: 1.5V

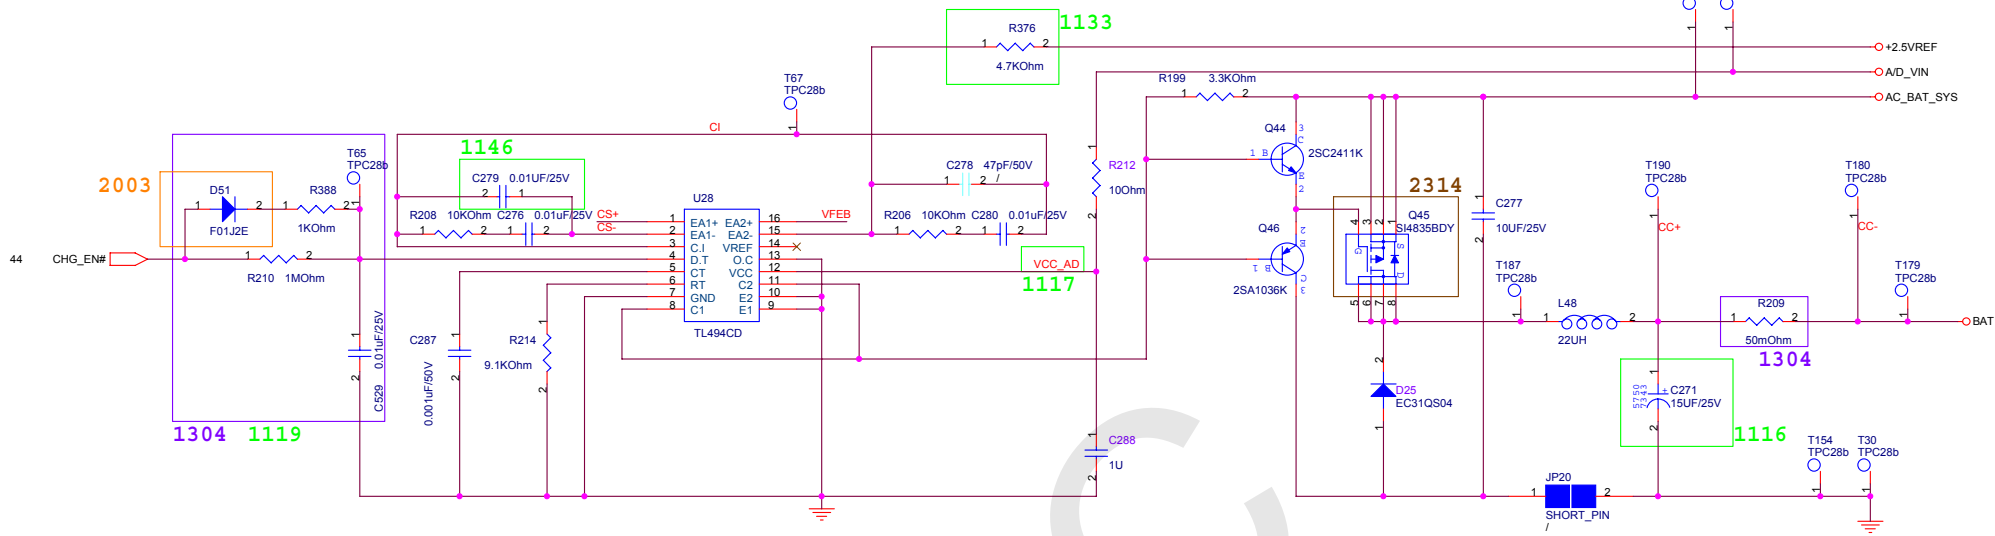
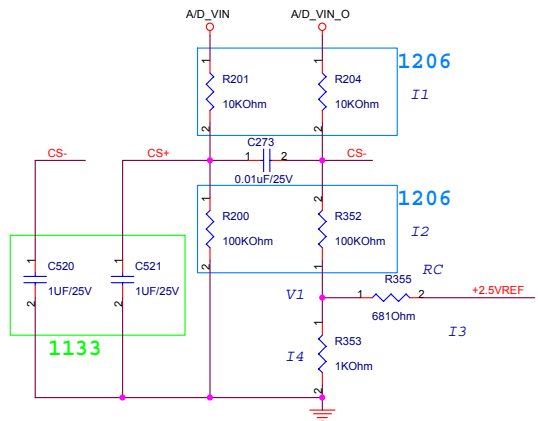
Current sharing = 3.1A

$A/D_VIN=19V$ $A/D_VIN_O=19V-3.1A*50\text{ohm}=18.845V$
 $CS+=CS-=19*(100/110)=17.272727V$
 $I1=(18.845V-17.272727V)/10K=0.15723mA$
 $V1=17.272727V-(0.15723mA*100K)=1.5497V$
 $I4=1.5497V/1K=1.5497mA$
 $I3=1.5497mA-0.15723mA=1.39247mA$
 $RC=(2.5V-1.5497V)/1.39247mA=681\text{ ohm}$

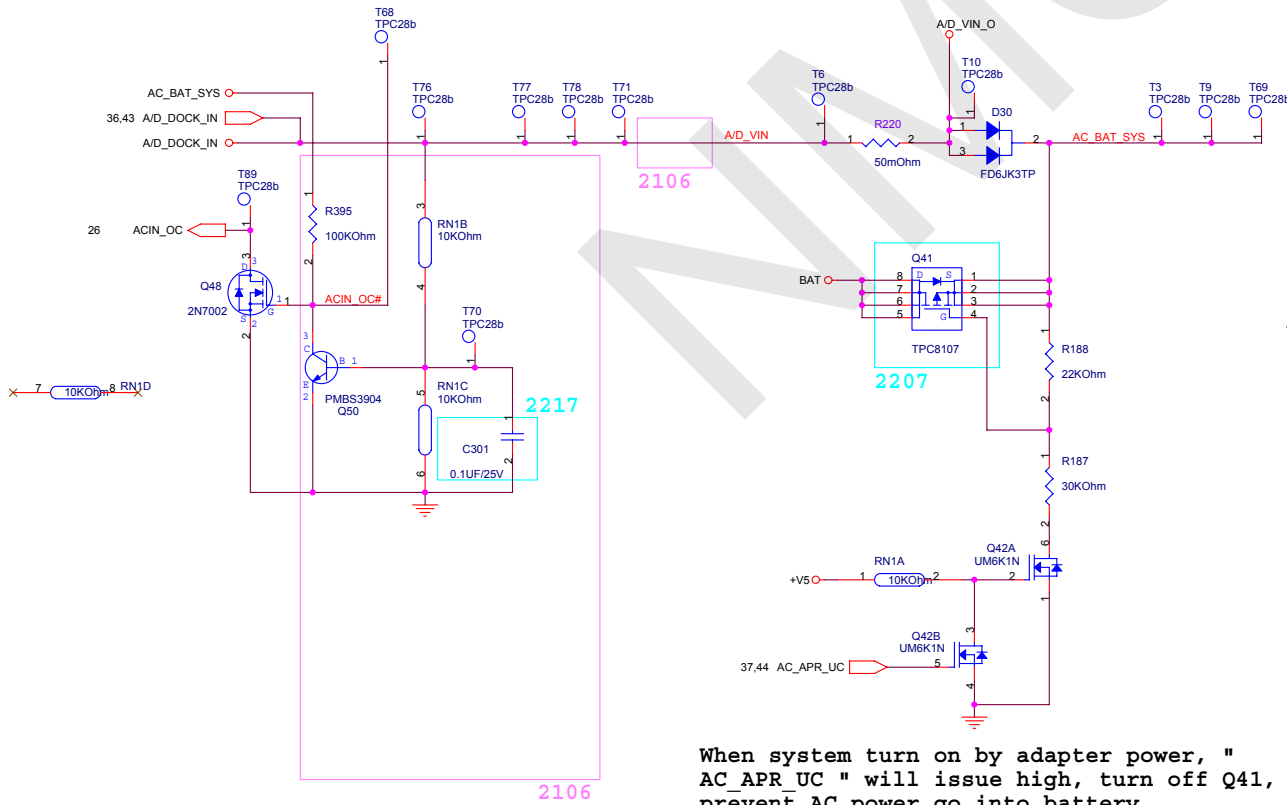
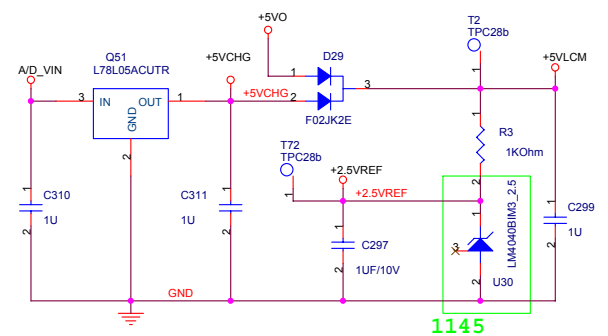
When system turn on by adapter power, "AC APR UC" will issue high, turn off Q41, to prevent AC power go into battery.

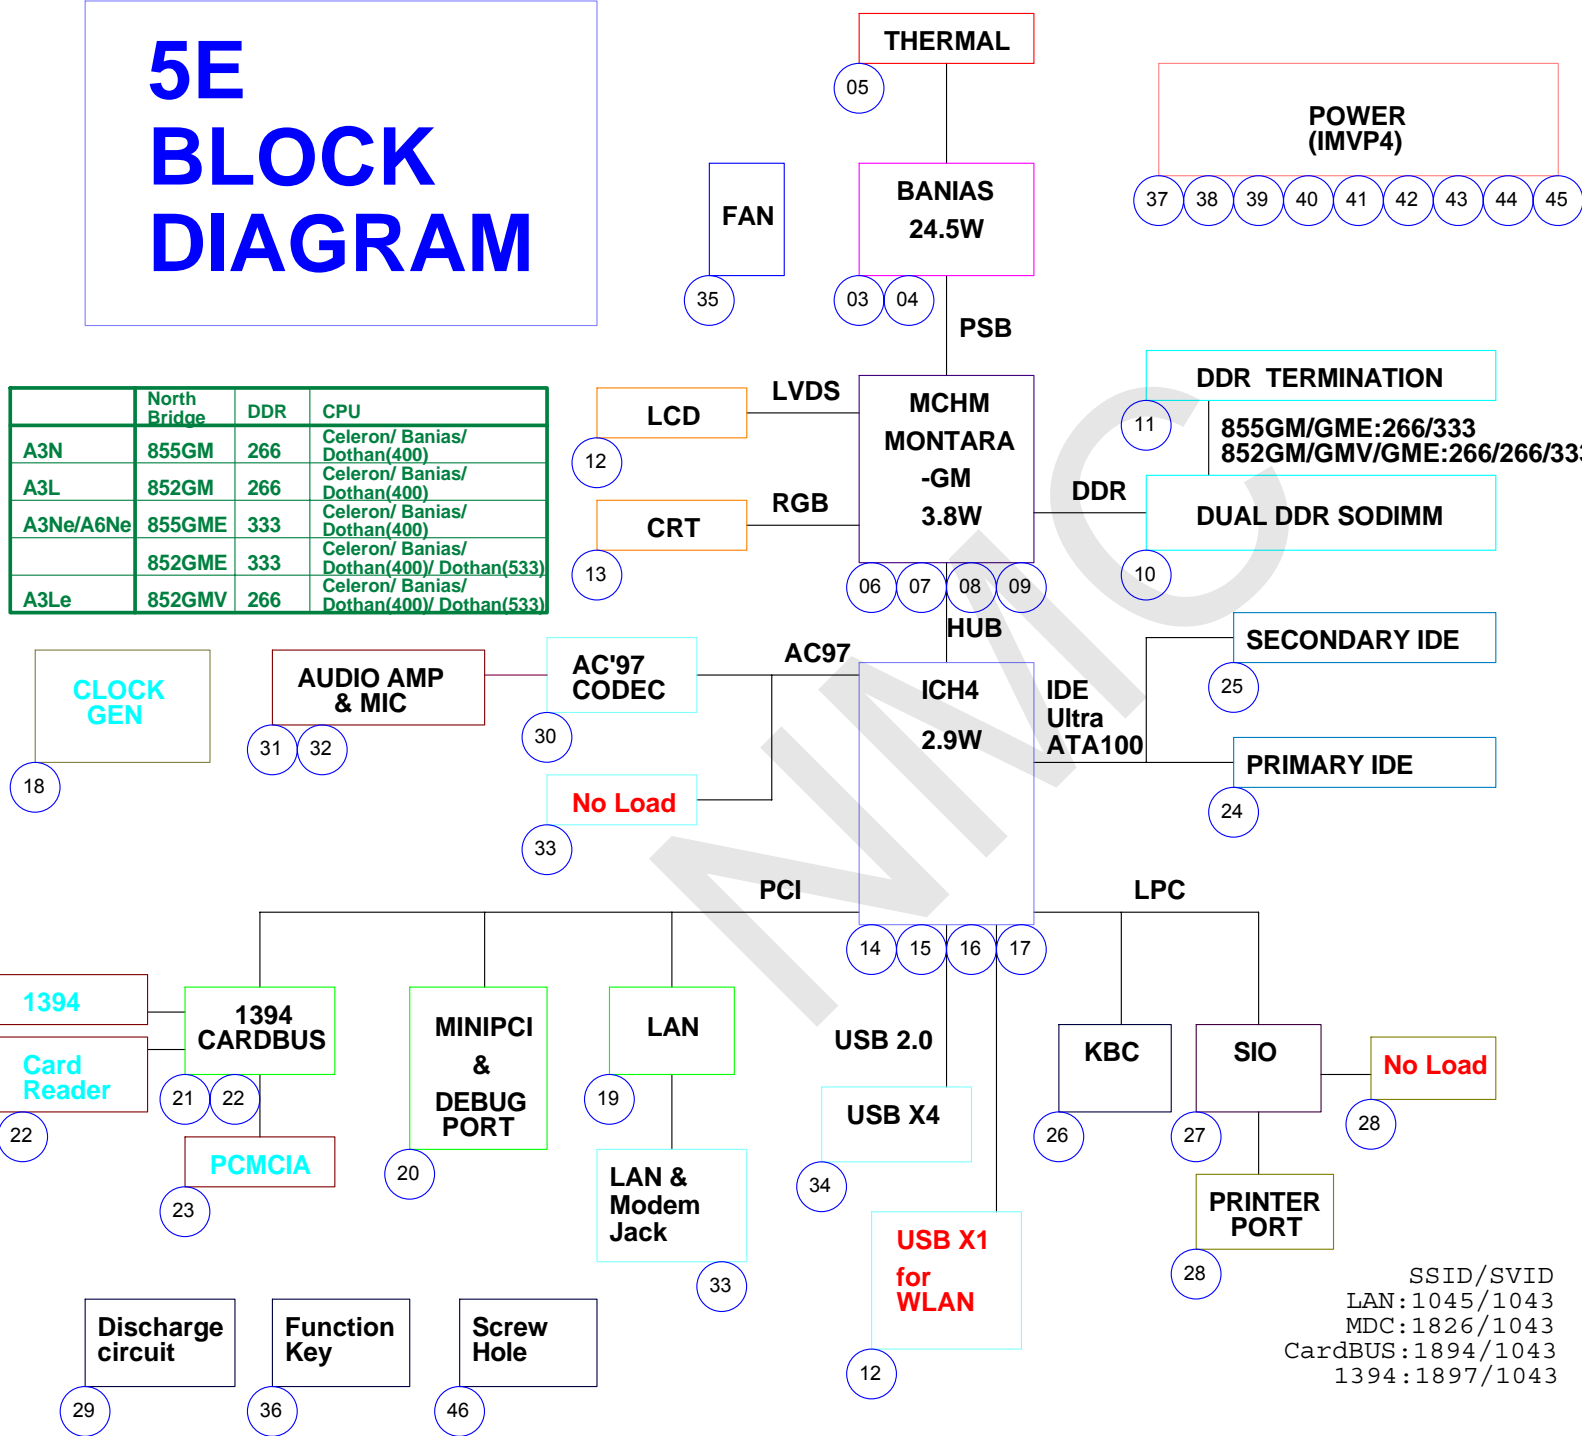
5E BLOCK DIAGRAM

North Bridge	DDR	CPU
A3N	855GM	266	Celeron/ Banias/ Dothan(400)
A3L	852GM	266	Celeron/ Banias/ Dothan(400)
A3Ne/A6Ne	855GME	333	Celeron/ Banias/ Dothan(400)
	852GME	333	Celeron/ Banias/ Dothan(400)/ Dothan(533)
A3Le	852GMV	266	Celeron/ Banias/ Dothan(400)/ Dothan(533)
