A6Ne BLOCK DIAGRAM

North Bridge	DDR	CPU
A3N	855GM	266	Celeron/ Banias/ Dothan(400)
A3L	852GM	266	Celeron/ Banias/ Dothan(400)
A3Ne/A6Ne	855GME	333	Celeron/ Banias/ Dothan(400)
	852GME	333	Celeron/ Banias/ Dothan(400)/ Dothan(533)
A3Le	852GMV	266	Celeron/ Banias/ Dothan(400)/ Dothan(533)

ASUS Title : CPU-BANIAS(HOST)
 ASUSTek COMPUTER INC. NB1 Engineer: John Hung
 Size Project Name
 Custom A6N
 Date: Thursday, October 14, 2004 Sheet 3 of 51

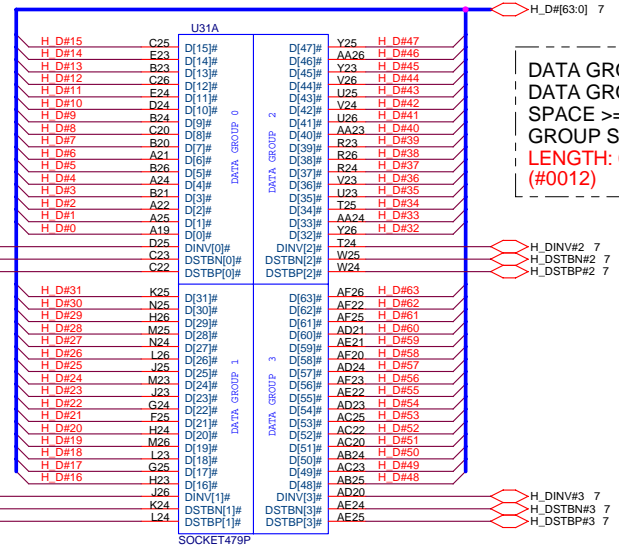
ADDR GROUP 0 -> L6
 ADDR GROUP 1 -> L6
 SPACE >= 1.2
 STROBE SPACE >= 1.3
 GROUP SPACE >= 1.5
 LENGTH: 0.5" - 6.5"
 (#0012)

DATA GROUP 0,2 -> L6
 DATA GROUP 1,3 -> L6
 SPACE >= 1.3
 GROUP SPACE >= 1.5
 LENGTH: 0.5" - 5.5"
 (#0012)

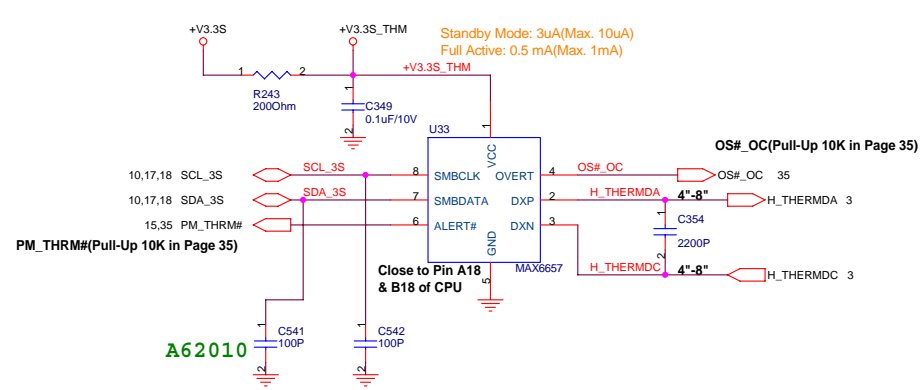
Route H_THERMDA and H_THERMDC on the same layer

-----OTHER SIGNALS
 12 mils
 =====GND
 10 mils
 =====H_THERMDA(10 mils)
 10 mils
 =====H_THERMDC(10 mils)
 10 mils
 =====GND
 12 mils
 -----OTHER SIGNALS

Avoid BPSB,Power

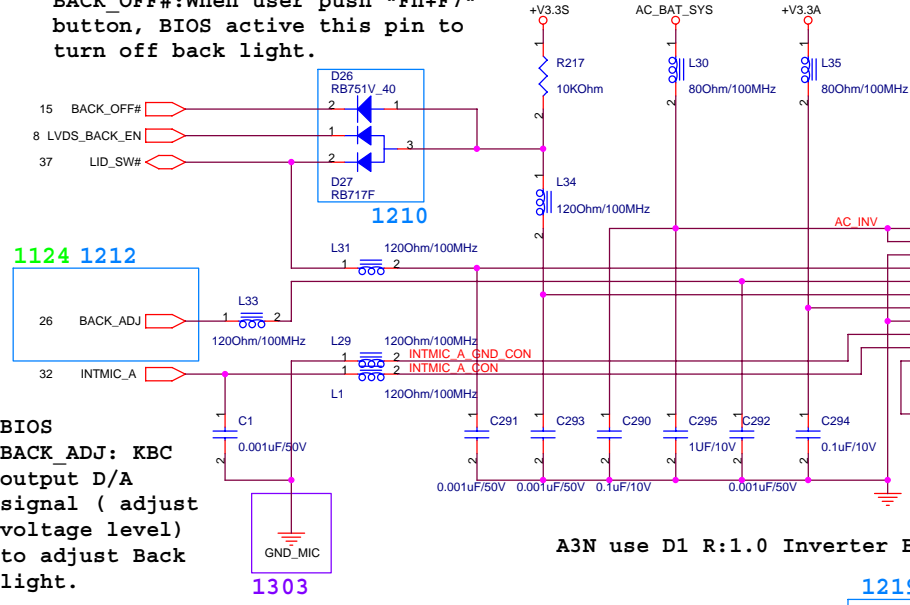
BIOS
BACK_OFF#: When user push "Fn+F7" button, BIOS active this pin to turn off back light.

BIOS
BACK_ADJ: KBC output D/A signal (adjust voltage level) to adjust Back light.

LCD	CABLE ID:	PID3	PID2	PID1	PID0
14.1	XGA	1	1	1	1
15.1	XGA	1	1	0	1
15.1	SXGA+	1	0	1	1
15.1	WXGA	1	1	1	0
15.1	WSXGA+	0	1	1	1

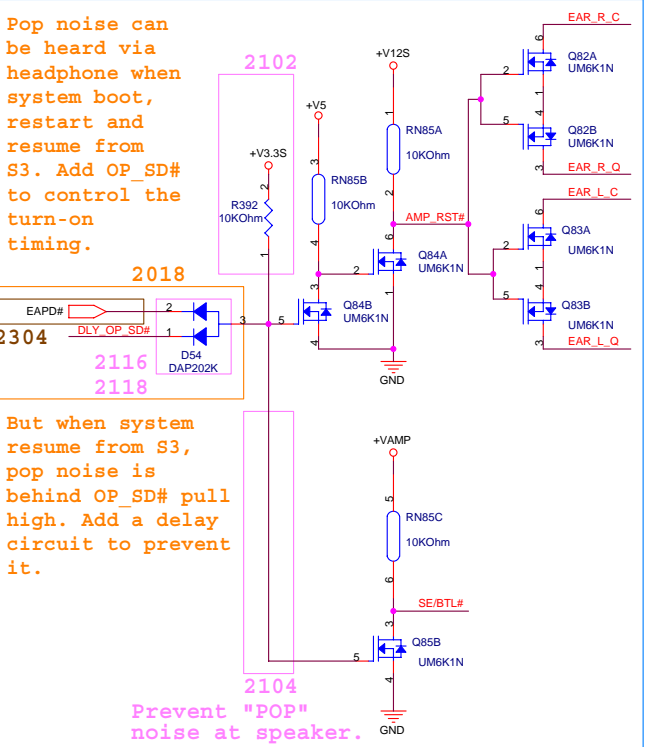
Pop noise can be heard via headphone when system boot, restart and resume from S3. Add OP_SD# to control the turn-on timing.

But when system resume from S3, pop noise is behind OP_SD# pull high. Add a delay circuit to prevent it.

Prevent "POP" noise at speaker.

BTL Gain=-2

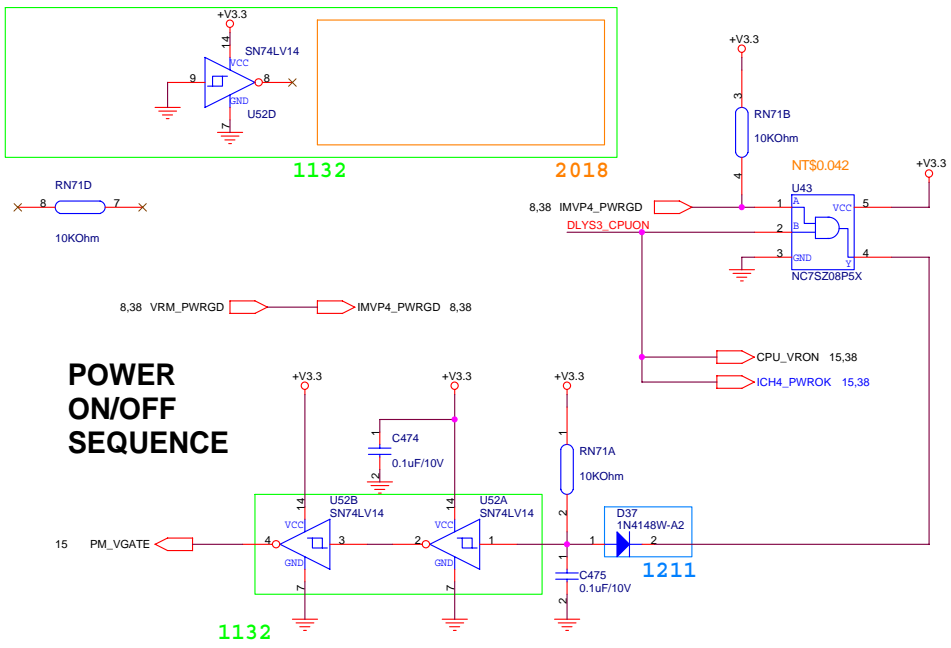
POWER ON/OFF SEQUENCE

System Power Sequence
 +VCCRTC -> RTCRST# -> V5REFSUS -> 3.3/1.8VSUS -> RSMRST# -> SLPS4# -> SLPS3# -> VCCLAN -> LANPWROK -> V5REF -> VCC -> VCORE -> PWROK -> VGATE
 SUSSTAT# -> PCIRST#
 CPU : +V CORE, +VCCP, +V1.8S
 NB : +V1.2S, +V1.5S, +2.5V, +VCCP
 SB : +V1.5SUS, +V3.3SUS, +VCCP, +V1.5S, +V3.3S
 DDR : +V2.5, +V1.25, +V1.25S
