LBK-ADDs Schematic

DDQ12/LA1901 Schematic with Capture CIS and Function field
uFCPGA Banias
06-24-2003
REV: 1.0

Title			Rev
Cover Sheet			1.0
Size	Document Number	DDQ12/11/01 with LA-1901	
Date:	Thursday, July 03, 2003	Sheet	1 of 58

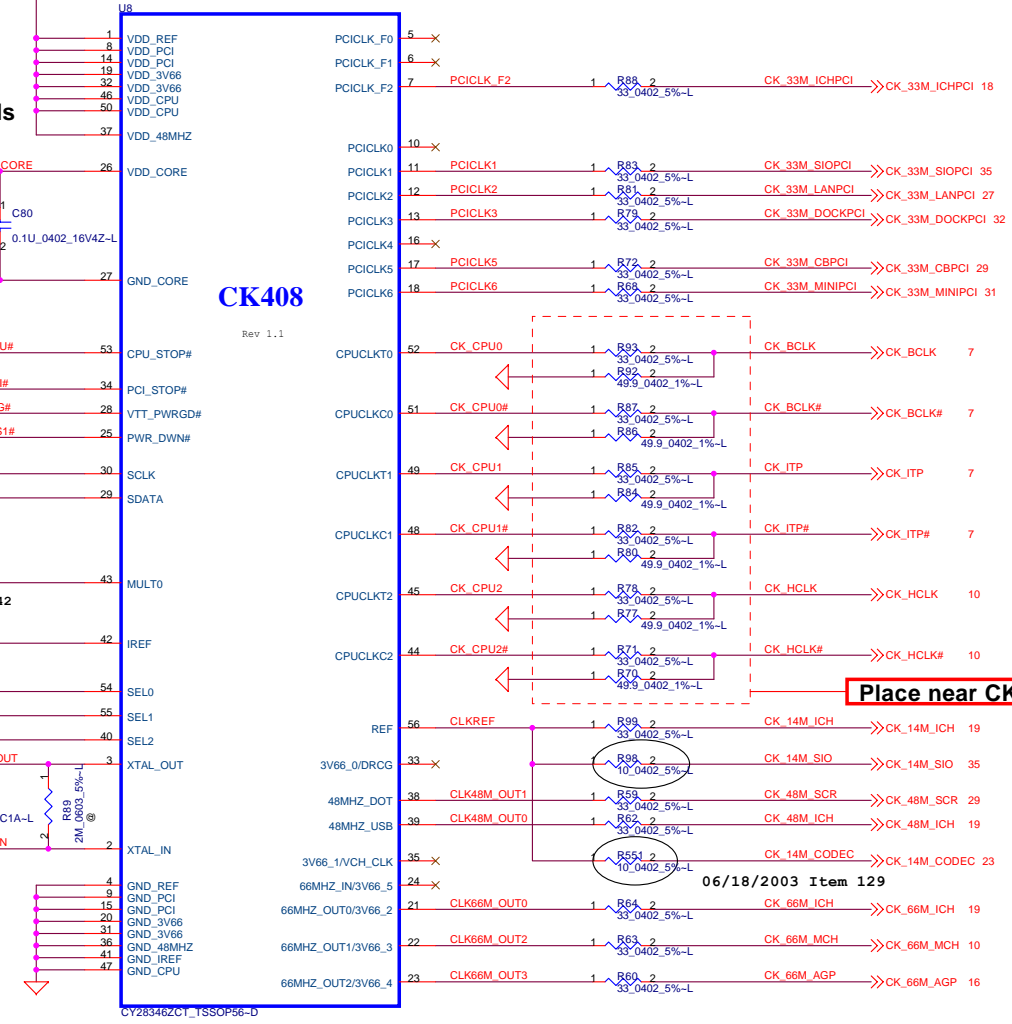
Place crystal within
500 mils of CK408

Place near CK408

S2	S1	S0	CPU	3V66[0..4]	3V66 5/66IN
1	0	0	66	66IN	66 Input
1	0	1	100	66IN	66 Input
1	1	0	200	66IN	66 Input
1	1	1	133	66IN	66 Input
0	0	0	66	66	66 Input
0	0	1	100	66	66 Input
0	1	0	200	66	66 Input
0	1	1	133	66	66 Input
Mid	0	0	Hi-z	Hi-z	Hi-z
Mid	0	1	TCLK/2	TCLK/2	TCLK/2
Mid	1	0	Reserve	Reserve	Reserve
Mid	1	1	Reserve	Reserve	Reserve

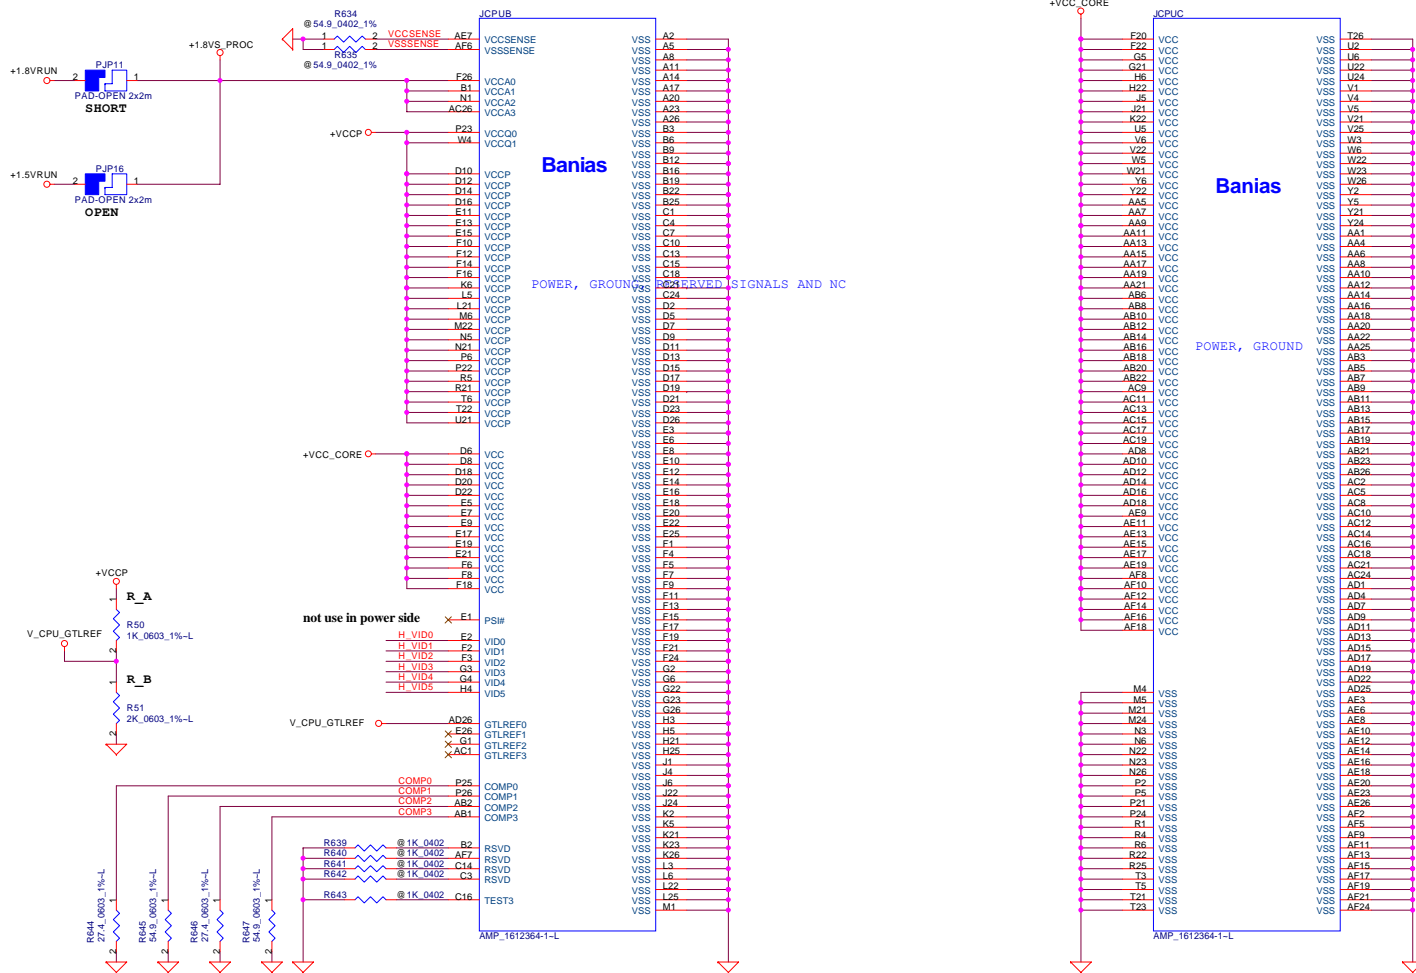
Title		Banias Processor in mFCPGA479	
Size	Document Number	DDQ12/11/01 with LA-1901	
Date:	Thursday, July 03, 2003	Sheet	7 of 58

Resistor placed within 0.5" of CPU pin. Trace should be at least 25 miles away from any other toggling signal.

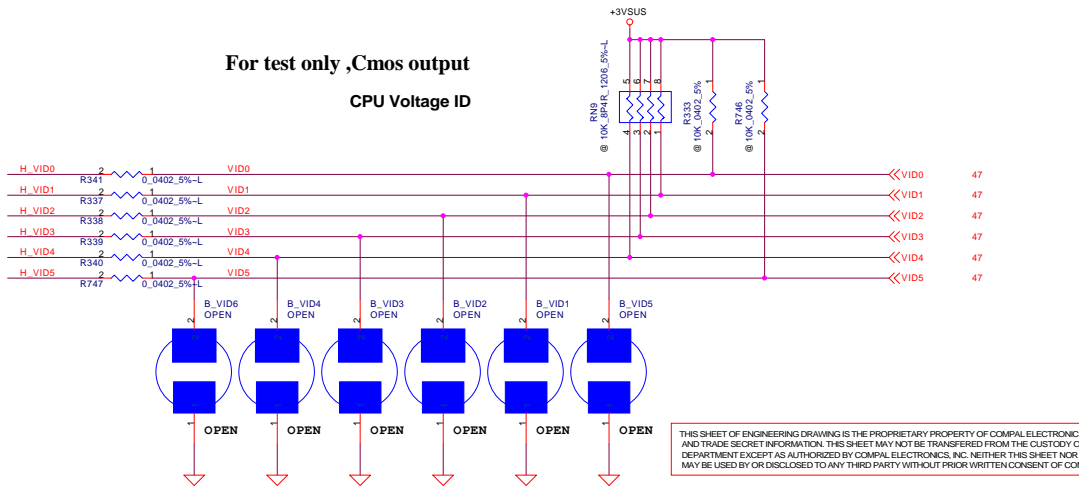
**For test only ,Cmos output
CPU Voltage ID**

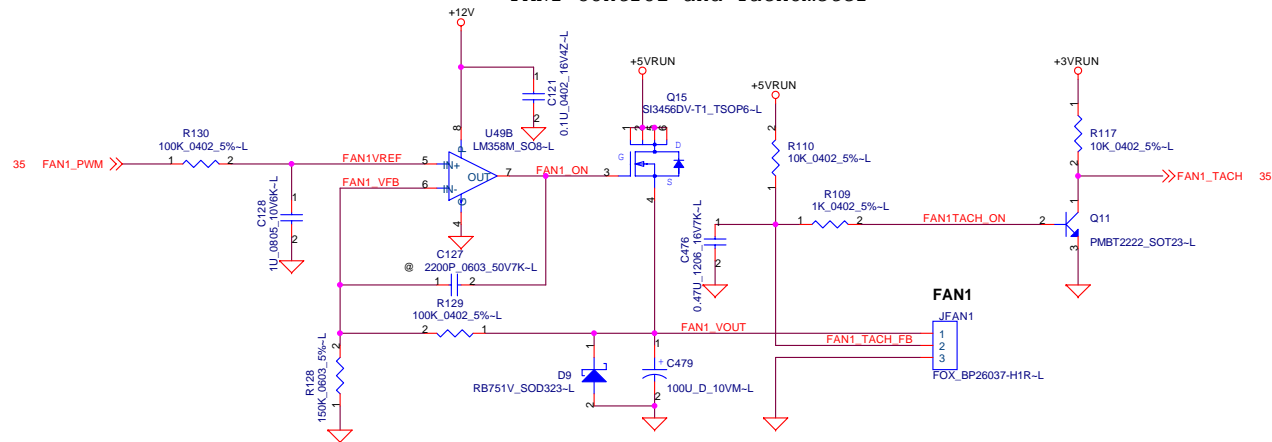
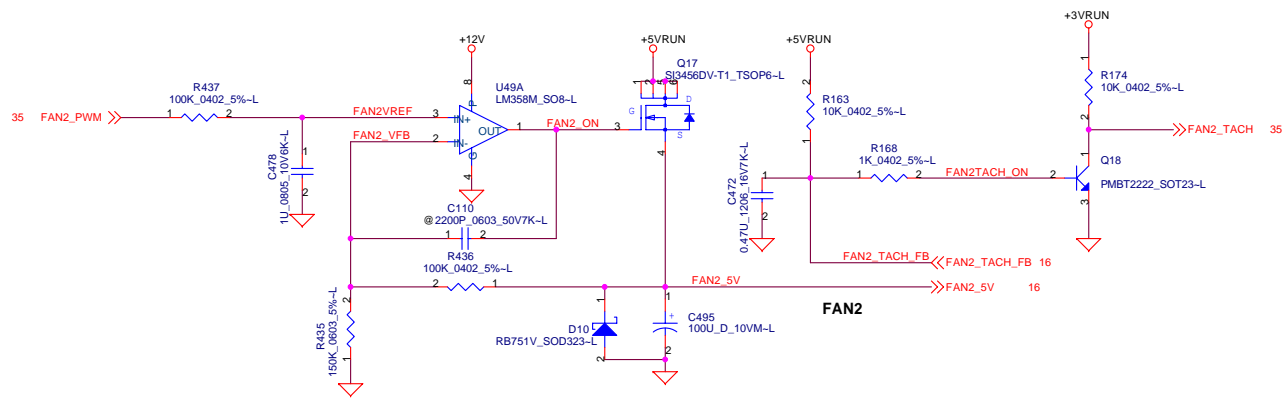
FAN1 Control and Tachometer

Title		
ITP Debug CONN. & FAN		
Size	Document Number	Rev
	DDQ12/11/01 with LA-1901	1.0
Date:	Thursday, July 03, 2003	Sheet 13 of 58

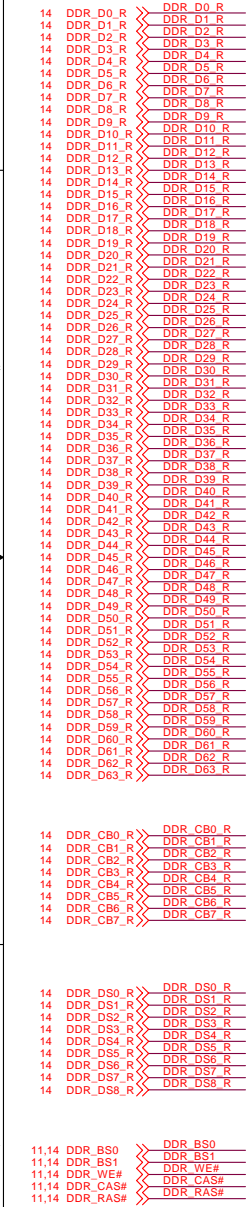
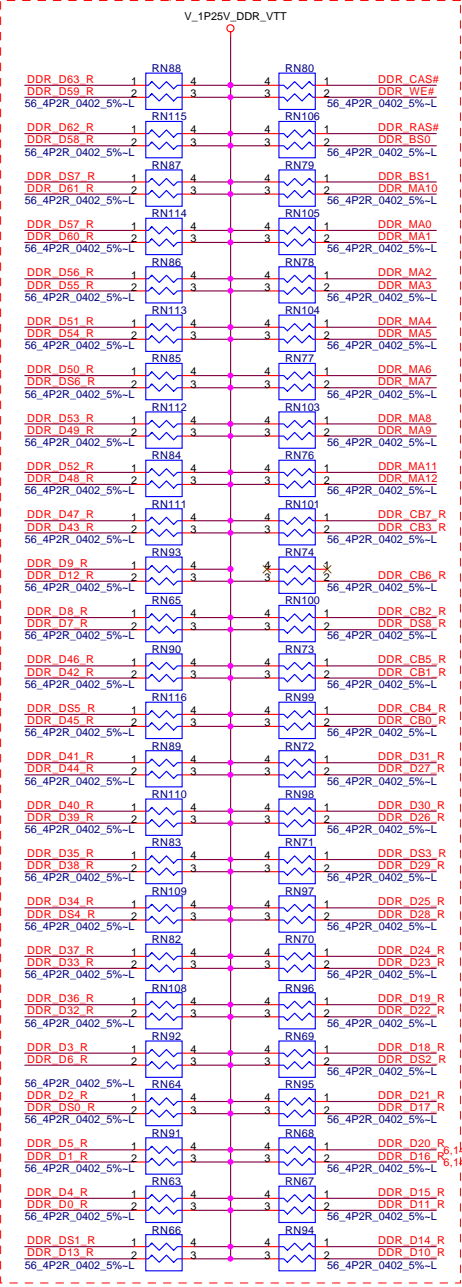
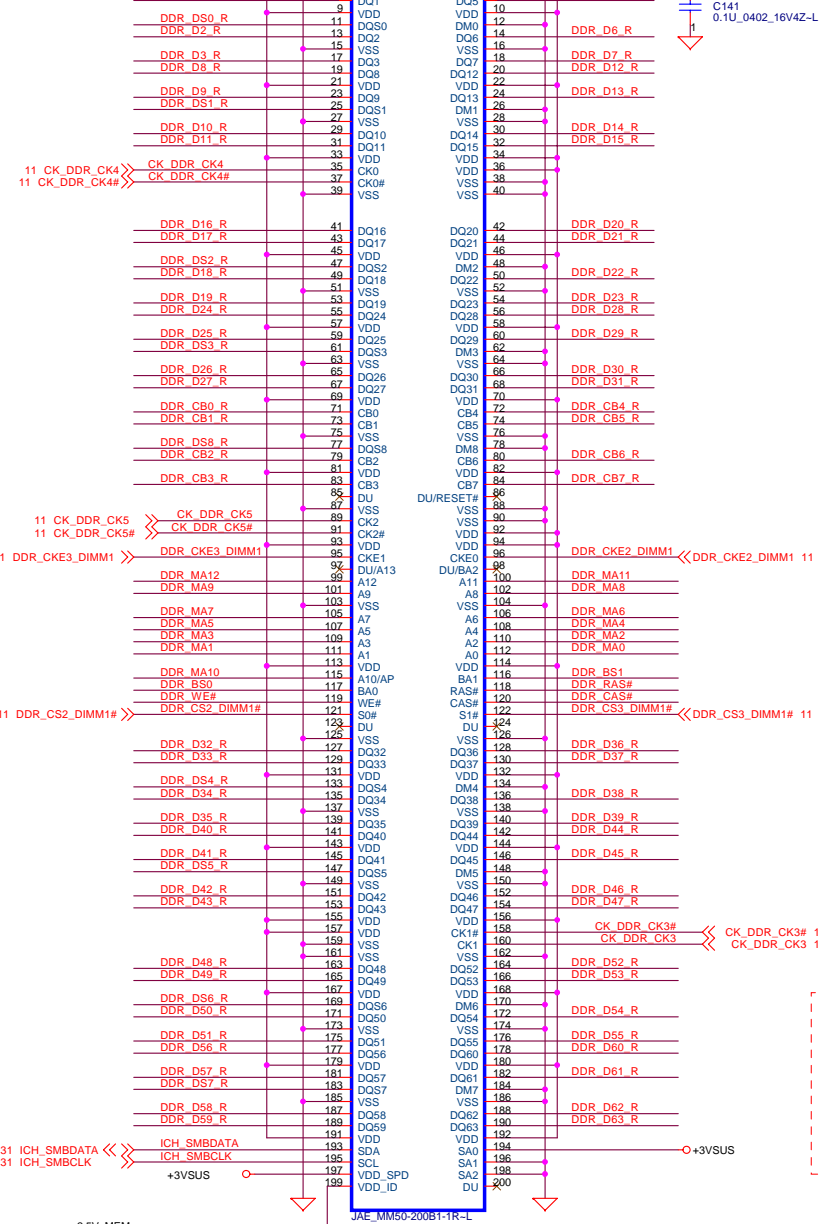
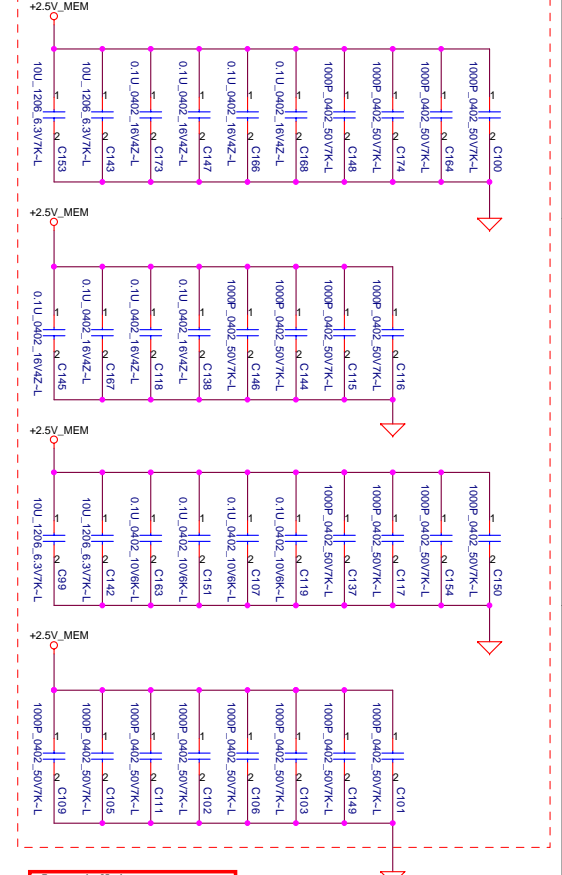
Title		DDR-SODIMM SLOT2	
Size	Document Number	Rev	
Date: Thursday, July 03, 2003		Sheet 15 of 58

Layout Note:
Place these resistors
closely DIMM1, all
trace length <= 800 mil

Layout Note:
Place CAP
near SODIMM
pin.

Layout Note:
Place these resistor
closely DIMM1, all
trace length
Max=1.3"

Place by pin197 of each SODIMM

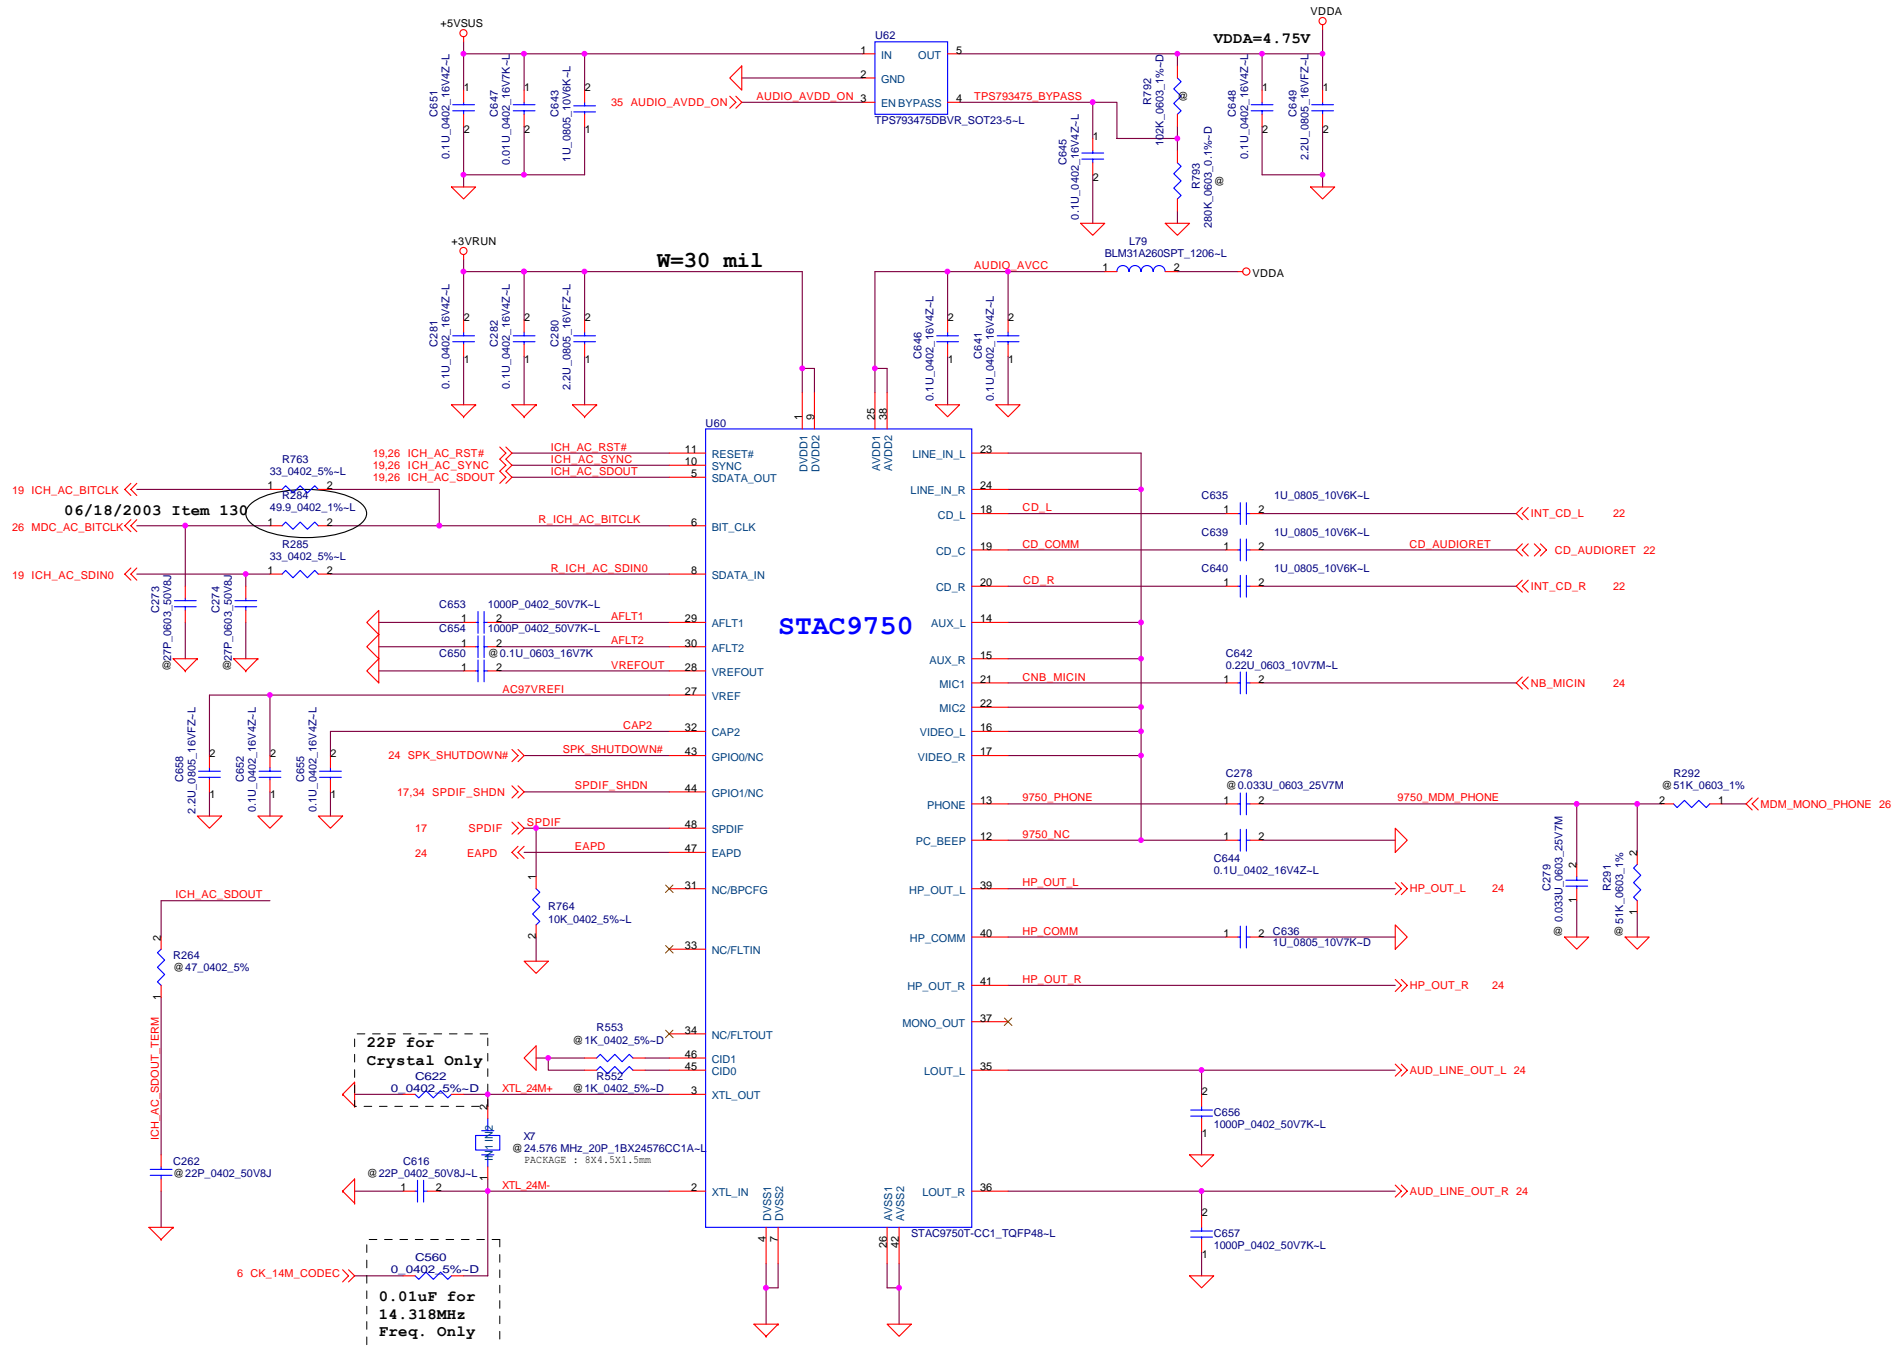
CLOCK SOURCE	Pin46 CID1	Pin45 CID0	Pin3 XTL_OUT
14.318 MHz	OPEN	OPEN	GND
27 MHz	OPEN	1K	GND
48 MHz	1K	OPEN	GND
24.576 MHz	1K	1K	GND

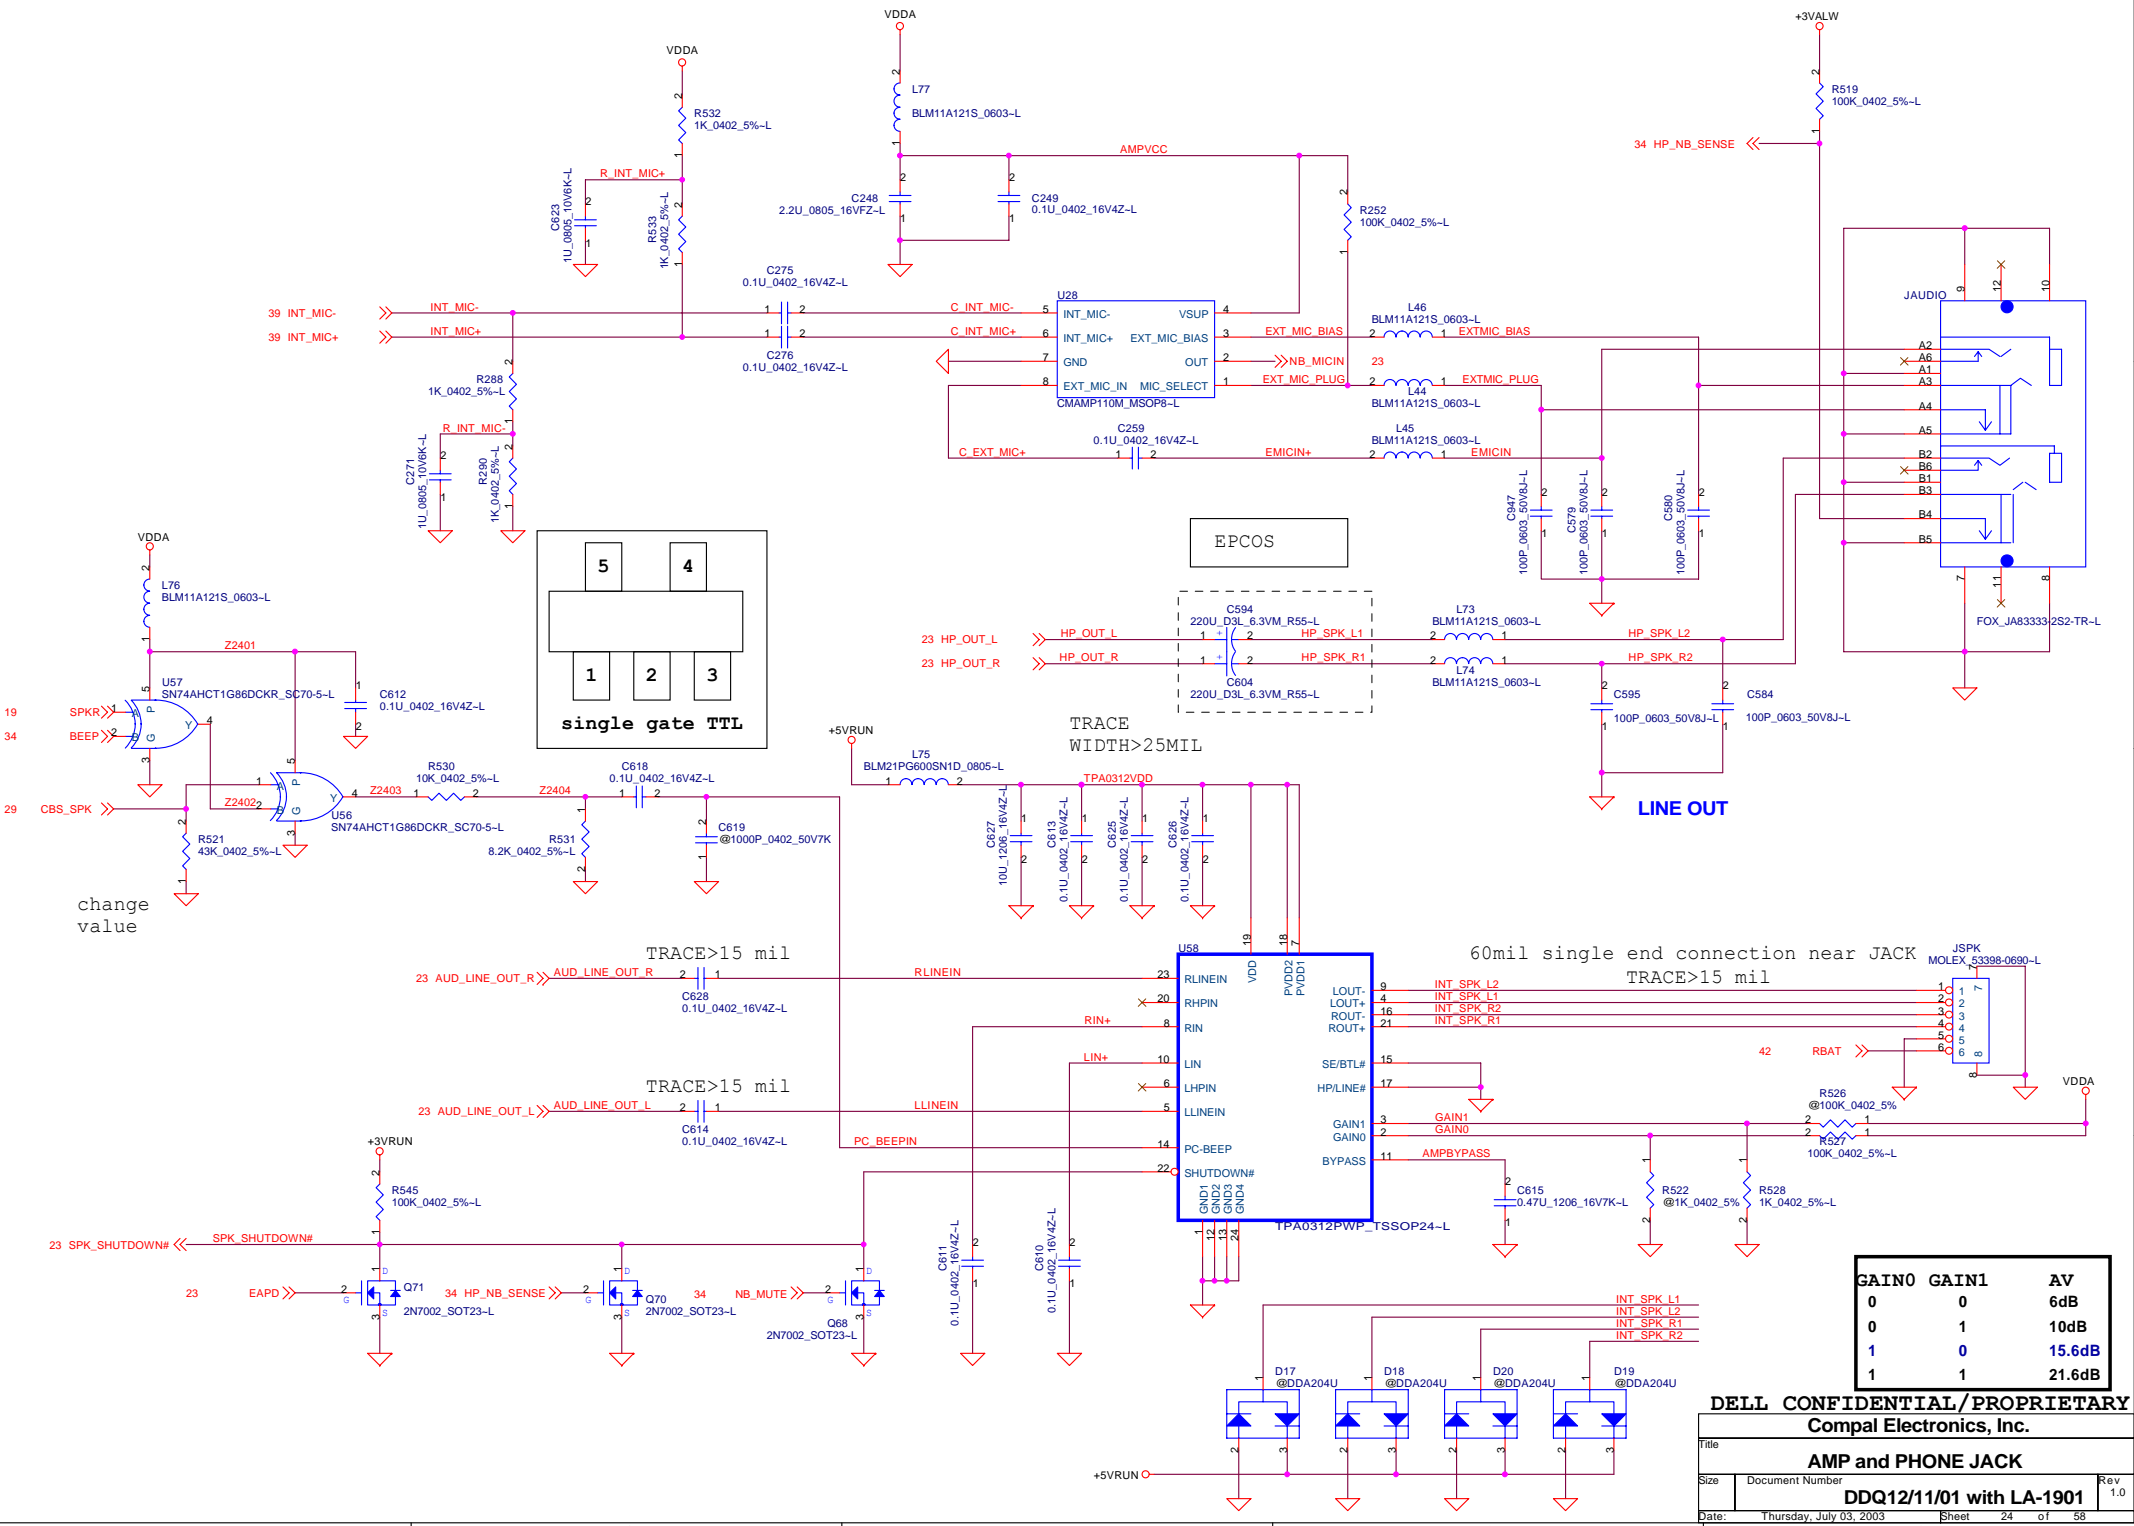
TRACE WIDTH > 25MIL

TRACE > 15 mil

60mil single end connection near JACK
TRACE > 15 mil

GAIN0	GAIN1	AV
0	0	6dB
0	1	10dB
1	0	15.6dB
1	1	21.6dB

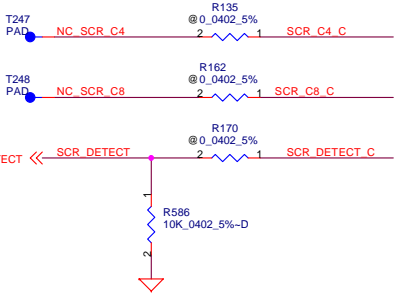
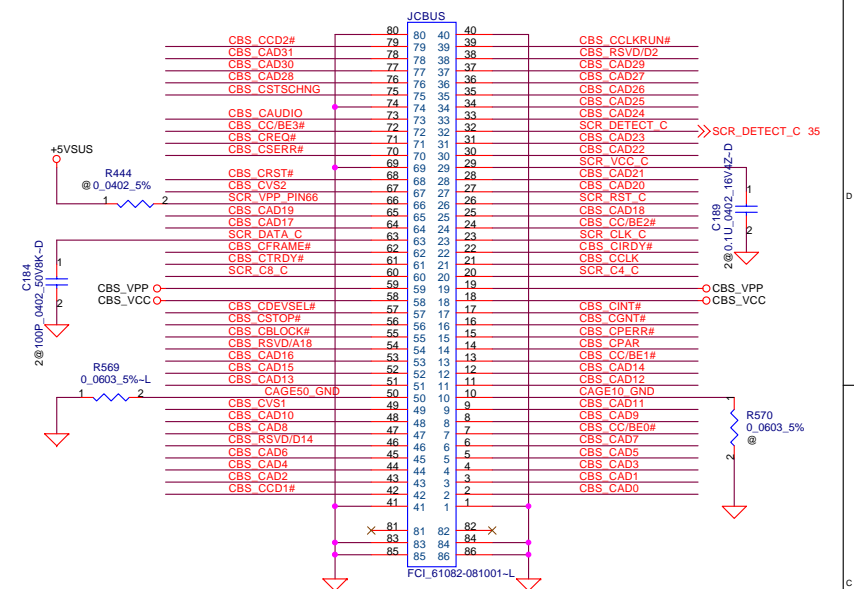
PCMCIA Controller		
DDQ12/11/01 with LA-1901		
File	Document Number	Rev
Size	Thursday, July 03, 2003	1.0
Date	Sheet 29 of 58

SHDN#	VPPD1	VPPD0	CBS_VPP
1	0	0	
1	0	1	
1	1	0	
1	1	1	
0	X	X

AVPP: 150mA

SHDN#	VCCD1#	VCCD0#	CBS_VCC
1	0	0	
1	0	1	
1	1	0	
1	1	1	
0	X	X

AVCC: 1A

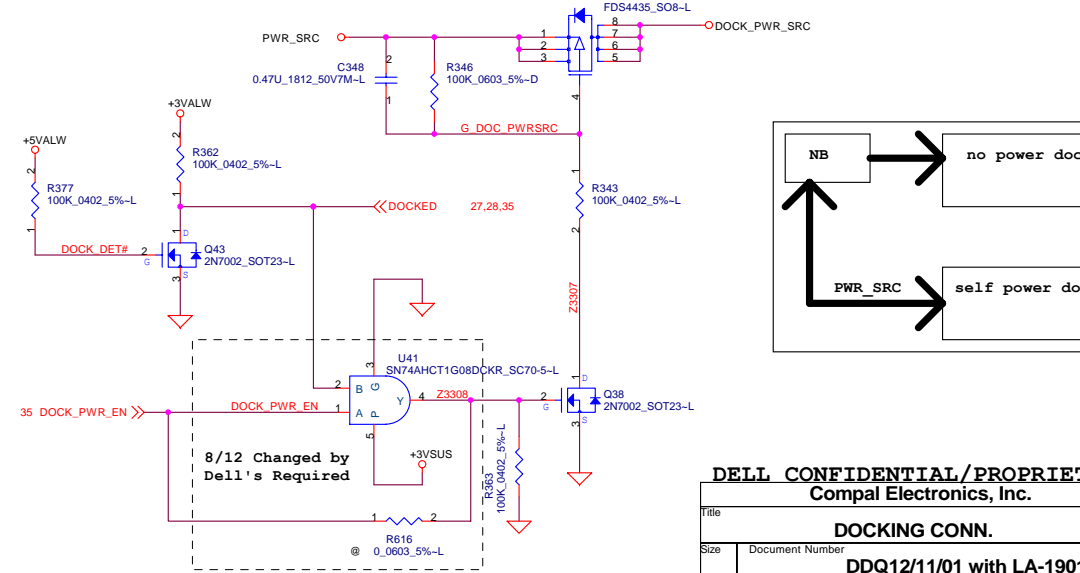
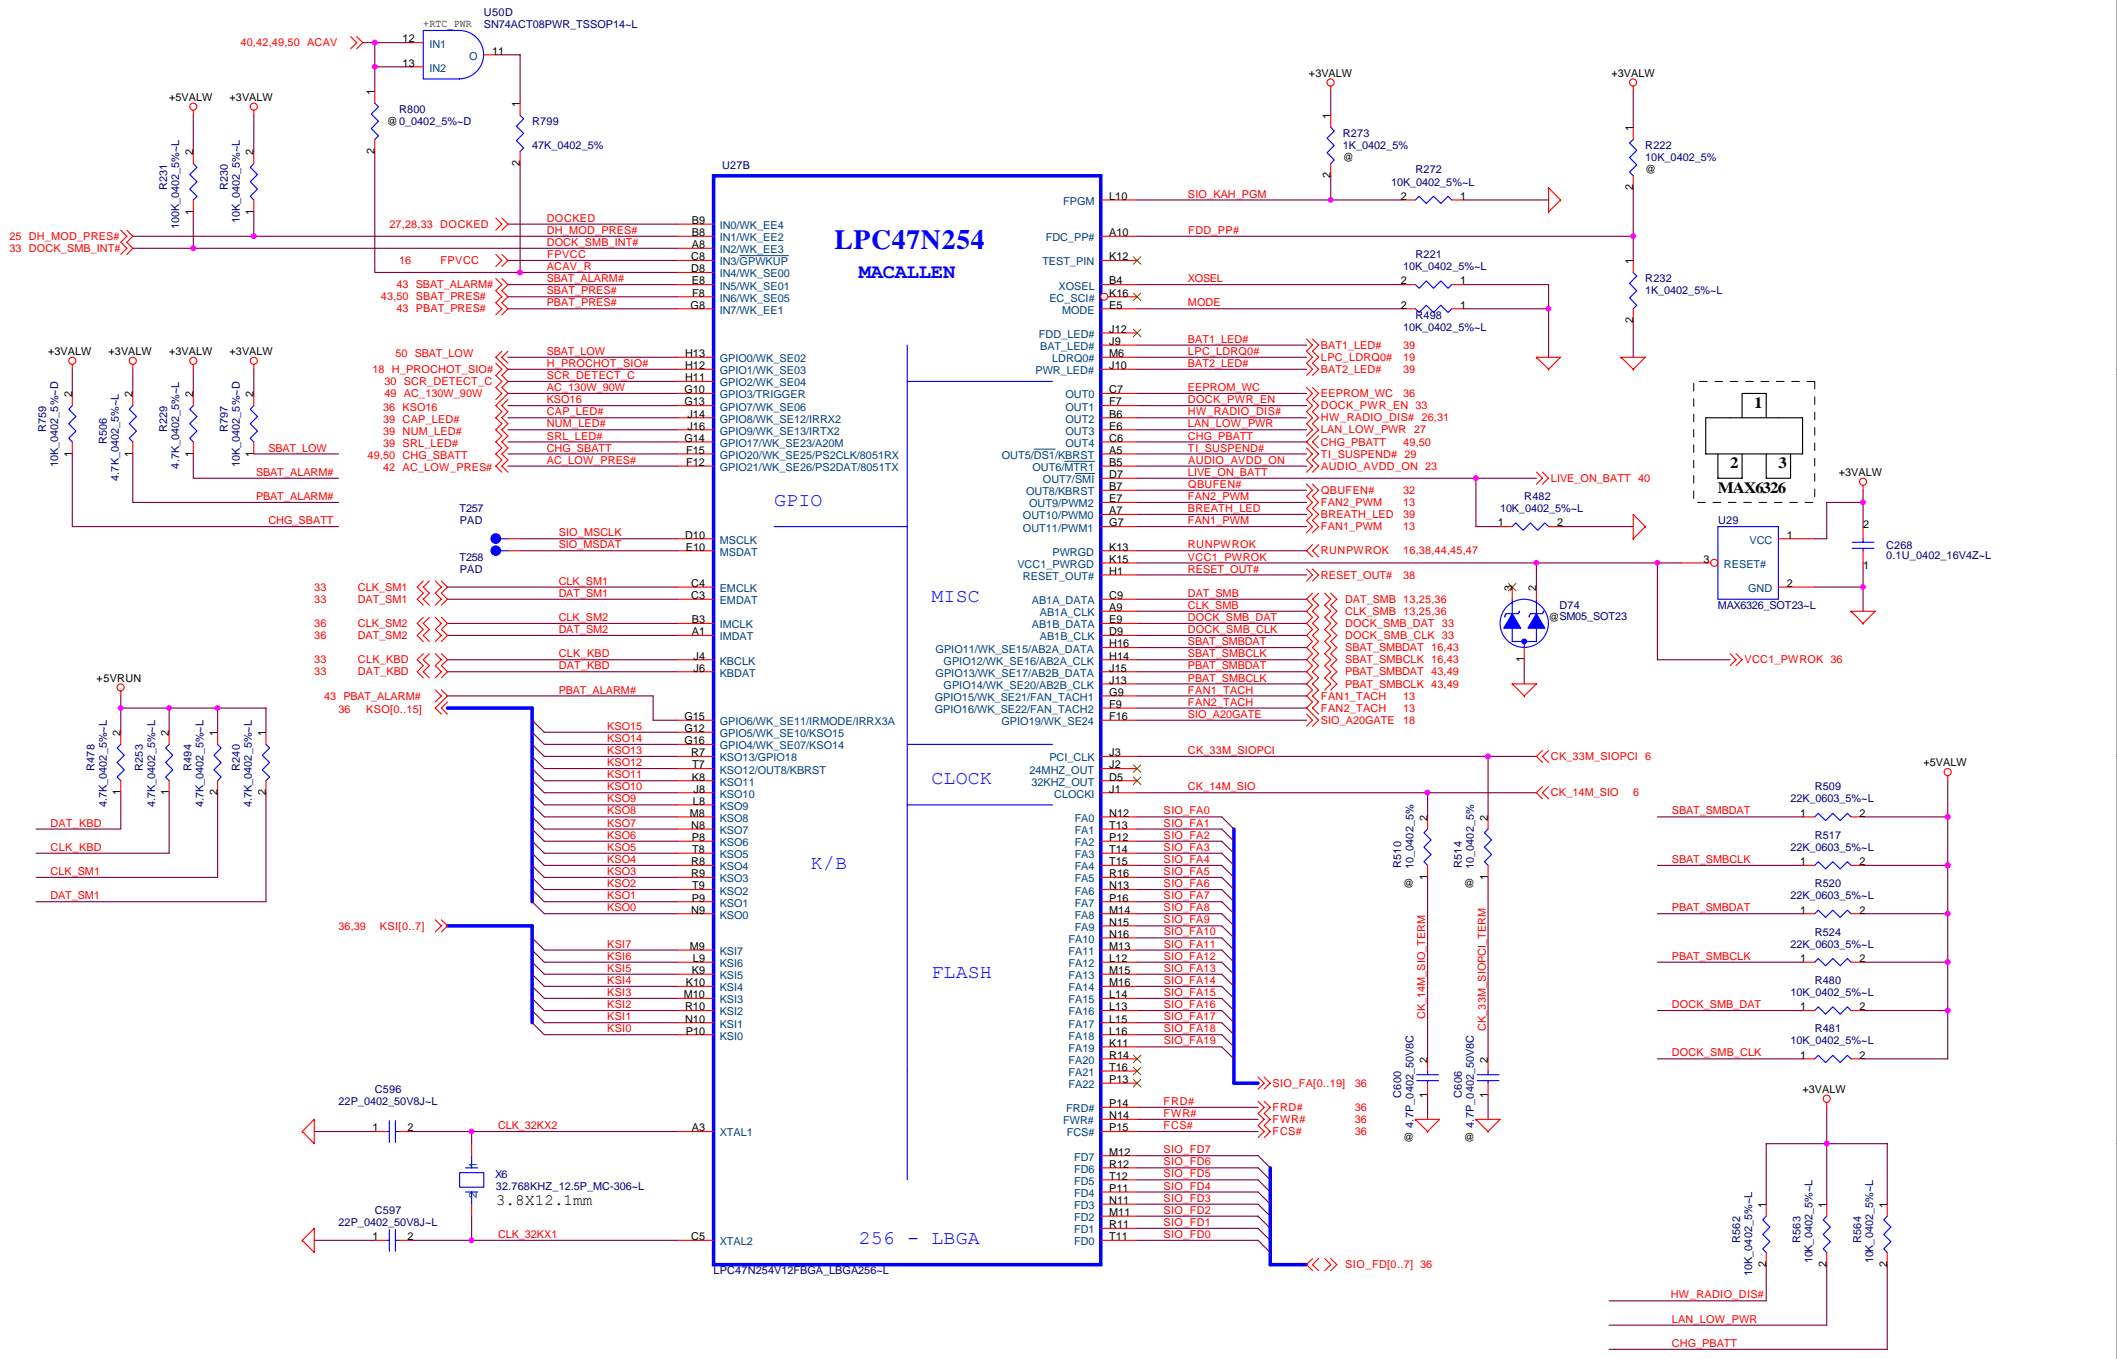
SIO (2/2)		
File		
Size	Document Number	Rev
	DDQ12/11/01 with LA-1901	1.0
Date	Thursday, July 03, 2003	Sheet 35 of 58

PLACE TERMINATIONS CLOSE TO DOCK CONNECTOR

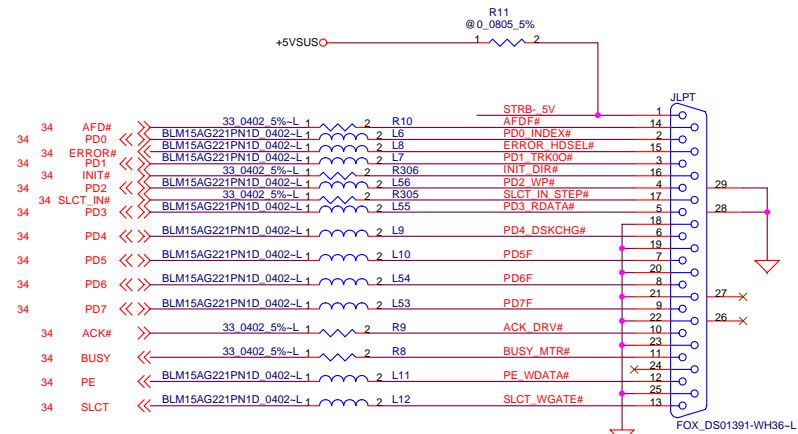
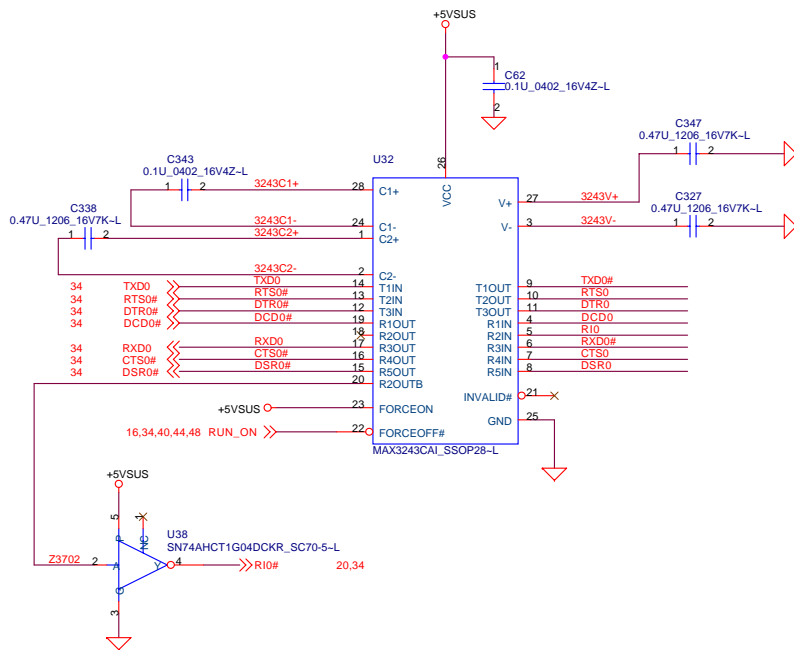
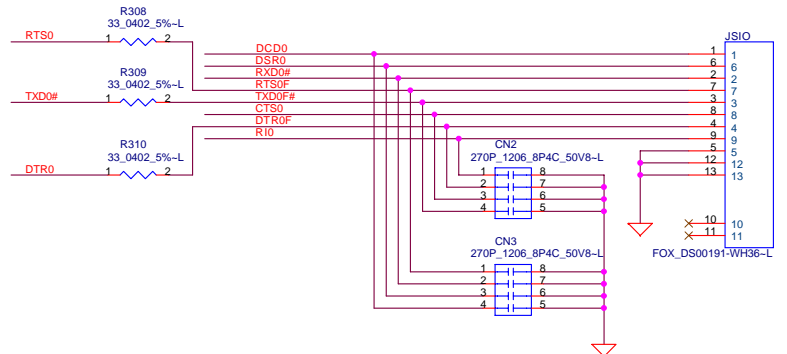
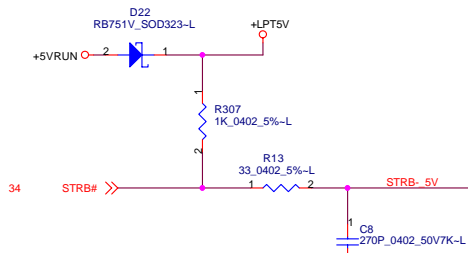
Title			LPT		
Size			Document Number		
Date			Thursday, July 03, 2003		
Sheet			37 of 58		
Rev			1.0		
DDQ12/11/01 with LA-1901

Parallel Port

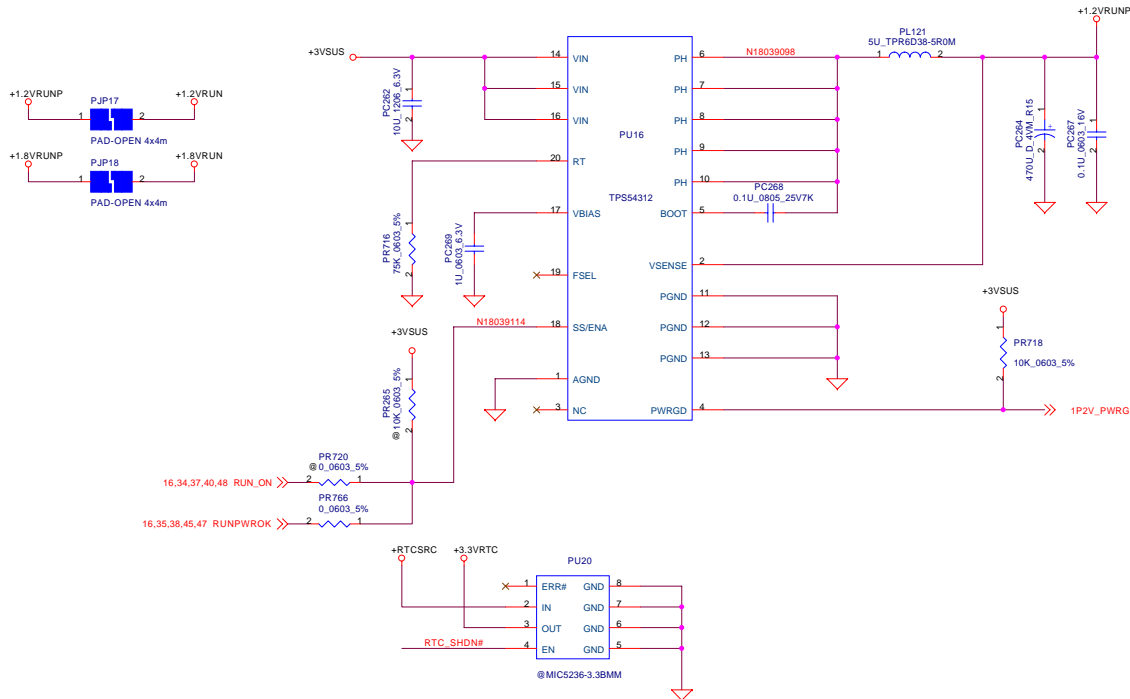
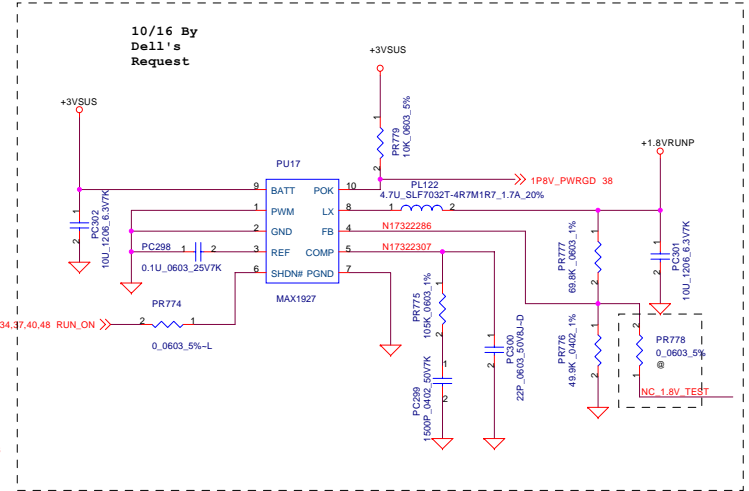
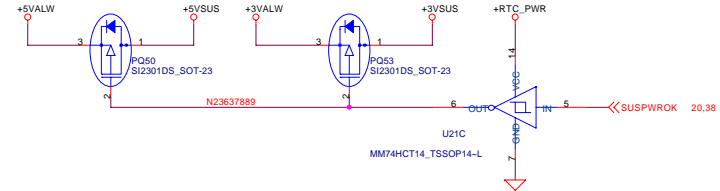
Title SCHEM,PLN,MN,KAPALUA II +1.2V & +1.8V

+1.2VRUN/+1.8VRUN SOURCE

Allows SUS planes to power ALW planes when possible

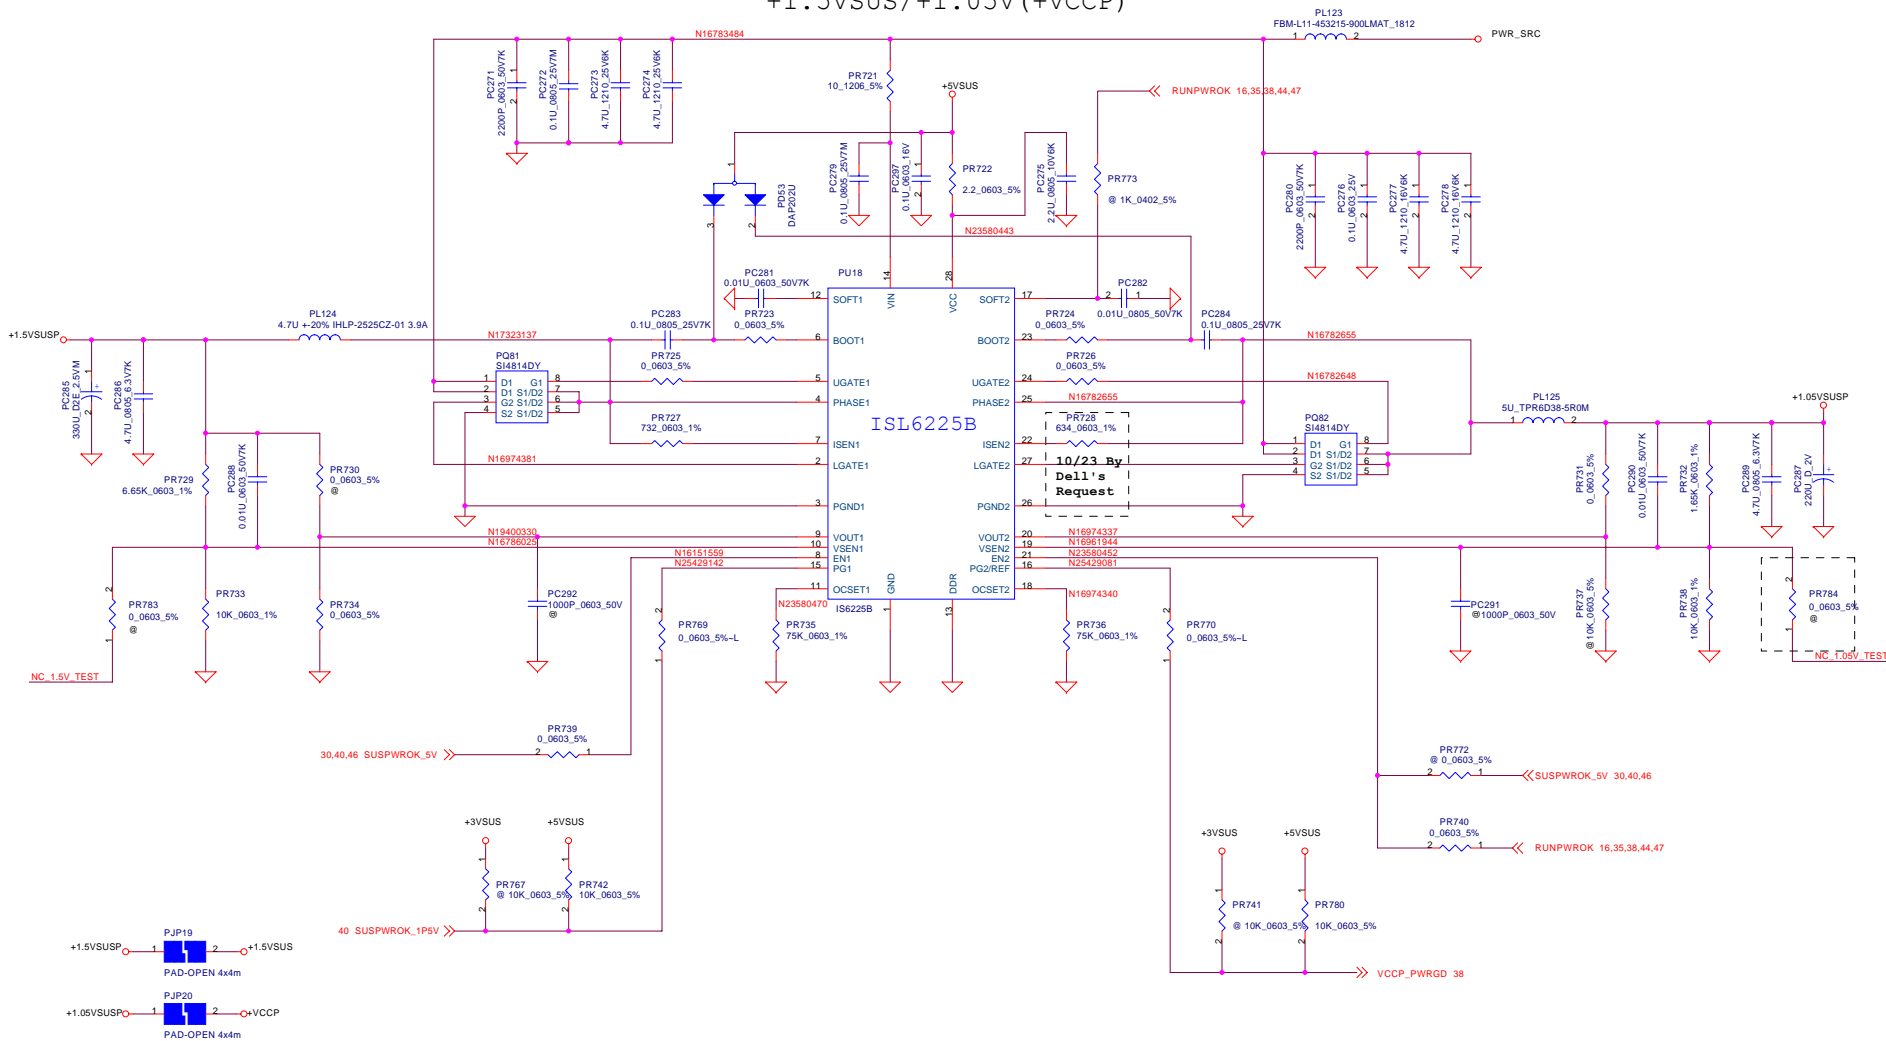
Title		SCHEM,PLN,MN,KAPALUA II +1.5V & +1.05V	
Size	Document Number	DDQ12/11/01 with LA-1901	Rev 1.0
Date:	Thursday, July 03, 2003	Sheet	45 of 58

+1.5VSUS/+1.05V (+VCCP)
