LBK-ADDs Schematic

DDQ12/LA1901 Schematic with Capture CIS and Function field
uFCPGA Banias
06-24-2003
REV: 1.0

Title			Rev
Cover Sheet			1.0
Size	Document Number	DDQ12/11/01 with LA-1901	
Date:	Thursday, July 03, 2003	Sheet	1 of 58

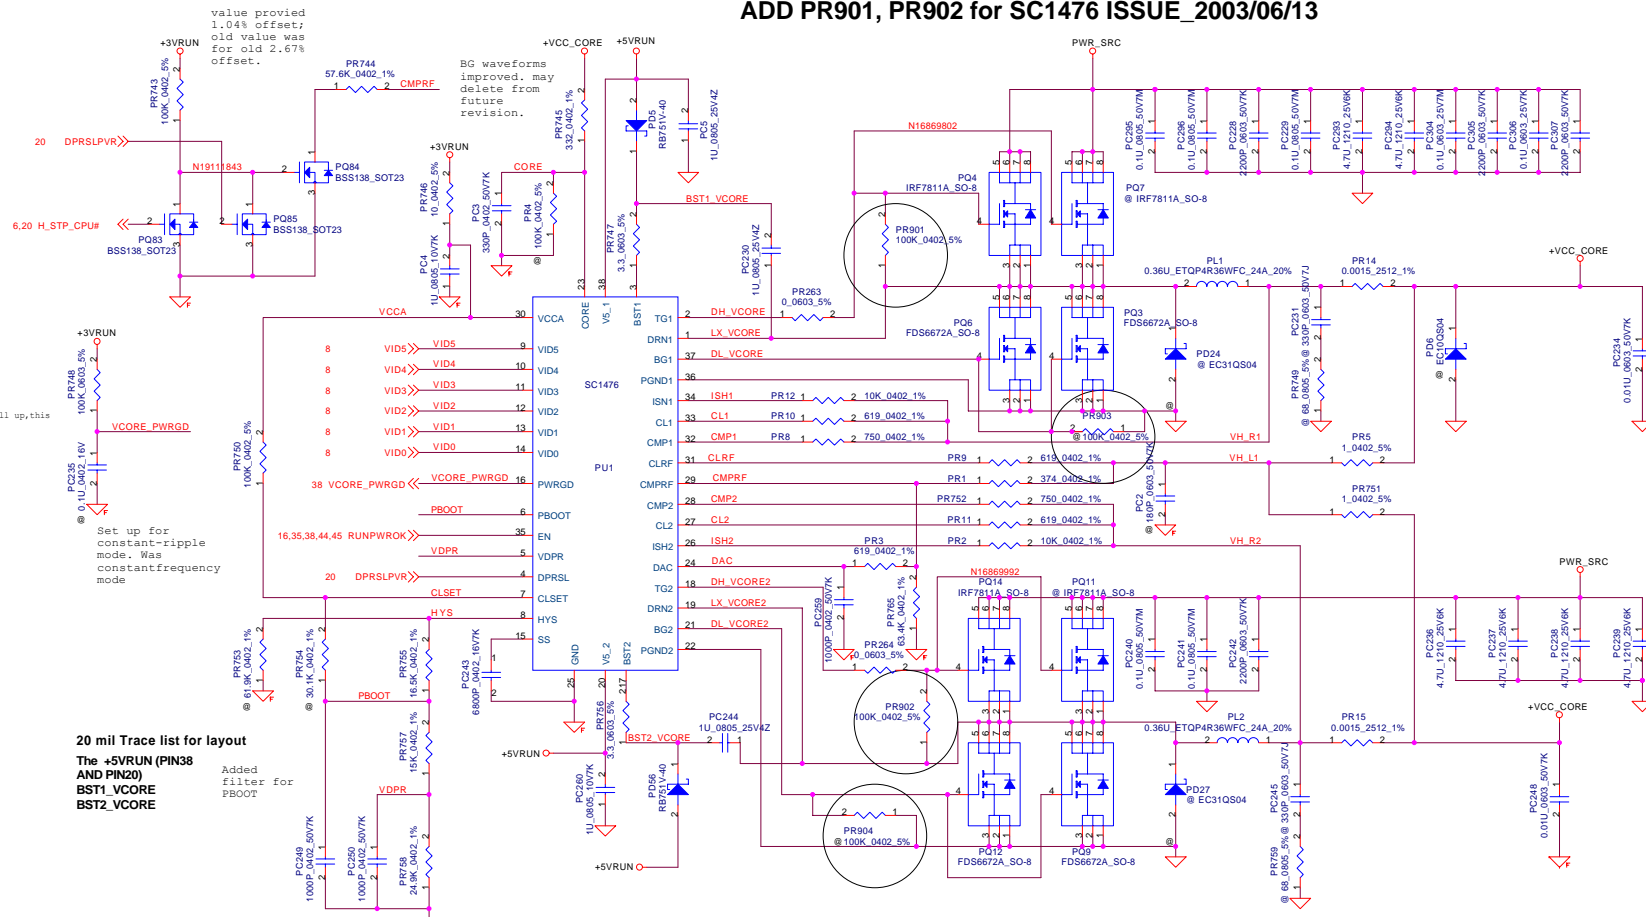
ADD PR901, PR902 for SC1476 ISSUE_2003/06/13

value provided
1.04% offset;
old value was
for old 2.67%
offset.

BG waveforms
improved. may
delete from
future
revision.

Set up for
constant-ripple
mode. Was
constant-frequency
mode

20 mil Trace list for layout
The +5VRUN (PIN38
AND PIN20)
BST1_VCORE
BST2_VCORE

100 mil Trace list for layout

- DH_VCORE
- LX_VCORE
- DL_VCORE
- DH_VCORE2
- LX_VCORE2
- DL_VCORE2

35	43	Battery Conn.	03/05/2003	Dell	To Use Common Part as Bondi (Change PN to DC04001440L)	JSBAT	A00
36	49	Chaqrger	03/05/2003	Compal	To Reduce RTC Bridge Battery Leakage Current (Changed Power Plane from +RTC_PWR to +5VALW)	PU13. PC216, PR637, PC217, Depop PR641	A01
37	42	Power DC-IN	04/07/2003	Dell	Reserve zero ohm bypass resistor for Rbatt fuse	Adding PR850 (@)	X00
38	42	Power DC-IN	04/07/2003	Dell	Fuse PFS2 Removed and Diode PD3 Shorted. The RBAT Blow Up (200 deg F). POP the Fuse instead of the Ohm resister.	Pop PFS2 Depop PR850	X00
39	45	1.5V / 1.05V	04/23/2003	Dell	Increased OCP for S3 Issue. (330Ω to 732Ω)	PR727	X00
40	47	Vcc_core	06/13/2003	Dell	CPU_core PWM SC1476 IC issue	Adding PR901, PR902 to 100K, PR903 (@) PR904 (@)	A00

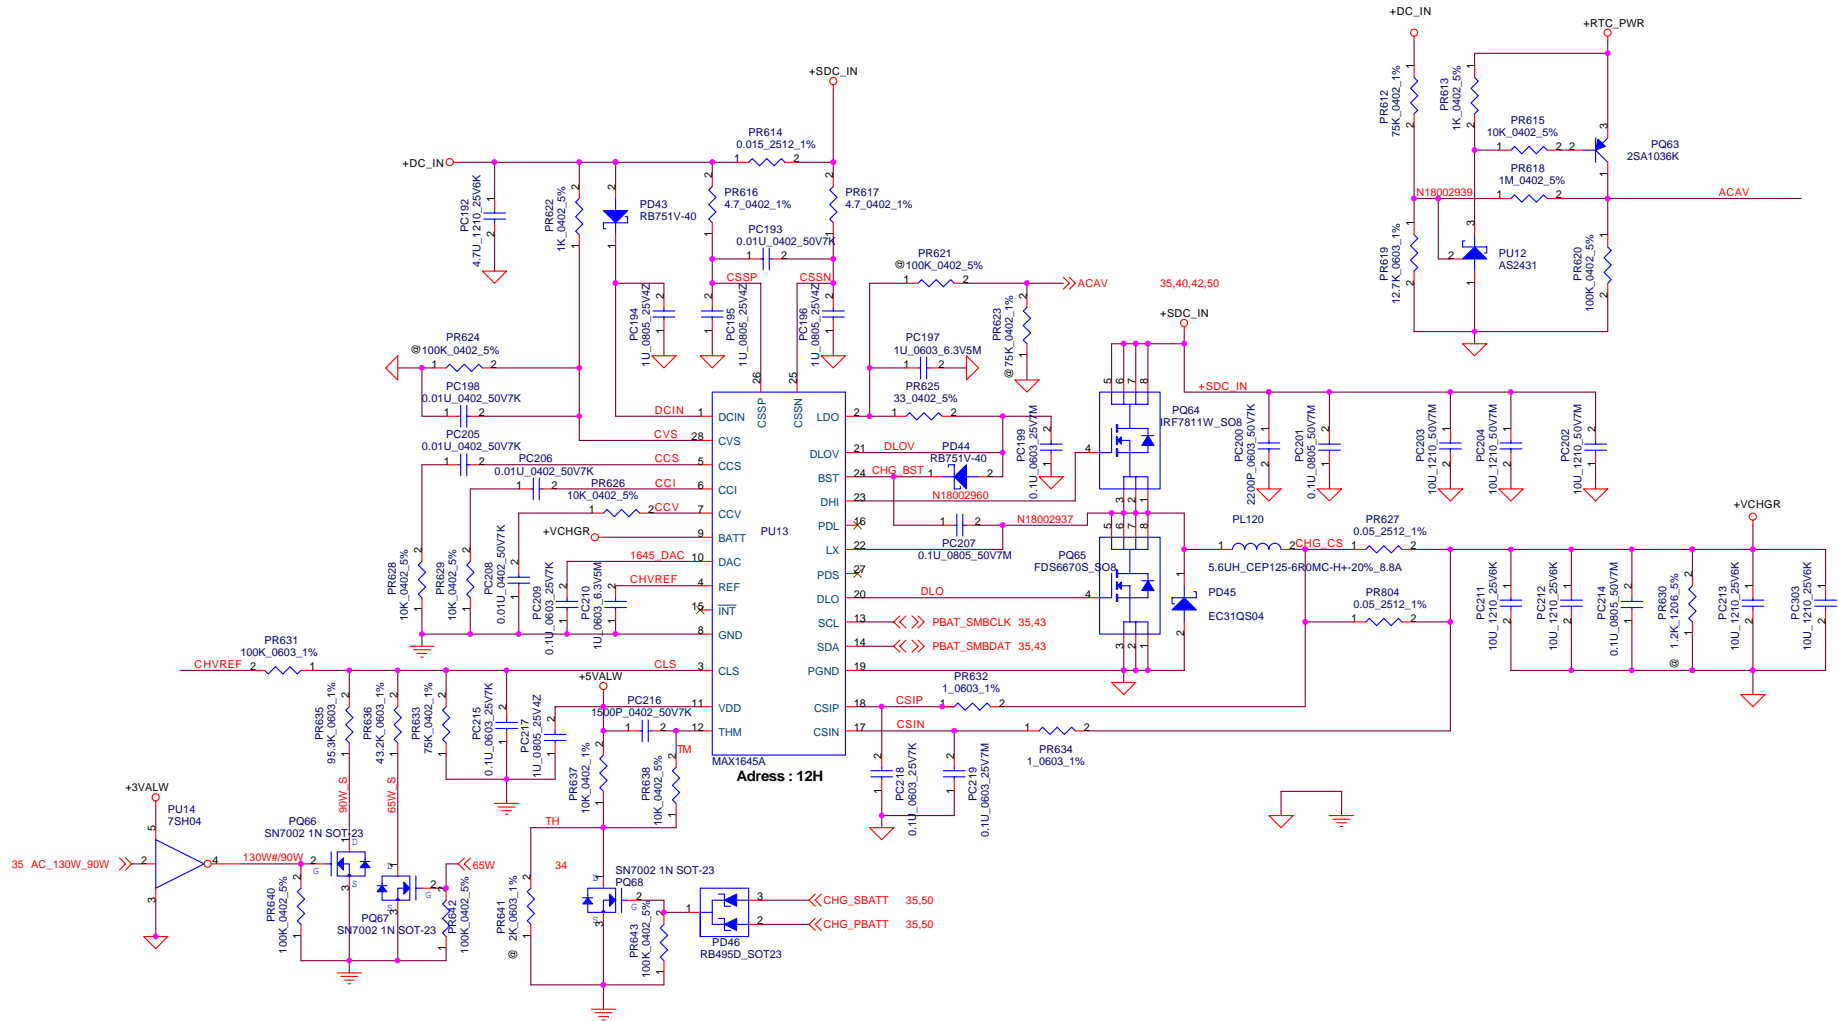
Title		SCHEM,PLN,MN,KAPALUA II CHARGER CONTROL	
Size	Document Number	Rev	1.0
Date: Thursday, July 03, 2003		Sheet	49 of 58

65W (2.93A)	90W (4.0A)	130W (5.85A)
65W	H	L	L
AC_130W_90W	H	L	H
