# LKB-ADDs, Plus Schematic

DDQ12/LA1901 Schematic with Capture CIS and Function field  
uFCPGA Banias  
01-02-2004  
REV: 3.0

Title		
Cover Sheet		
Size	Document Number	Rev
	DDQ12/11/01 with LA-1901	3.0
Date:	Wednesday, January 07, 2004	Sheet 1 of 59

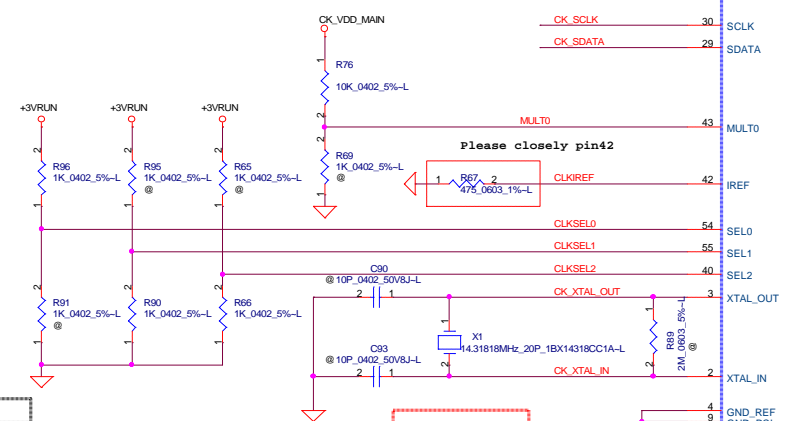
Place crystal within  
500 mils of CK408

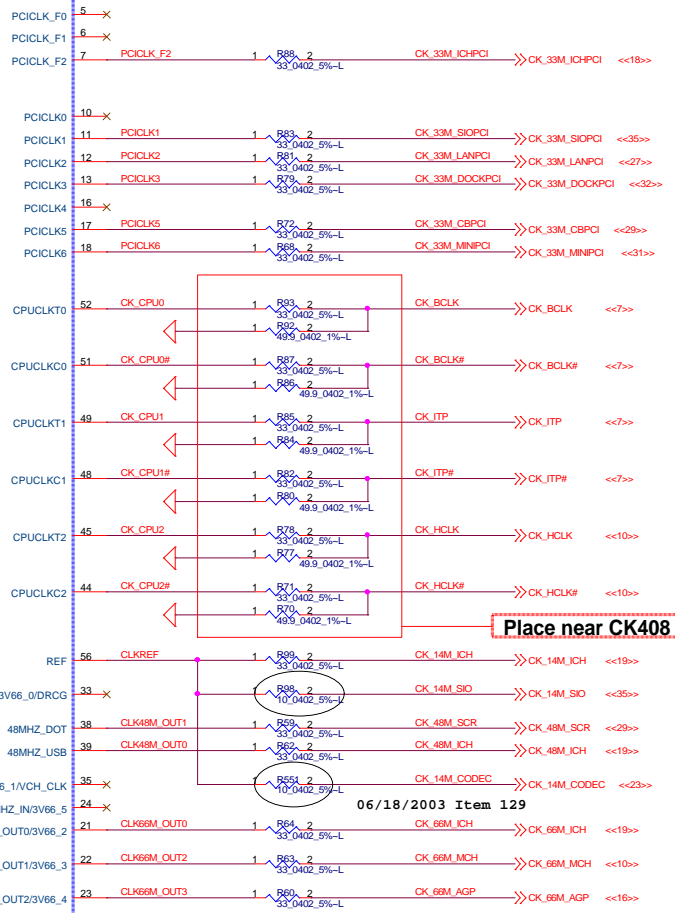
Place near CK408

S2	S1	S0	CPU	3V66[0.4]	3V66_5/66IN	
1	0	0	66	66IN	66	Input
1	0	1	100	66IN	66	Input
1	1	0	200	66IN	66	Input
1	1	1	133	66IN	66	Input
0	0	0	66	66	66	Input
0	0	1	100	66	66	Input
0	1	0	200	66	66	Input
0	1	1	133	66	66	Input
Mid	0	0	Hi-z	Hi-z	Hi-z	
Mid	0	1	TCLK/2	TCLK/2	TCLK/2	
Mid	1	0	Reserve	Reserve	Reserve	
Mid	1	1	Reserve	Reserve	Reserve

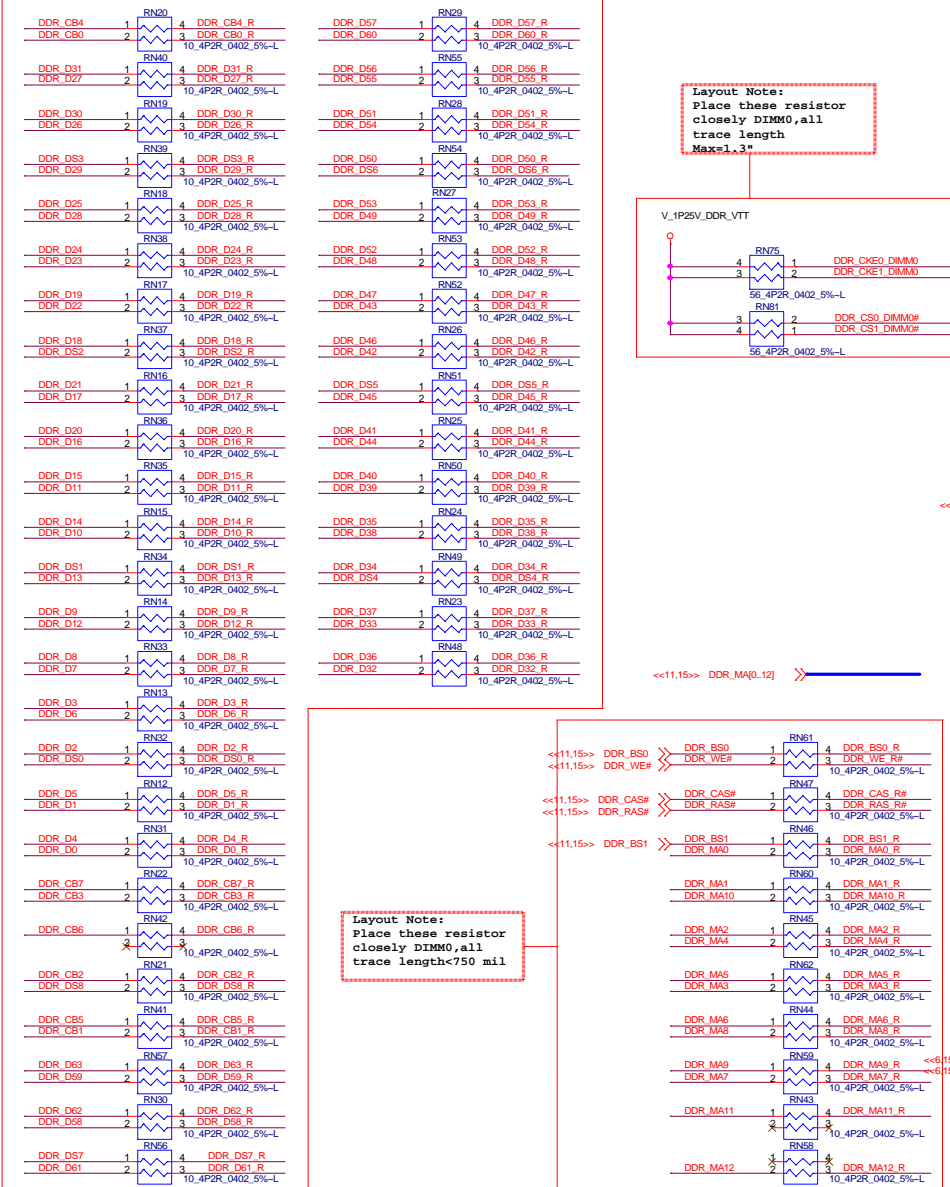
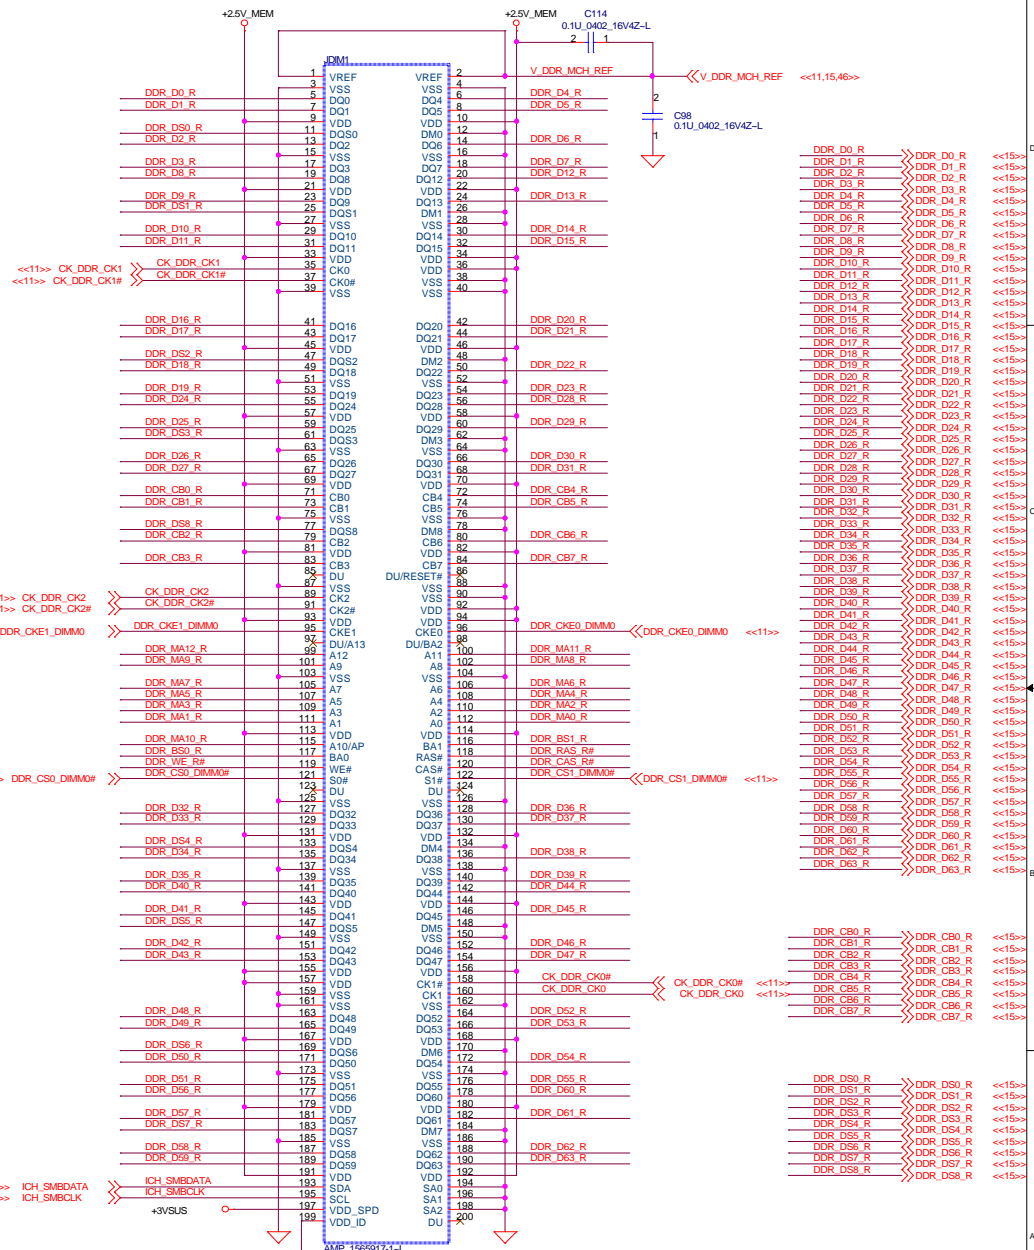
Title			
<b>DDR-SODIMM SLOT1</b>			
Size	Document Number	Rev	
		<b>DDQ12/1/01 with LA-1901</b>	
Date:	Wednesday, January 07, 2004	Sheet	14 of 59

**Layout Note:**  
 Place these resistor  
 closely DIMM0,all  
 trace length<750 mil

**Layout Note:**  
 Place these resistor  
 closely DIMM0,all  
 trace length  
 Max=1.3"

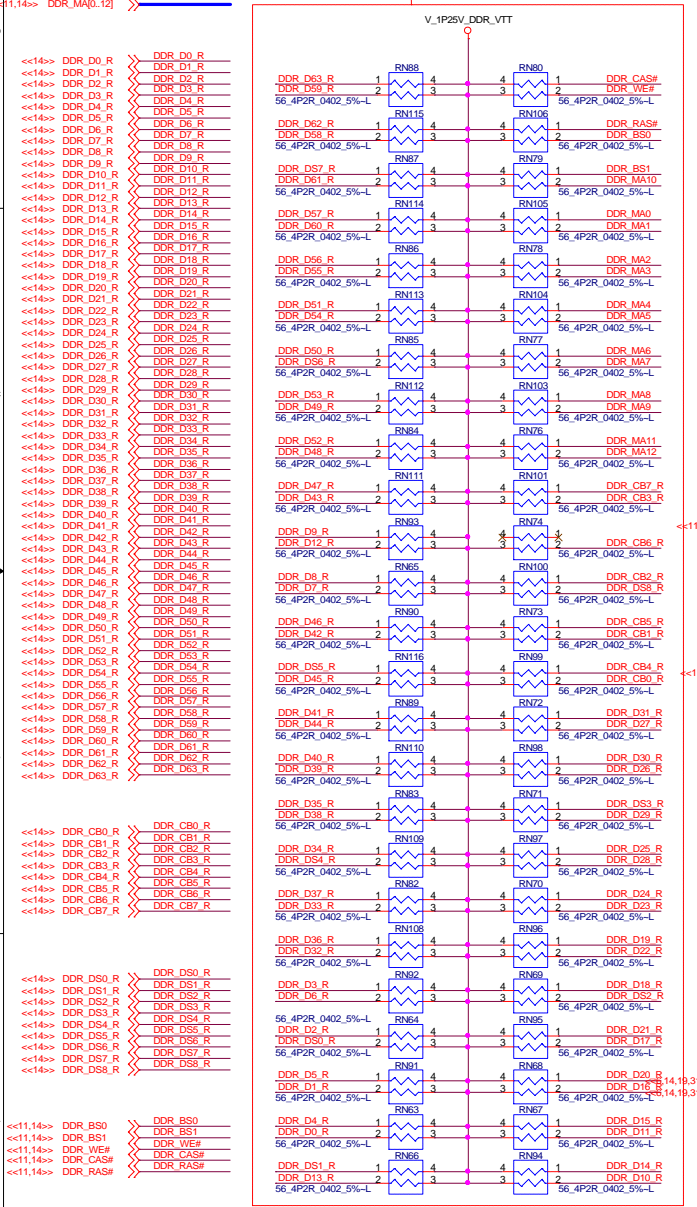
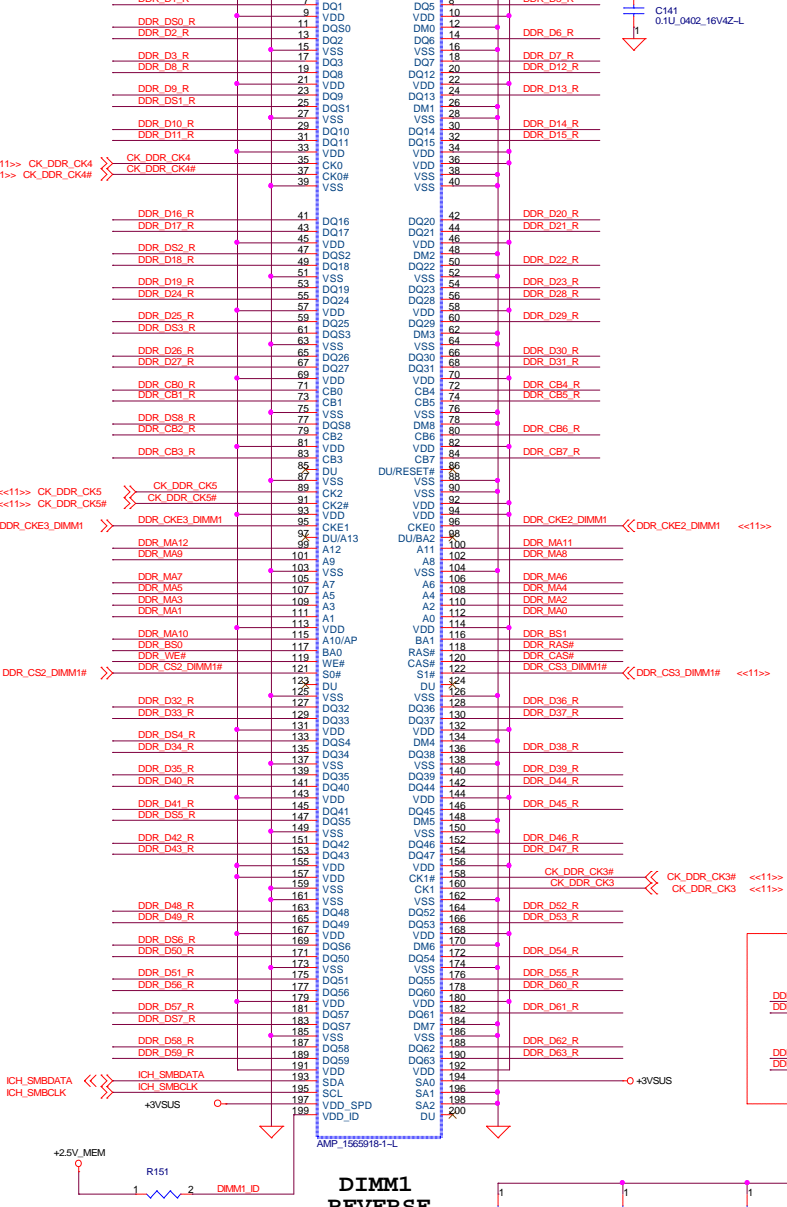
Title		DDR-SODIMM SLOT2	
Size	Document Number	DDQ12/11/01 with LA-1901	
Date:	Wednesday, January 07, 2004	Sheet	15 of 59
Rev	3.0

**Layout Note:**  
Place these resistors closely DIMM1, all trace length=800 mil

**Layout Note:**  
Place CAP near SODIMM

One .1uF cap per power pin. Place each cap close to pin.

**Layout Note:**  
Place these resistor closely DIMM1, all trace length Max=1.3"

**DIMM1 REVERSE**

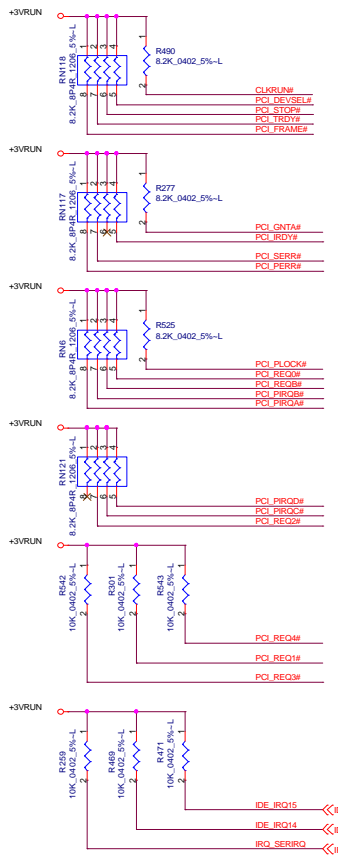
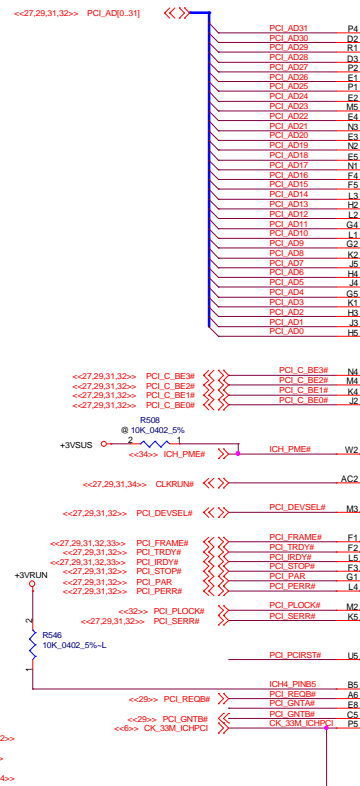
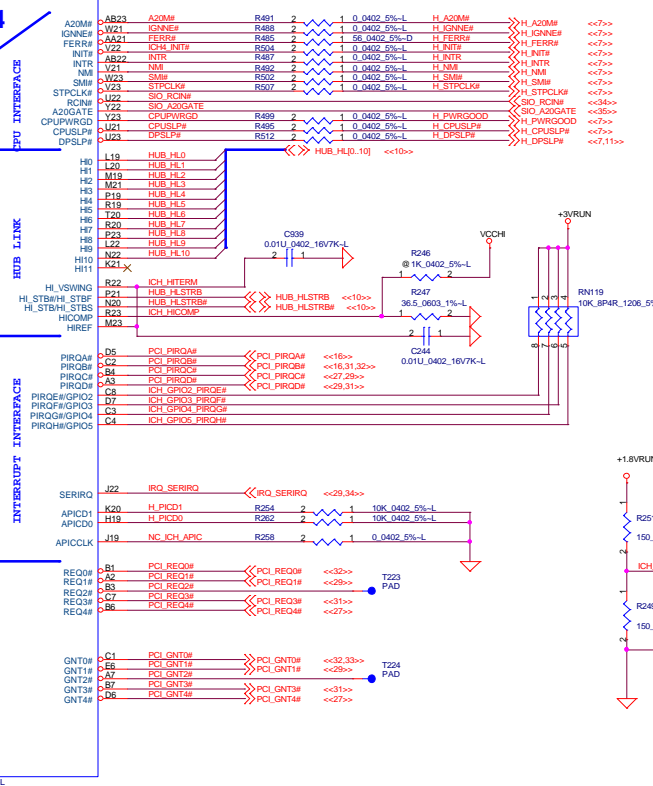
Title		ICH4(1/4)	
Size	Document Number	DDQ12/11/01 with LA-1901	
Date	Wednesday, January 07, 2004	Sheet	16 of 58

Hub interface Layout:  
Route signal with 5/15 trace/space, < 8 inches  
Signal must match +/- 0.1" of HL\_STB/STB# signals.

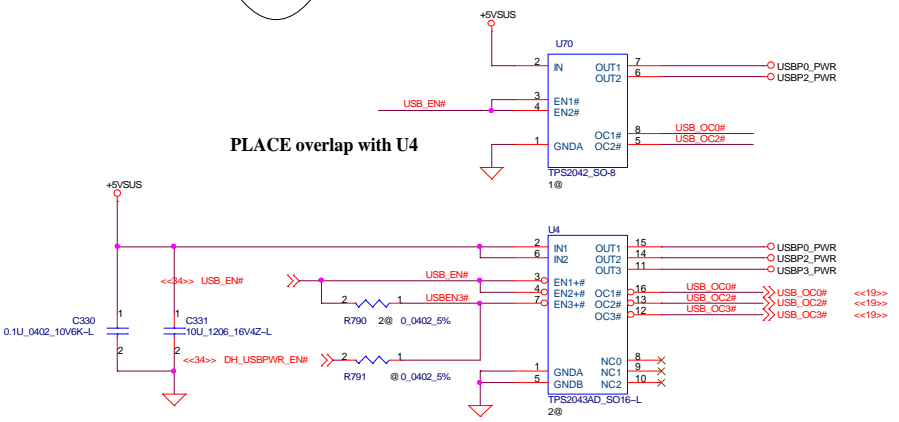
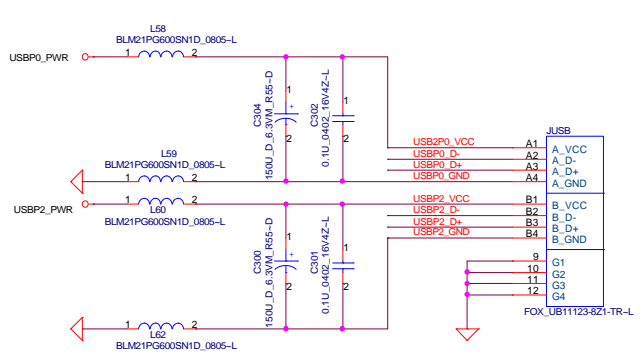
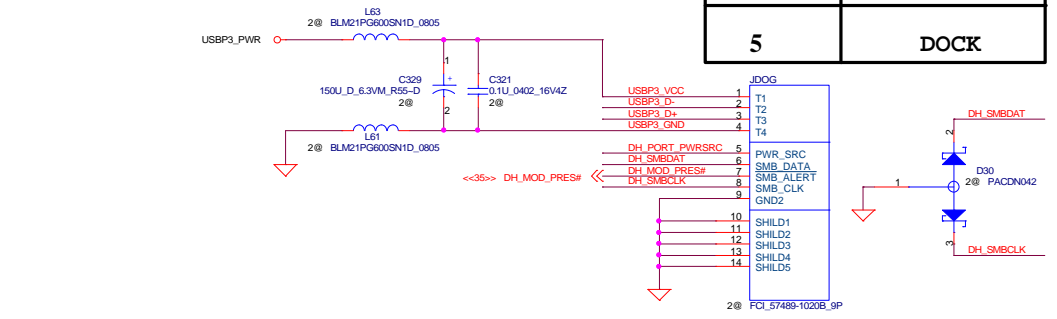
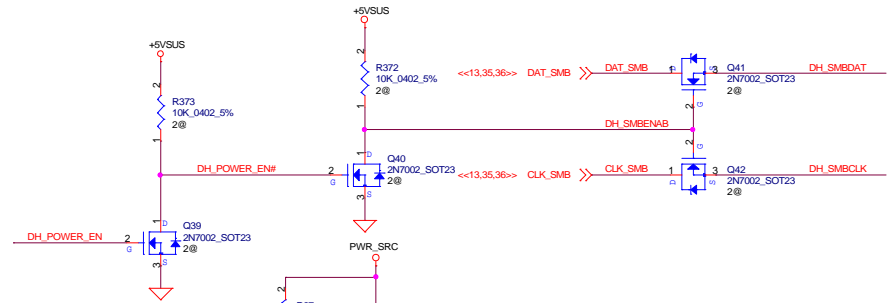
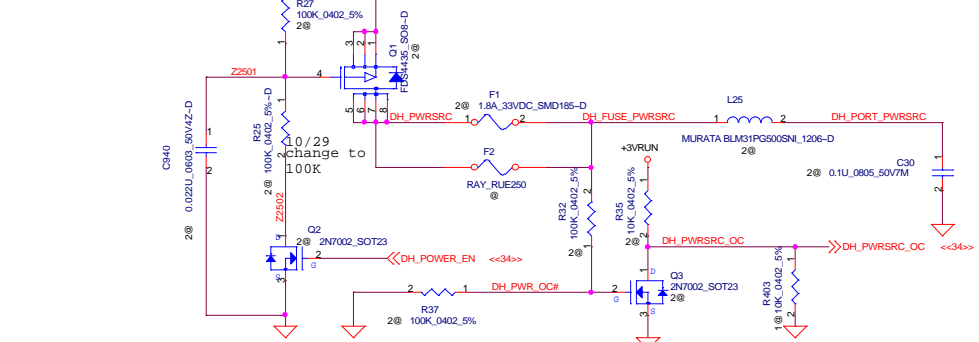
USB 2.0		
Title	Document Number	Rev
	DDQ12/11/01 with LA-1901	3.0
Date:	Wednesday, January 07, 2004	Sheet 25 of 59

PLACE CHOKE  
NEAR  
CONNECTOR

PLACE overlap with U4

USB PORT#	DESTINATION
0	BACK
1	BT
2	BACK
3	DOG
4	MOD
5	DOCK

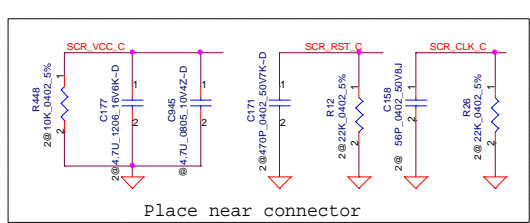
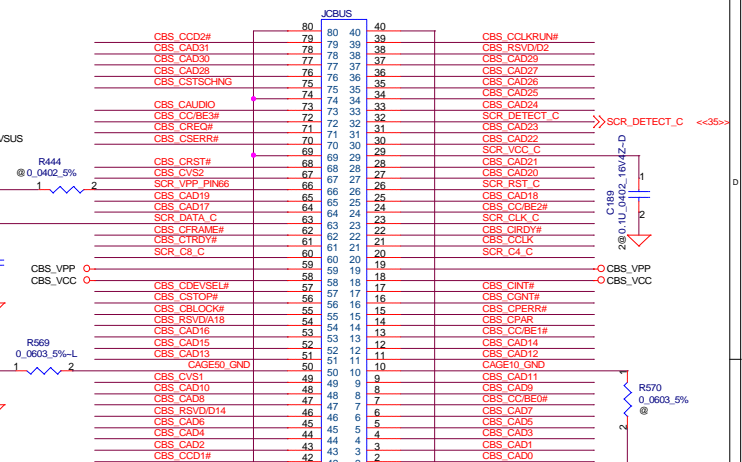
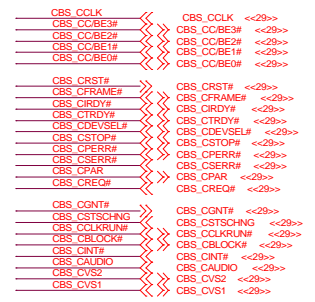
**CardBus Socket**

SHDN#	VPPD1	VPPD0	CBS_VPP
1	0	0	
1	0	1	
1	1	0	
1	1	1	
0	X	X

AVPP: 150mA

SHDN#	VCCD1#	VCCD0#	CBS_VCC
1	0	0	
1	0	1	
1	1	0	
1	1	1	
0	X	X

AVCC: 1A

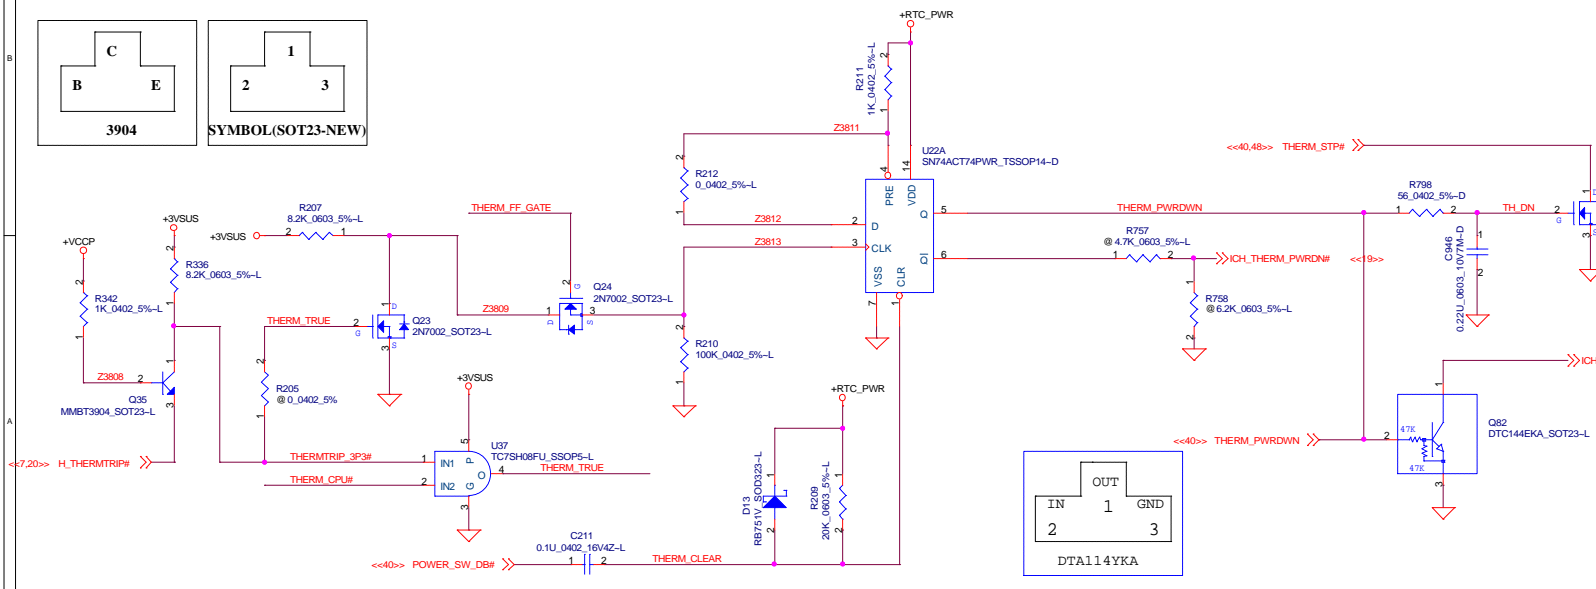
**HYST:**  
VCC for 10 degree  
GND for 2 degree

**SET-HOT Vrsion**

MAX6509 goes in CPU cavity.  
Discretes go outside.

Thermistor goes in CPU cavity.  
Dell P/N 8K573  
Semitech P/N 103KT2125-1P

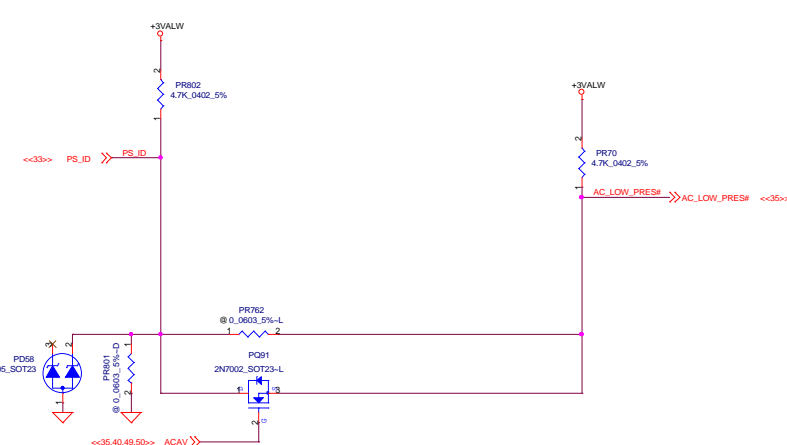
PET on when in suspend, current flow is from that to PWR\_SRC to sustain power during battery swap mode  
depop pr82,pq35,pq36

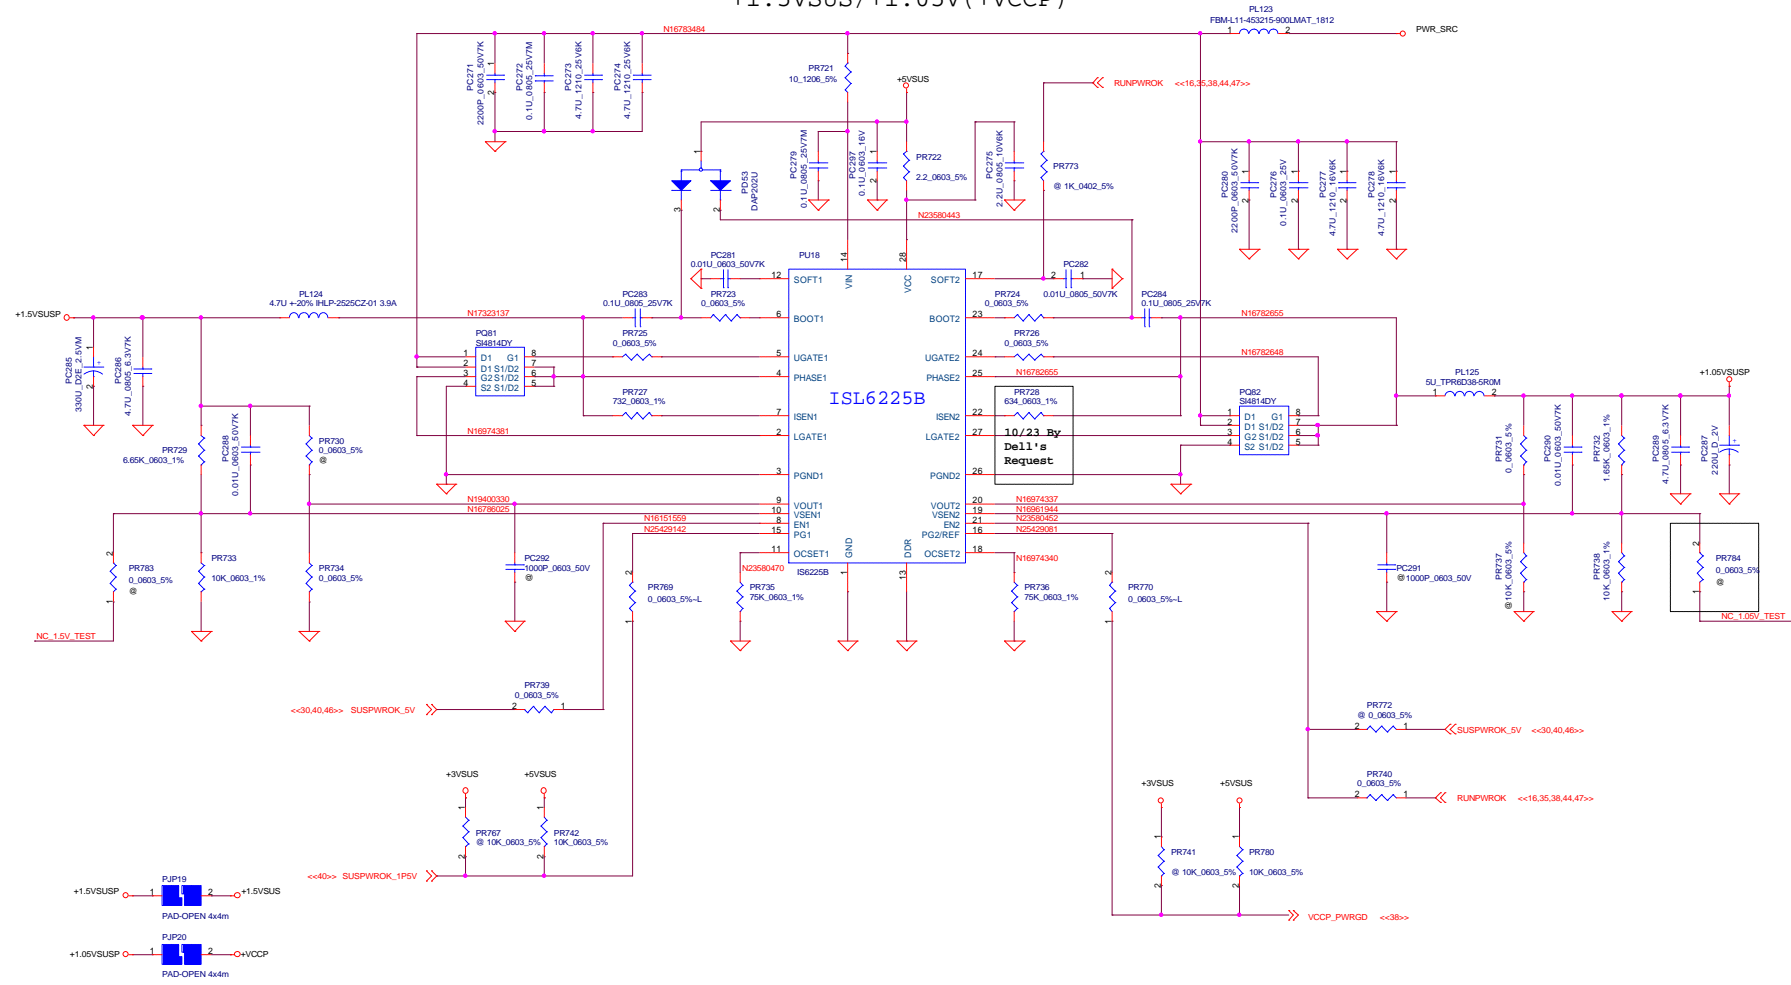
Title SCHEM\_PLN,MN,KAPALUA II +1.5V & +1.05V

+1.5VSUS/+1.05V (+VCCP)
