Kapalua Schematic

BDQ11/LA1601 Schematic with Capture CIS and Function field
uFCPGA Banias
12-27-2002
REV: 0.4

Title		
Cover Sheet		
Size	Document Number	Rev
	BDQ11/LA-1601	0.4
Date:	星期五, 十二月 27, 2002	Sheet 1 of 56

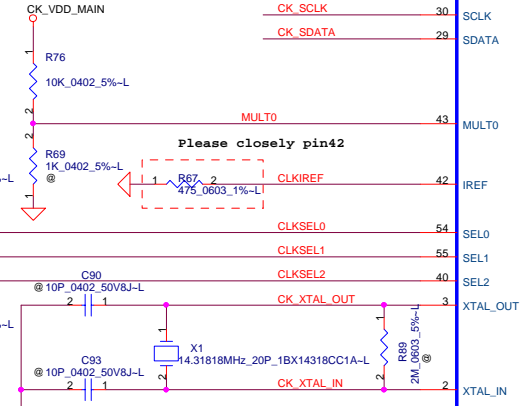
Place crystal within
500 mils of CK408

S2	S1	S0	CPU	3V66[0..4]	3V66_5/66IN
1	0	0	66	66IN	66 Input
1	0	1	100	66IN	66 Input
1	1	0	200	66IN	66 Input
1	1	1	133	66IN	66 Input
0	0	0	66	66	66 Input
0	0	1	100	66	66 Input
0	1	0	200	66	66 Input
0	1	1	133	66	66 Input
Mid	0	0	Hi-z	Hi-z	Hi-z
Mid	0	1	TCLK/2	TCLK/2	TCLK/2
Mid	1	0	Reserve	Reserve	Reserve
Mid	1	1	Reserve	Reserve	Reserve

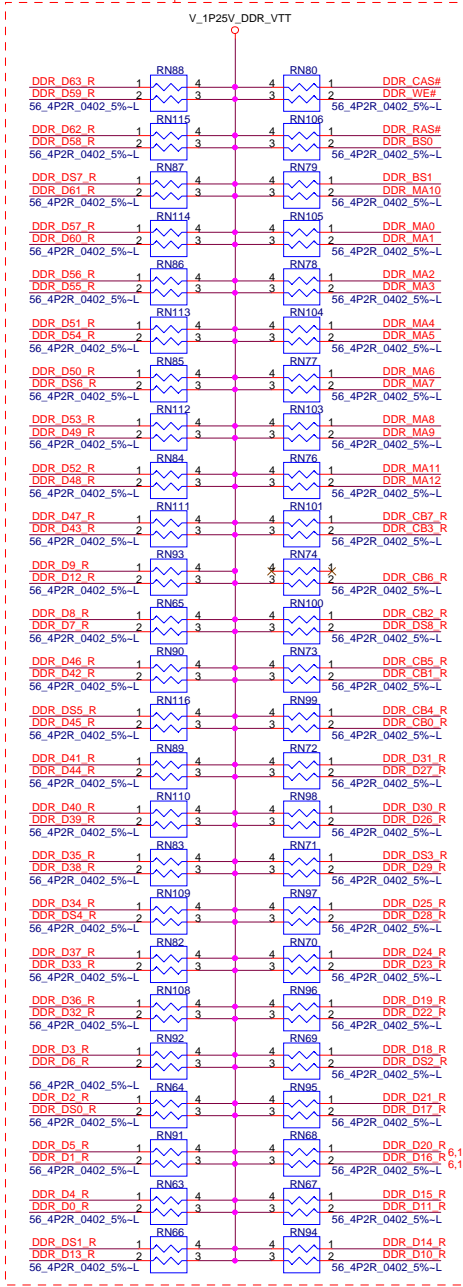
Layout Note:
Place these resistors
closely DIMM1, all
trace length=800 mil

Layout Note:
Place CAP
near SODIMM

One .1uF cap per power pin.
Place each cap close to
pin:

Layout Note:
Place this resistor
closely DIMM1, all
trace length
Max=1.3"

Place by pin197 of each SODIMM
